Targeted Bacteria Monitoring Project Field Investigation Final Report Assessment Unit 1007T _01 Bintliff Ditch

May 8, 2023

Environmental Institute of Houston, University of Houston-Clear Lake

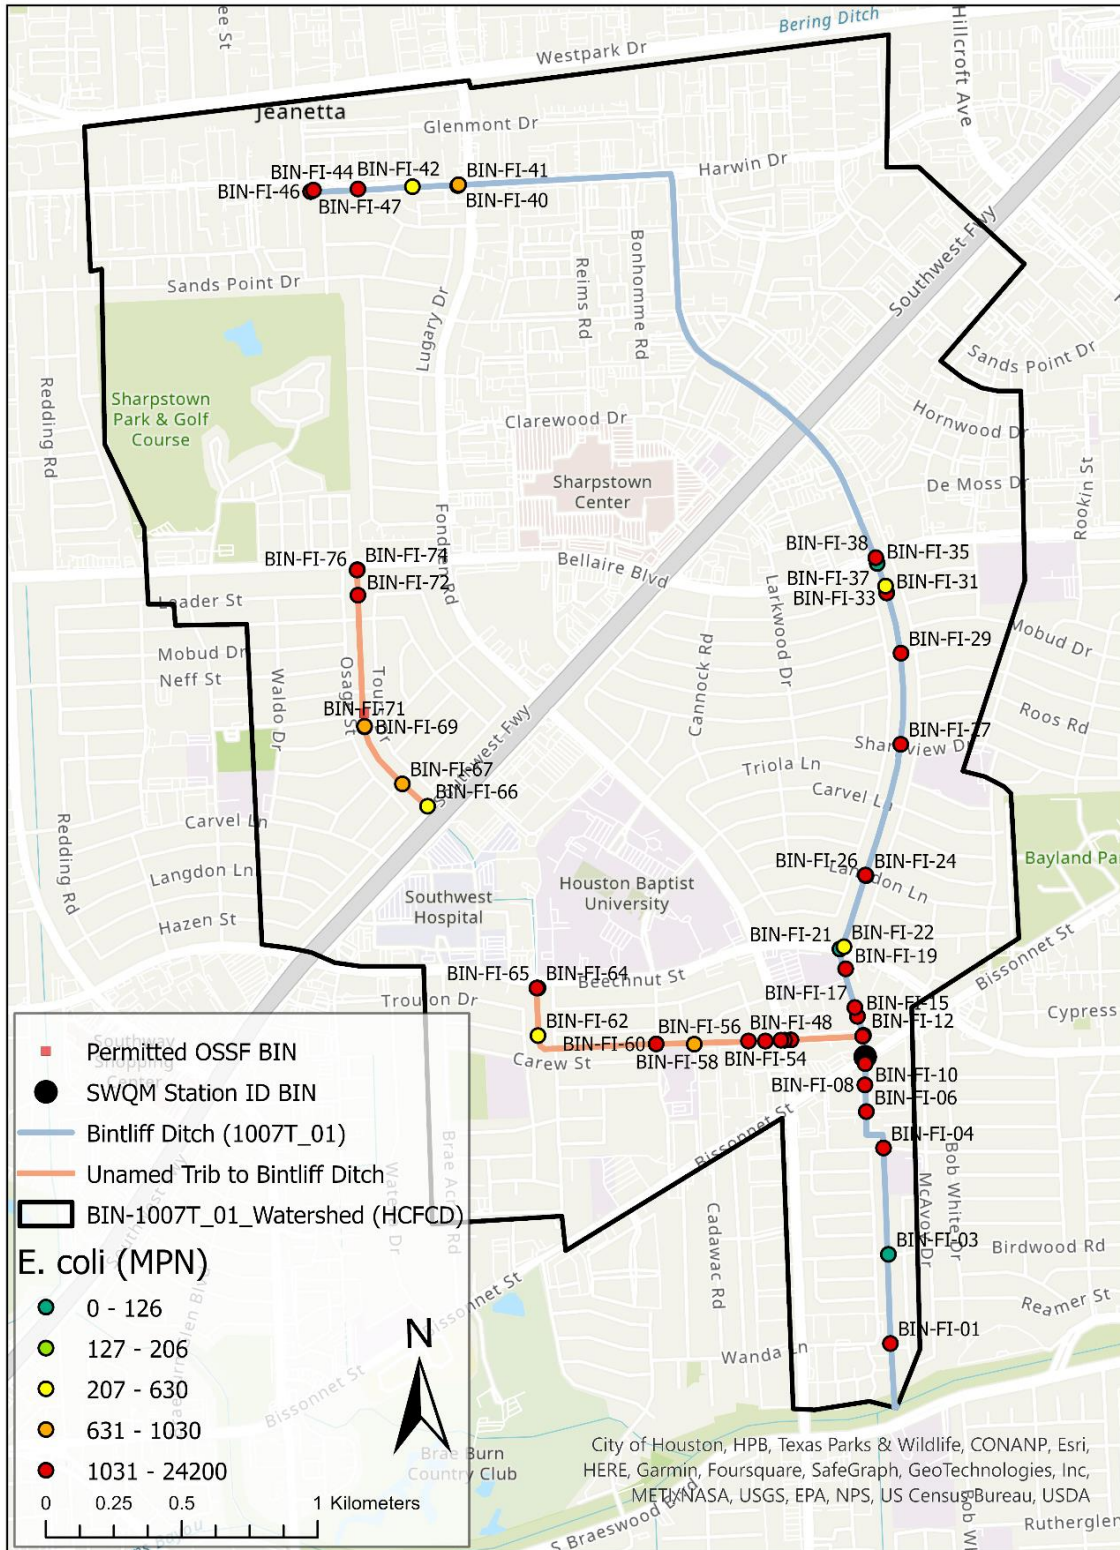
Figure 2: Field investigation bacteria sampling results from 04/06/2021 on Bintliff Ditch (AU 1007T_01).

The FI of the main stream and tributary was conducted on April 6, 2021 (nine days since last significant rainfall) and a total of 76 bacteria samples were collected. Findings from the 2021 FI indicated that there are many broken concrete and metal pipes throughout the segment and the unnamed tributary was contributing high bacteria levels into the segment. The values of the bacteria samples collected from downstream of permitted outfalls, or directly from unpermitted outfalls are illustrated in Figure 2. A total of eight referral locations with elevated *E. coli* bacteria levels measured during the FI were recommended for further investigation by the proper authorities (Oakley and Leshner 2021). Much of the segment had ambient samples with bacteria levels $\geq 24,200$ MPN/100 mL making a complete assessment of this segment impossible.

Based upon the results of the 2021 FI, a subsequent FI covering the entire length of the AU and the unnamed tributary is recommended. It was recommended for a 1mL dilution to be conducted for processing 2023 samples due to the number of locations with high bacteria levels greater than the detection limit of $> 24,200$ MPN/100mL. This allows for a reporting window of < 100 to $> 242,000$ and can facilitate identifying specific areas of concern in Bintliff Ditch and the unnamed tributary.

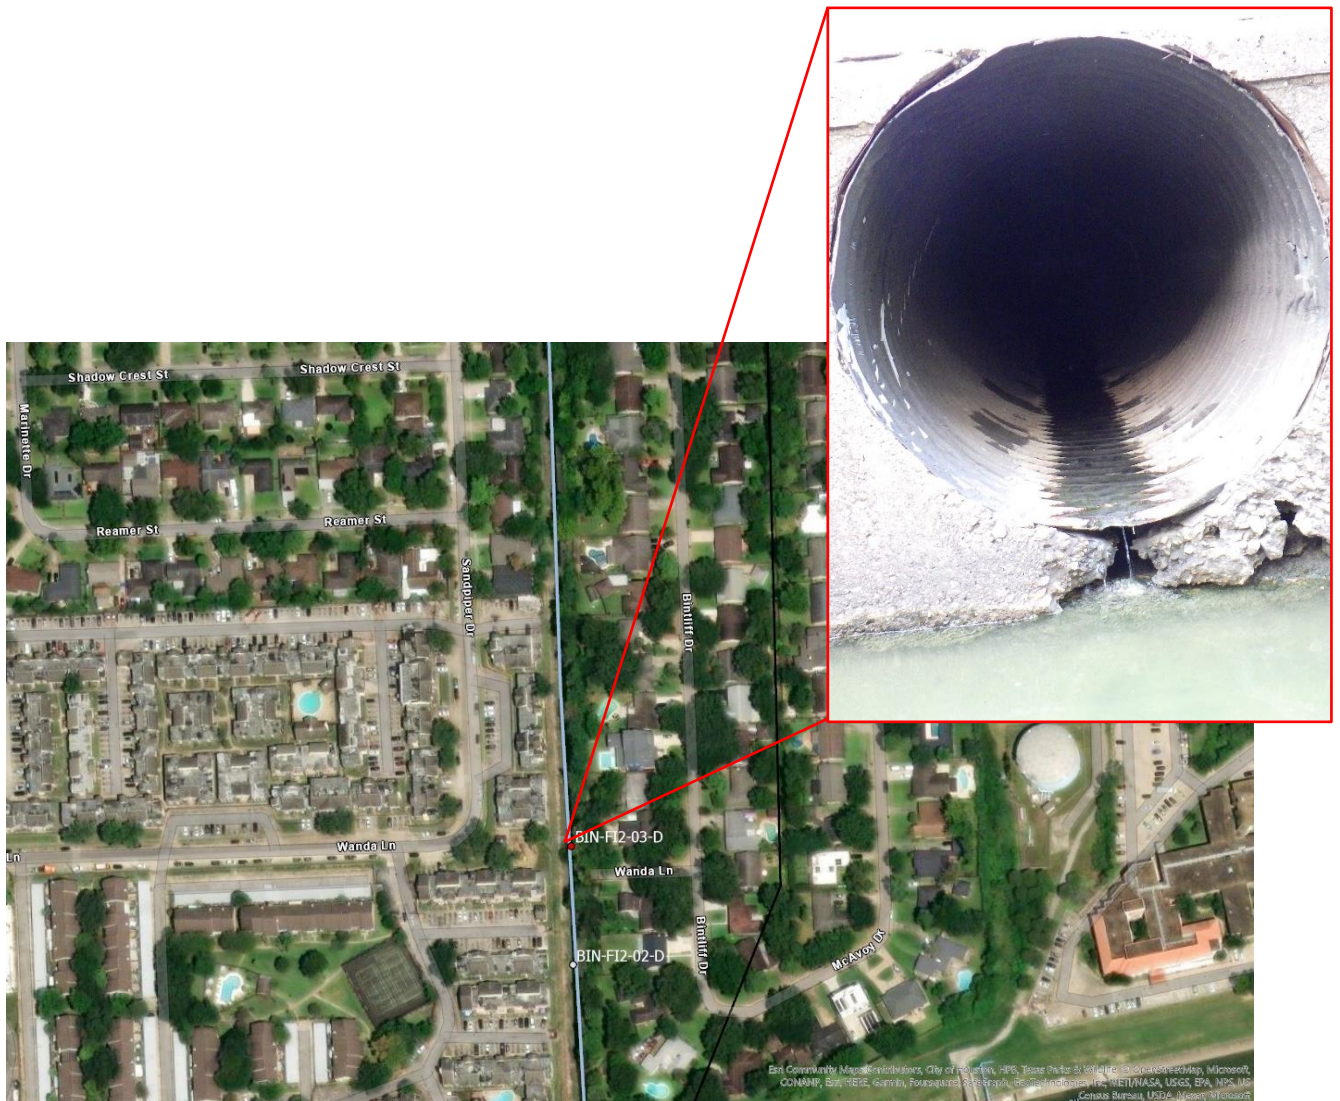
Referral site: BIN-FI2-03-D- High Priority

This is a 35 in. diameter metal pipe located on the right bank of Bintliff Ditch. Water within the pipe was 0.5 in. deep and trickling into the segment. There was a smell of effluent in the ambient air. There are apartments located in the area on the right bank. A sample taken 0.1 m downstream of the pipe had a bacteria value of 5,210 MPN/100 mL. The ambient sample collected upstream of the pipe had a bacteria value of 1,830 MPN/100 mL. This pipe is a high priority referral site for the proper local authority.

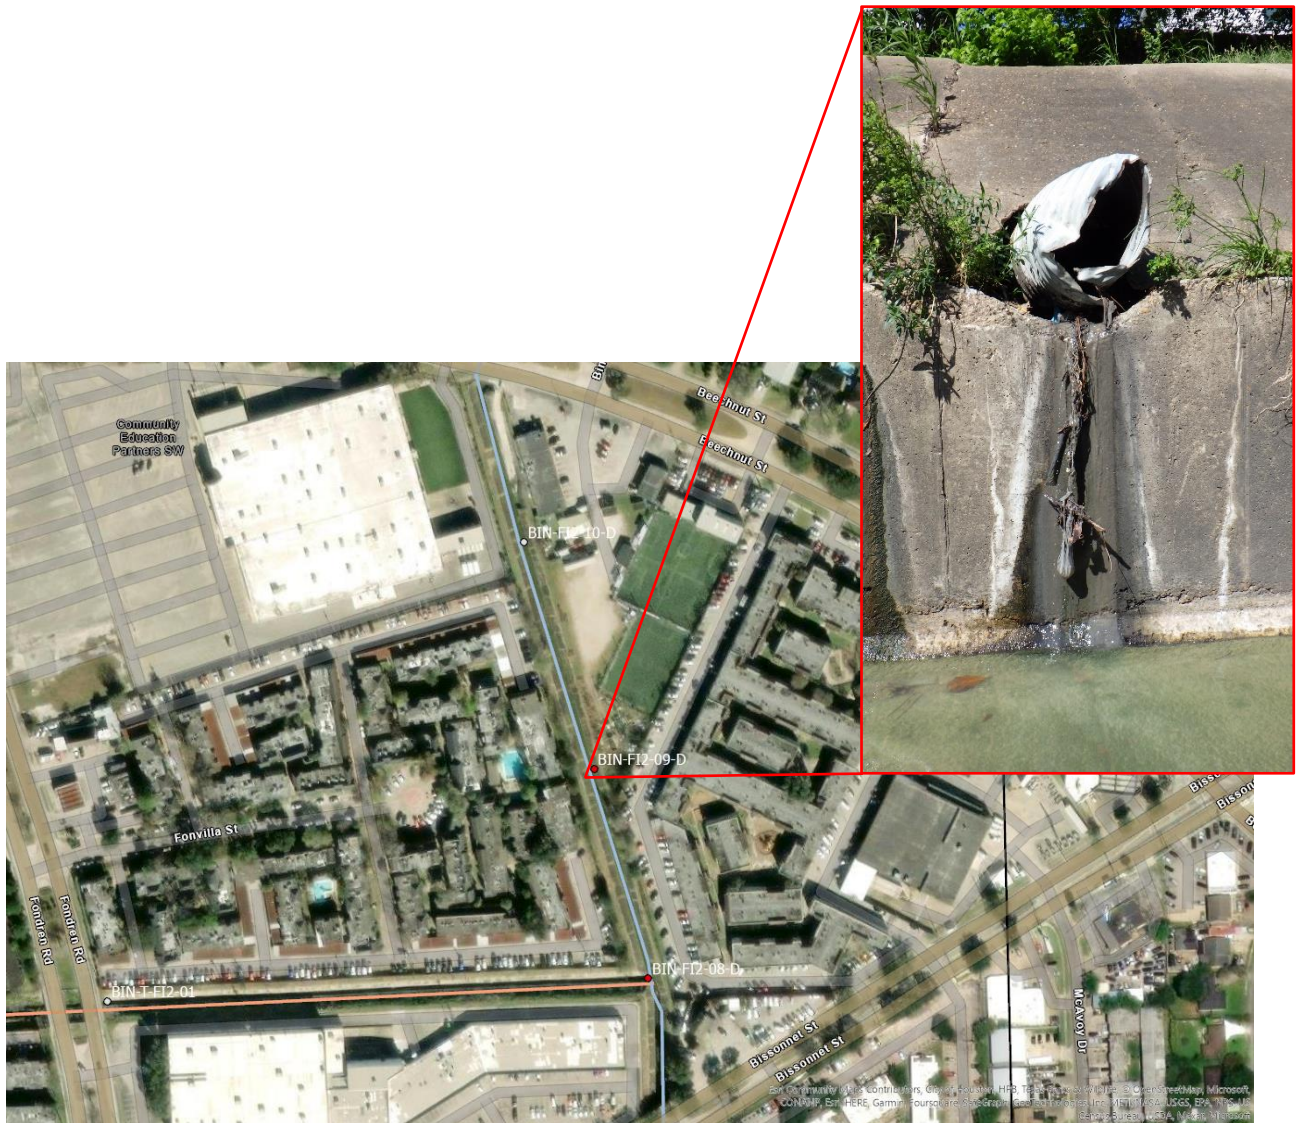
Referral site: BIN-FI2-09-D- High Priority

This is an approximately 20 in. diameter metal pipe located on the right bank of Bintliff Ditch. Water within the pipe was 0.1 in. deep and trickling into the segment. The pipe was partially collapsed and rusted through and the concrete around the pipe was broken. There are apartments located in the area on the right bank. A sample just 0.05 m downstream of the pipe had a bacteria value of > 242,000 MPN/100 mL. The ambient sample collected upstream of the pipe had a bacteria value of < 100 MPN/100 mL. This pipe is a high priority referral site for the proper local authority.

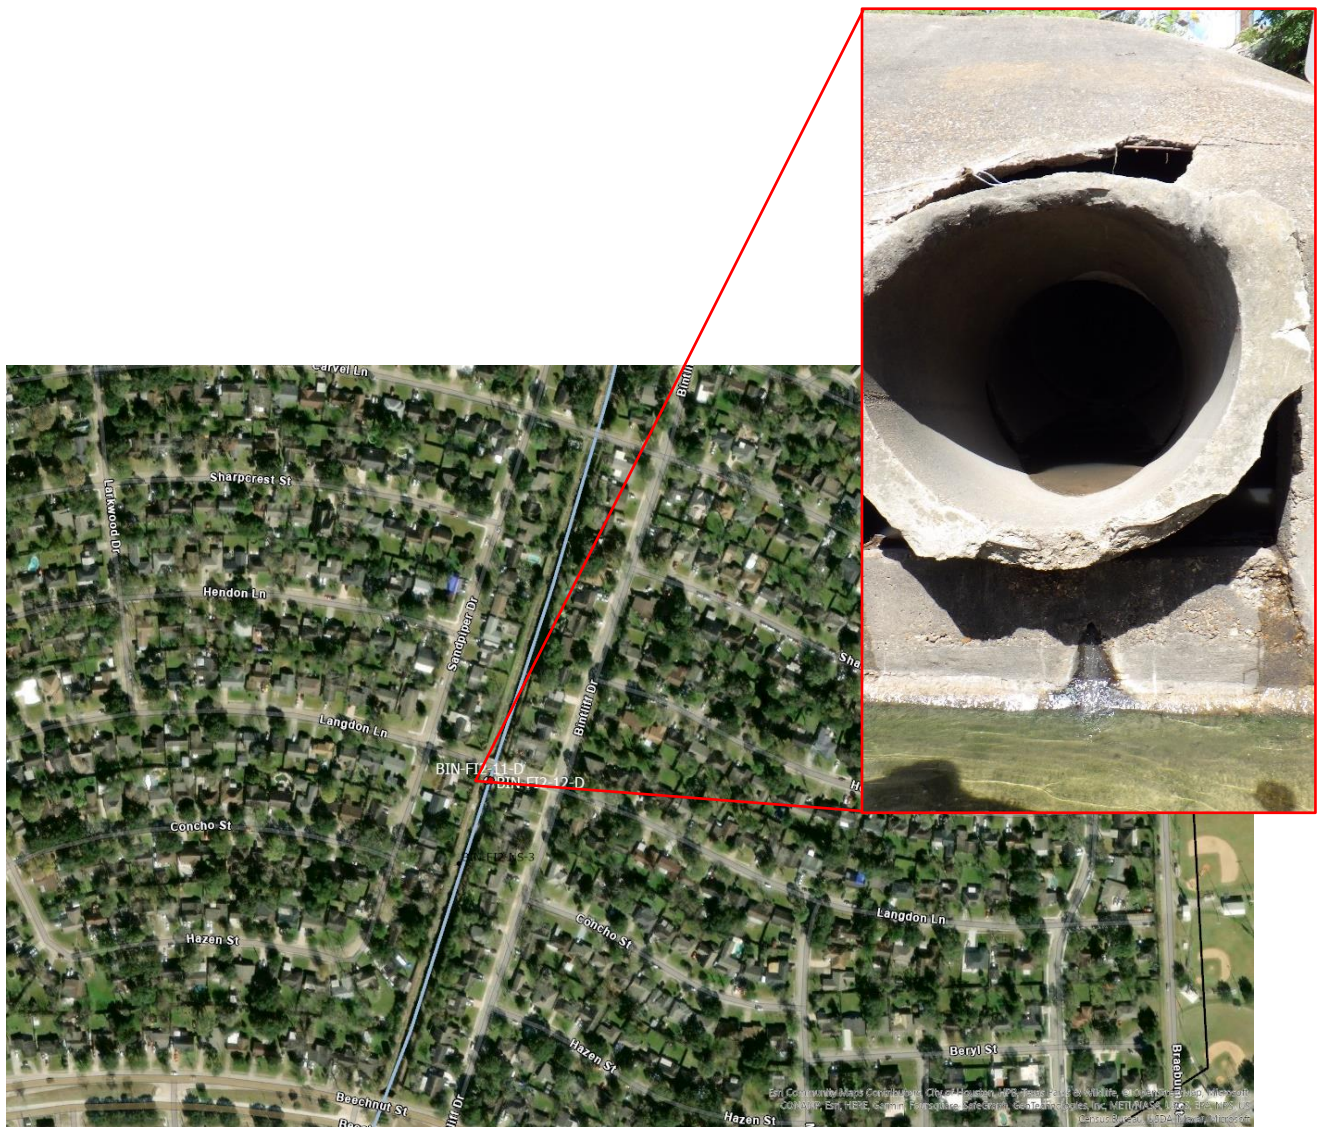
Referral site: BIN-FI2-12-D – High Priority

This is a 40 in. diameter concrete pipe located on the right bank of Bintliff Ditch. Water within the pipe was 0.1 in. deep and trickling into the segment through cracks in the cement wall. The cement pipe and the cement around the pipe was collapsed and broken. The field crew noted that the water was “sudsy”. There are single-family homes located in the area on the right bank. A sample just 0.1 m downstream of the pipe had a bacteria value of > 242,000 MPN/100 mL. The ambient sample collected upstream of the pipe had a bacteria value of 112,000 MPN/100 mL. This pipe is a high priority referral site for the proper local authority. Note: there was also a pipe located on the left bank directly across from this pipe which had significant flow and smelled like chlorine, but had a much lower downstream bacteria value of 4,040 MPN/100 mL and was not referred.

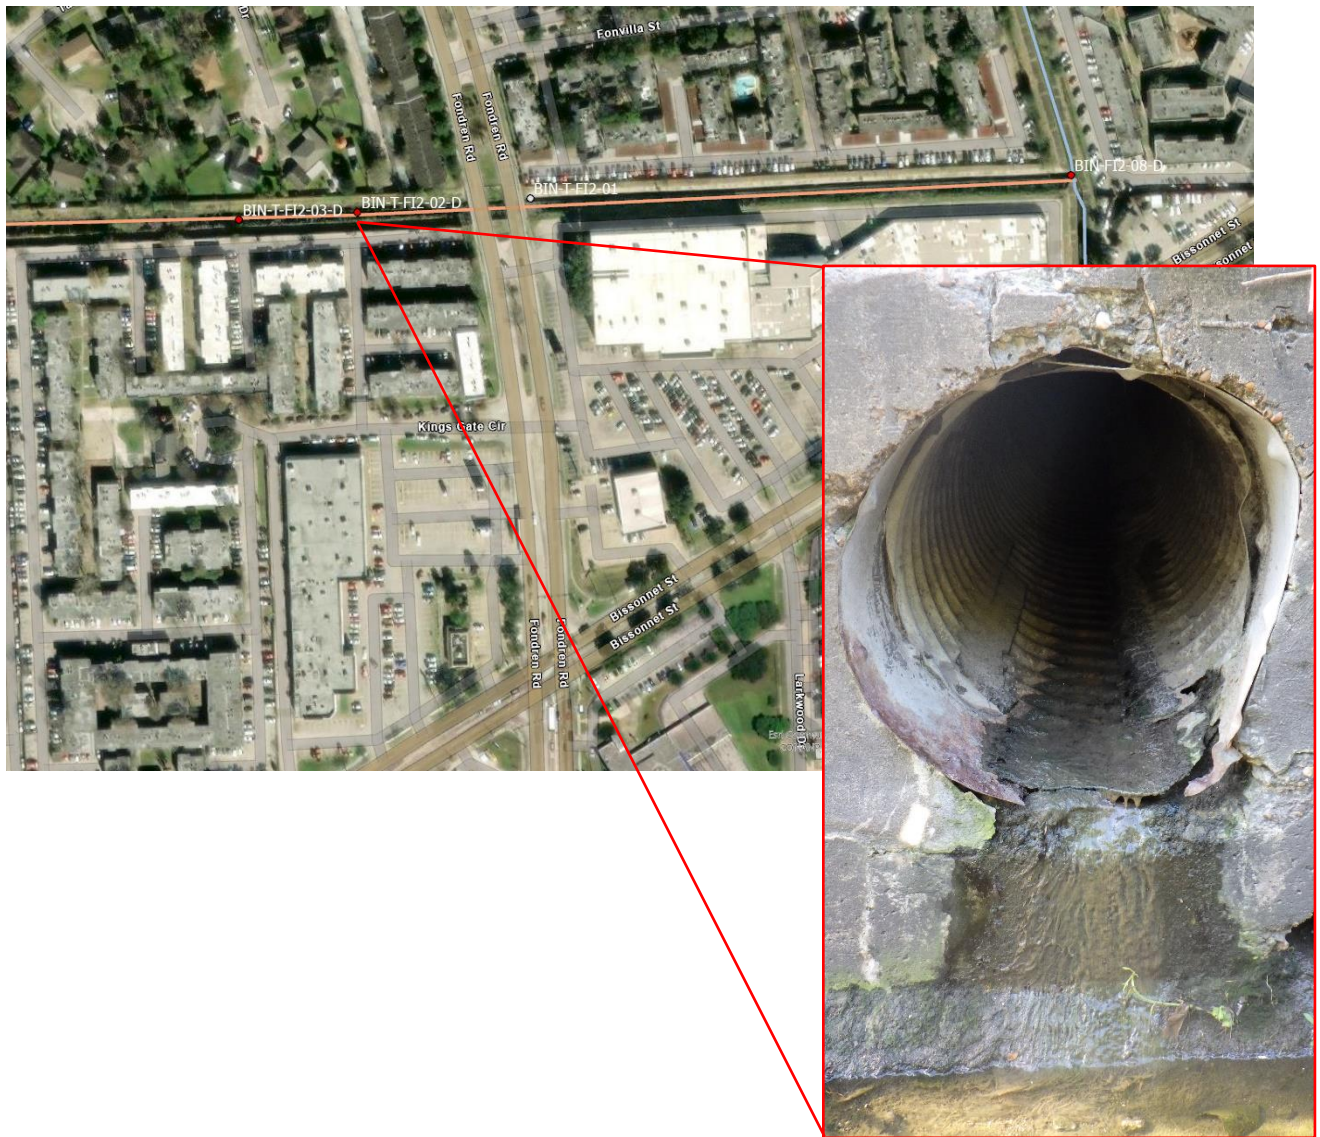
Referral site: BIN-T-FI2-02-D- High Priority

This is a 25 in. diameter metal pipe located on the right bank of the tributary to Bintliff Ditch. Water within the pipe was 0.125 in. deep and trickling into the segment. The pipe was partially collapsed and rusted through. The substrate that the water was flowing down on the cement was filamentous and light brown in color. There are apartments and commercial buildings located in the area on the right bank. A sample just 0.55 m downstream of the pipe had a bacteria value of 5,290 MPN/100 mL. The ambient sample collected upstream of the pipe had a bacteria value of 3,130 MPN/100 mL. This pipe is a high priority referral site for the proper local authority.

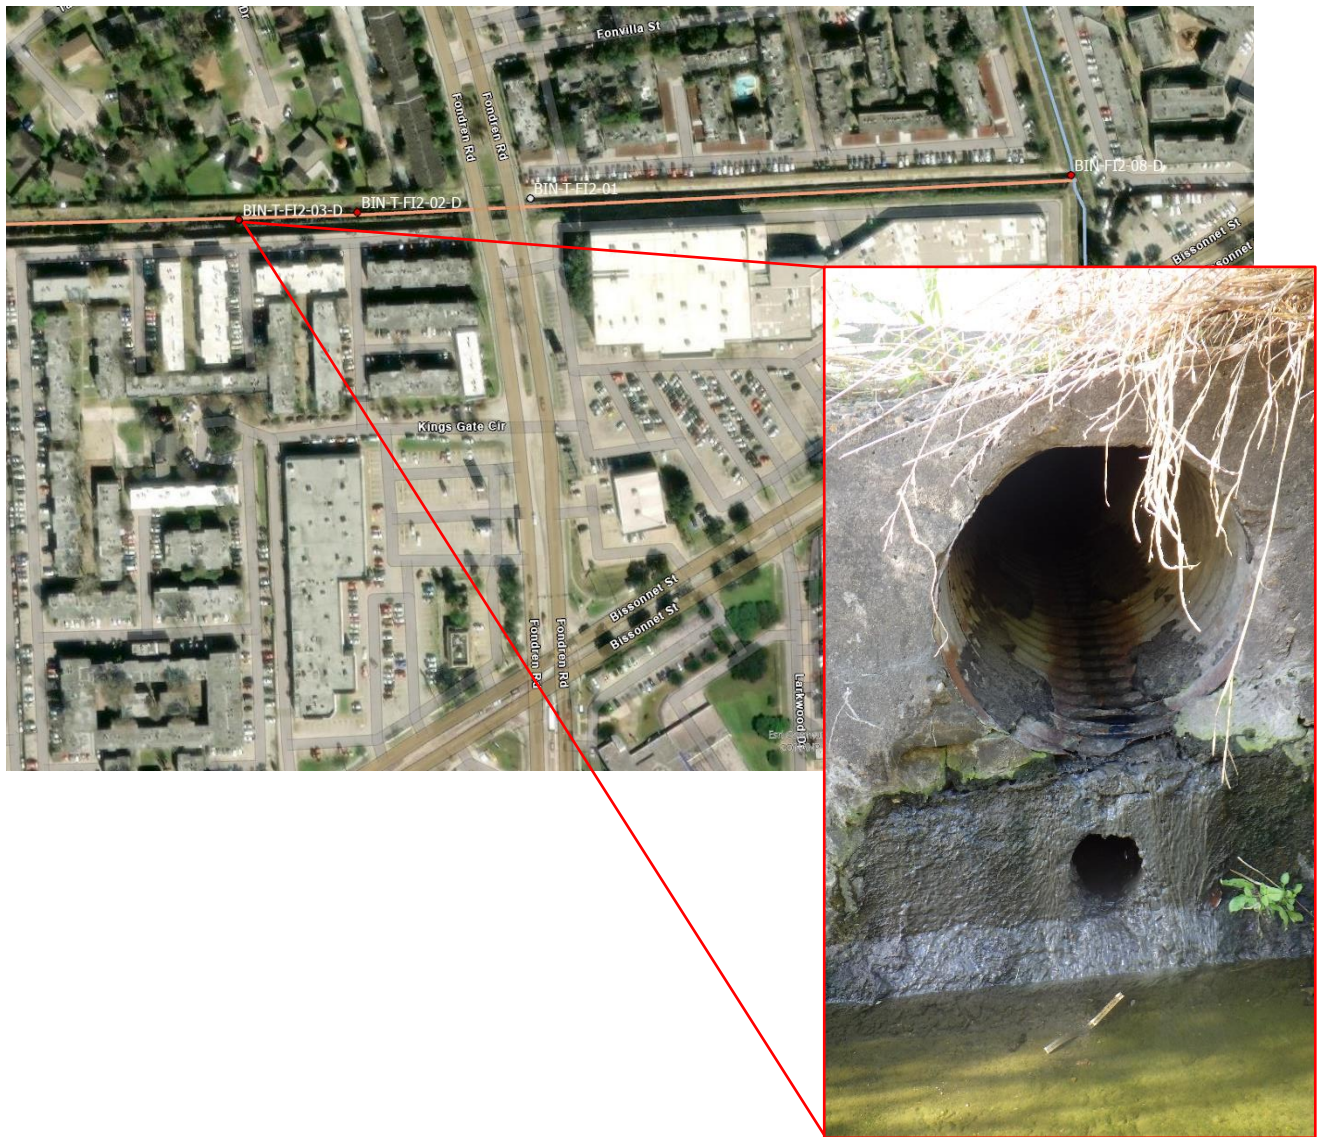
Referral site: BIN-T-FI2-03-D- High Priority

This is a 24 in. diameter metal pipe located on the right bank of the tributary to Bintliff Ditch. Water within the pipe was 0.125 in. deep and trickling into the segment. The pipe was rusted through and leaking behind the cement wall and a filamentous light brown substrate was observed where the water was pouring over the cement. There are apartments and commercial buildings located in the area on the right bank. A sample just 0.5 m downstream of the pipe had a bacteria value of 48,800 MPN/100 mL. The ambient sample collected upstream of the pipe had a bacteria value of 5,650 MPN/100 mL. This pipe is a high priority referral site for the proper local authority.

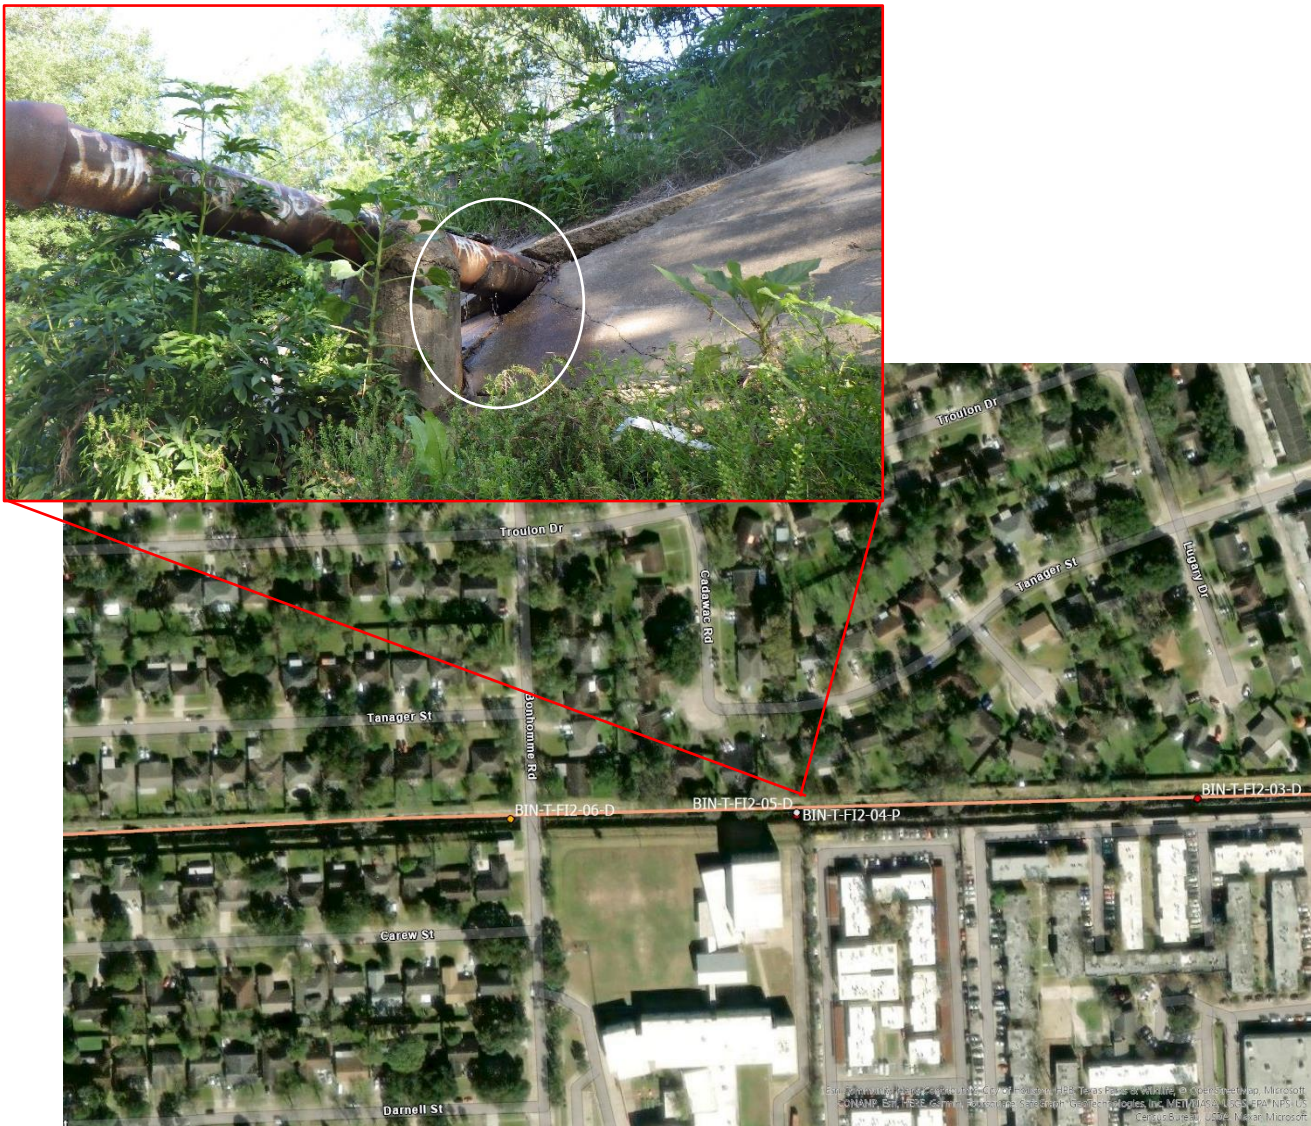
Referral site: BIN-T-FI2-04-P- High Priority

BIN-T-FI2-04-P	29.68885	-95.51241	> 242,000	NA	NA	Y-H	Water has strong sewage odor; leaking pipe over waterway; leak flowing down left bank.

This is a 12 in. diameter metal pipe that crosses above the tributary to Bintliff Ditch. It was broken/leaking and flowing down the left bank (white circle in photo below). The crew noted a strong sewage odor from the water leaking from the pipe. There are single-family homes located in the area on the left bank and Sugar Grove Elementary School located on the right bank. A sample taken directly from the leaking pipe had a bacteria value of > 242,000 MPN/100 mL. This pipe is a high priority referral site for the proper local authority.

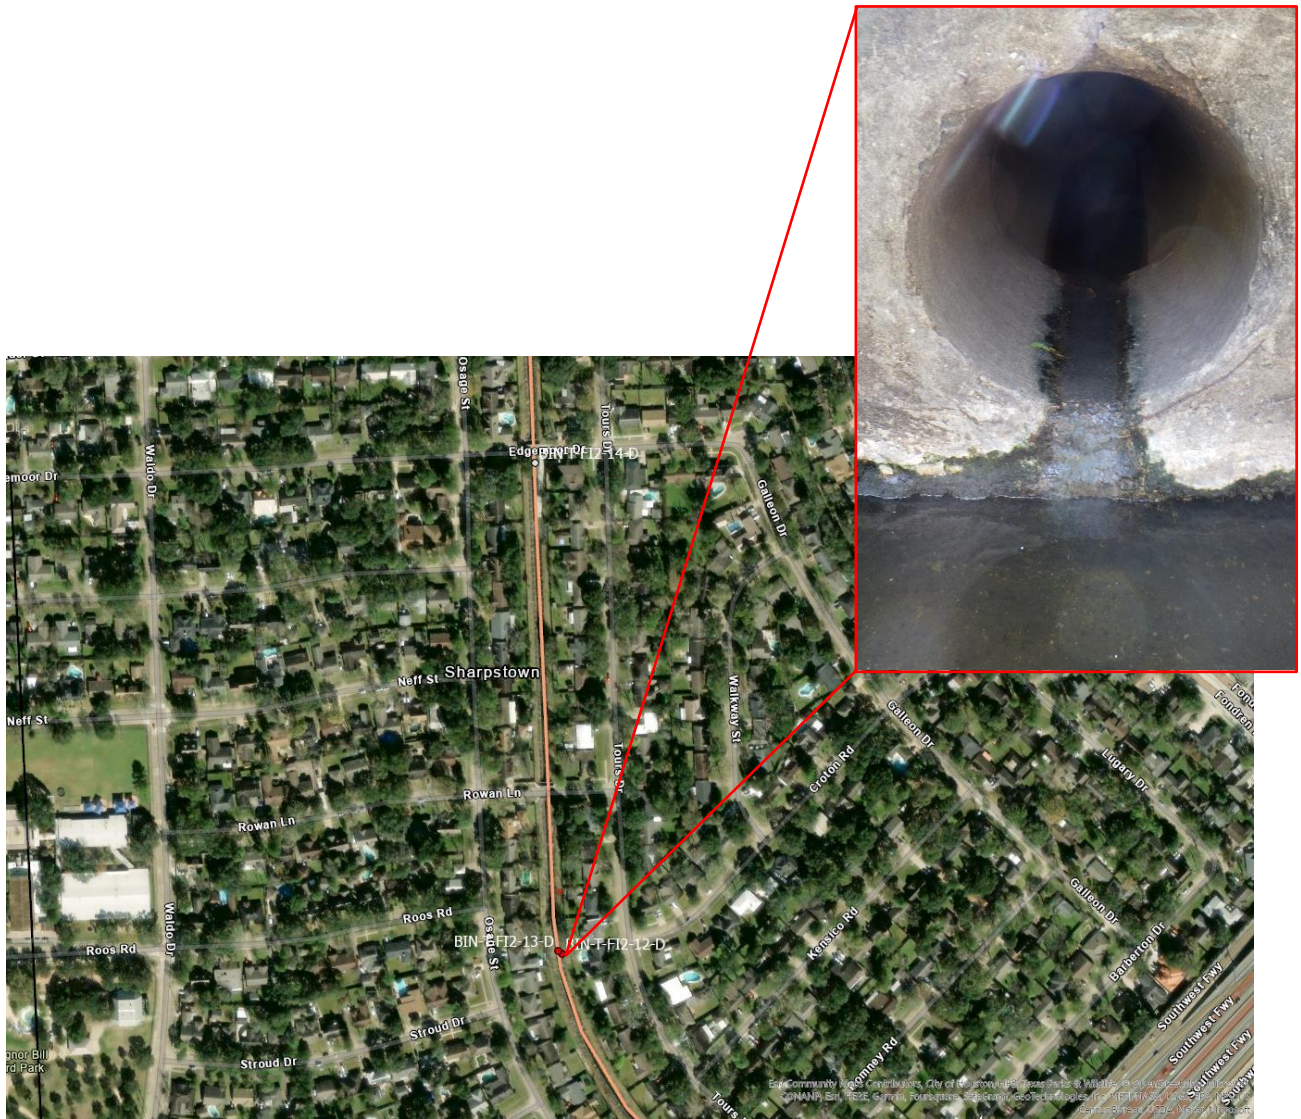
Referral site: BIN-T-FI2-12-D- High Priority

This is a 26 in. diameter cement pipe located on the left bank of the tributary to Bintliff Ditch. Water within the pipe was 0.125 in. deep and trickling into the segment. There are single-family homes located in the area on the left bank. A sample just 0.2 m downstream of the pipe had a bacteria value of > 242,000 MPN/100 mL. The ambient sample collected upstream of the pipe had a bacteria value of 1,580 MPN/10 mL. This pipe is a high priority referral site for the proper local authority. Note: the next referral site (BIN-T-FI2-13-D) is immediately upstream (approximately 1 m) of this pipe on the same bank.

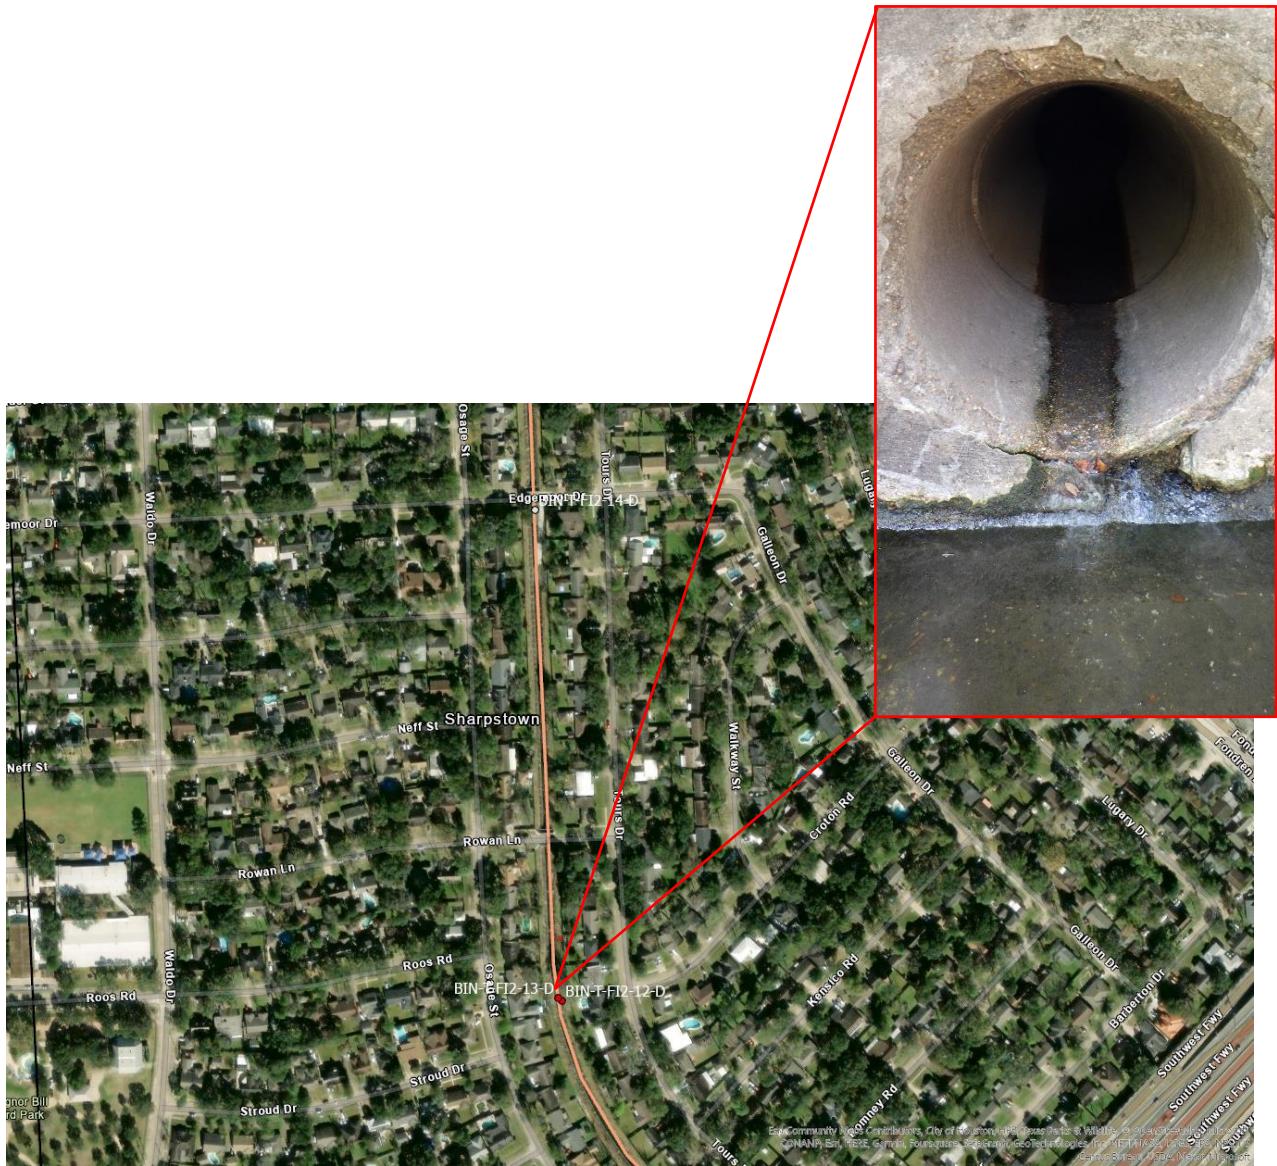
Referral site: BIN-T-FI2-13-D- High Priority

This is a 26 in. diameter cement pipe located on the left bank of the tributary to Bintliff Ditch, approximately 1 m upstream of the last referral site (BIN-T-FI2-12-D). Water within the pipe was 0.125 in. deep and trickling into the segment. There are single-family homes located in the area on the left bank. A sample just 0.2m downstream of the pipe had a bacteria value of > 242,000 MPN/100 mL. The ambient sample collected upstream of the pipe had a bacteria value of 1,580 MPN/100 mL. This pipe is a high priority referral site for the proper local authority.

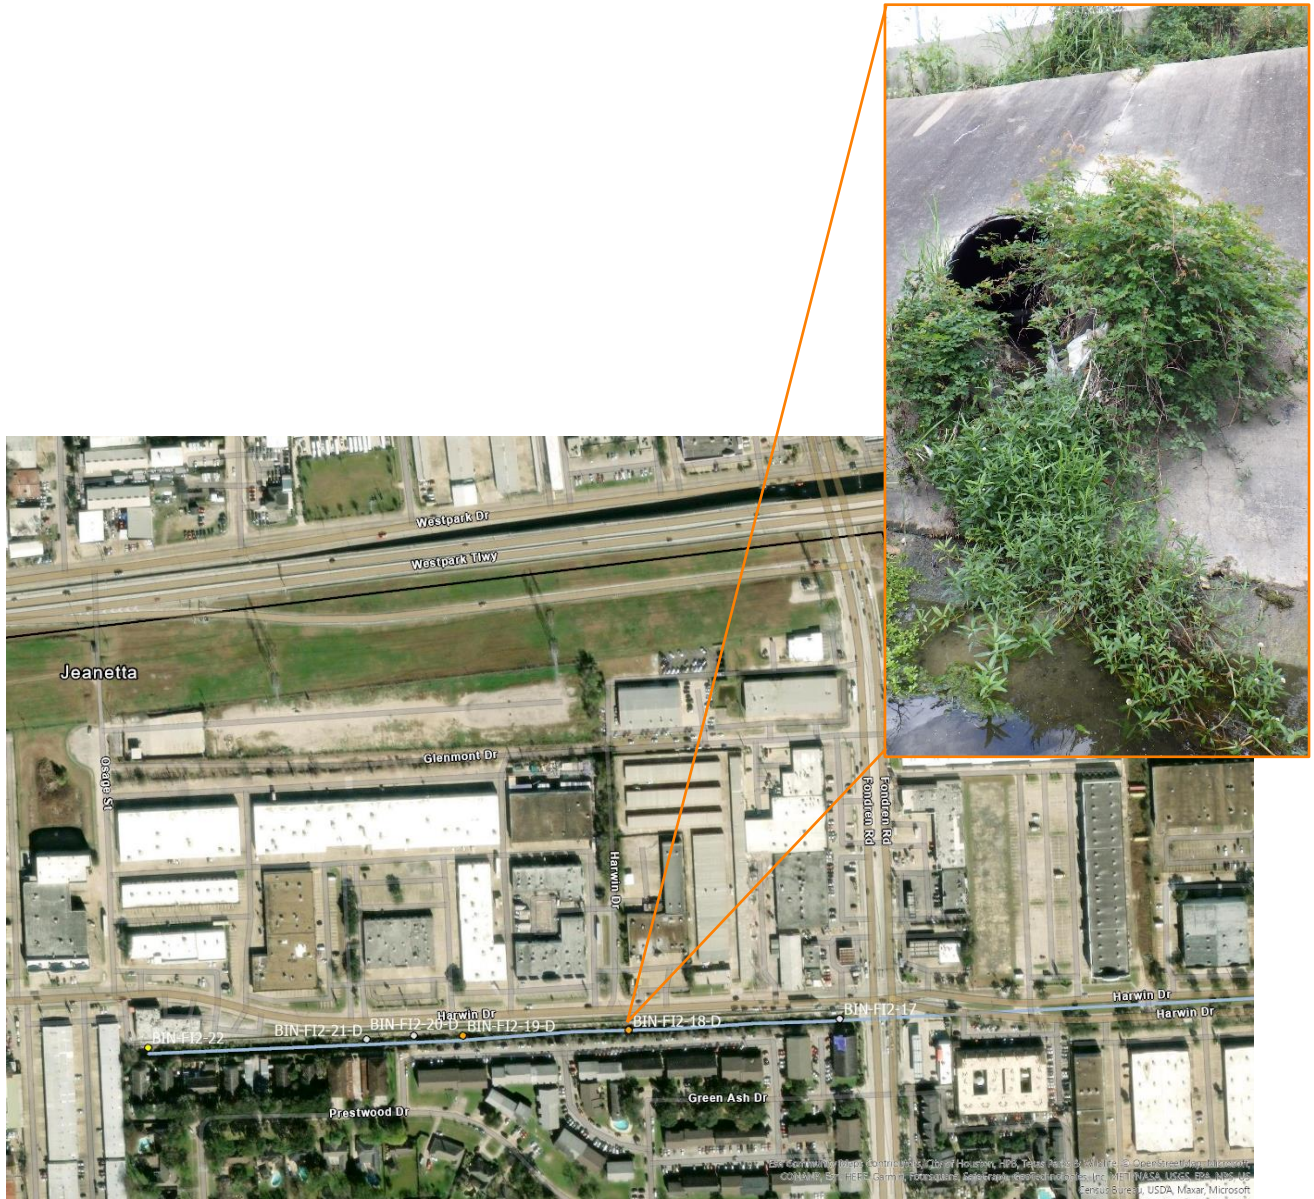
Referral site: BIN-FI2-18-D- Low Priority

This is a 36 in. diameter metal pipe located on the left bank of Bintliff Ditch. Water within the pipe was 0.25 in. deep and trickling into the segment through significant vegetation. There are commercial buildings located in the area on the left bank. A sample just 0.7 m downstream of the pipe had a bacteria value of 520 MPN/100 mL. The ambient sample collected upstream of the pipe had a bacteria value of 100 MPN/100 mL. This pipe is a low priority referral site for the proper local authority.

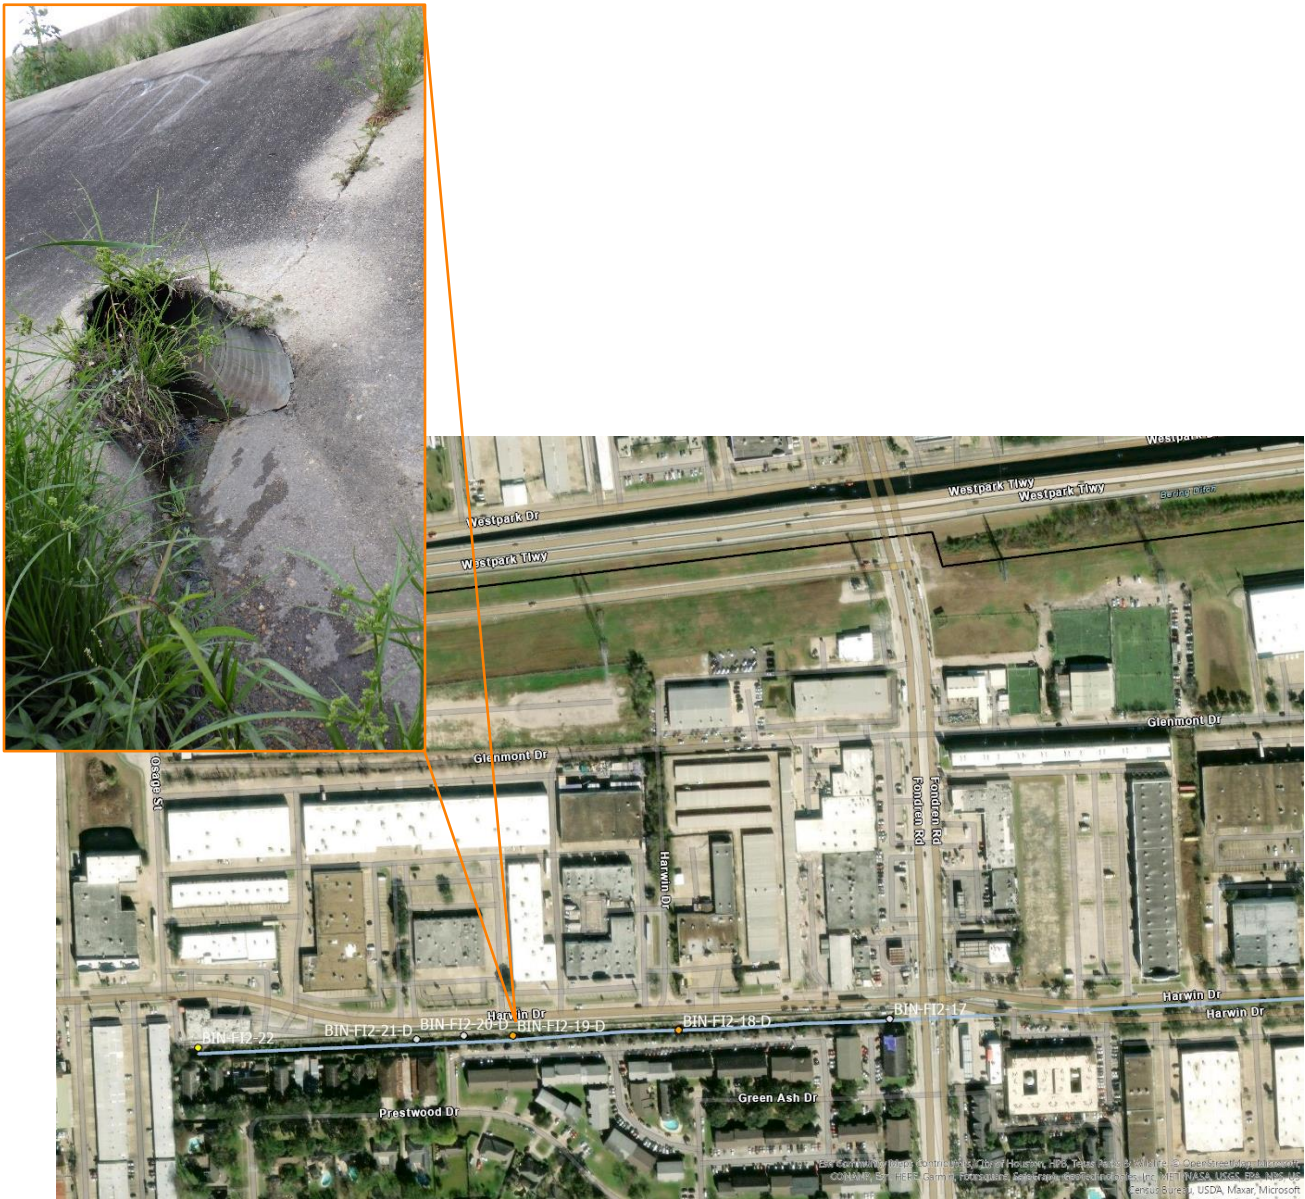
Referral site: BIN-FI2-19-D- Low Priority

This is a 21 in. diameter metal pipe located on the left bank of Bintliff Ditch. Water within the pipe was 2 in. deep and flowing into the segment over the cement wall through some vegetation. There are commercial buildings located in the area on the left bank. A sample just 1.3 m downstream of the pipe had a bacteria value of 630 MPN/100 mL. The ambient sample collected upstream of the pipe had a bacteria value of 300 MPN/100 mL. This pipe is a low priority referral site for the proper local authority.

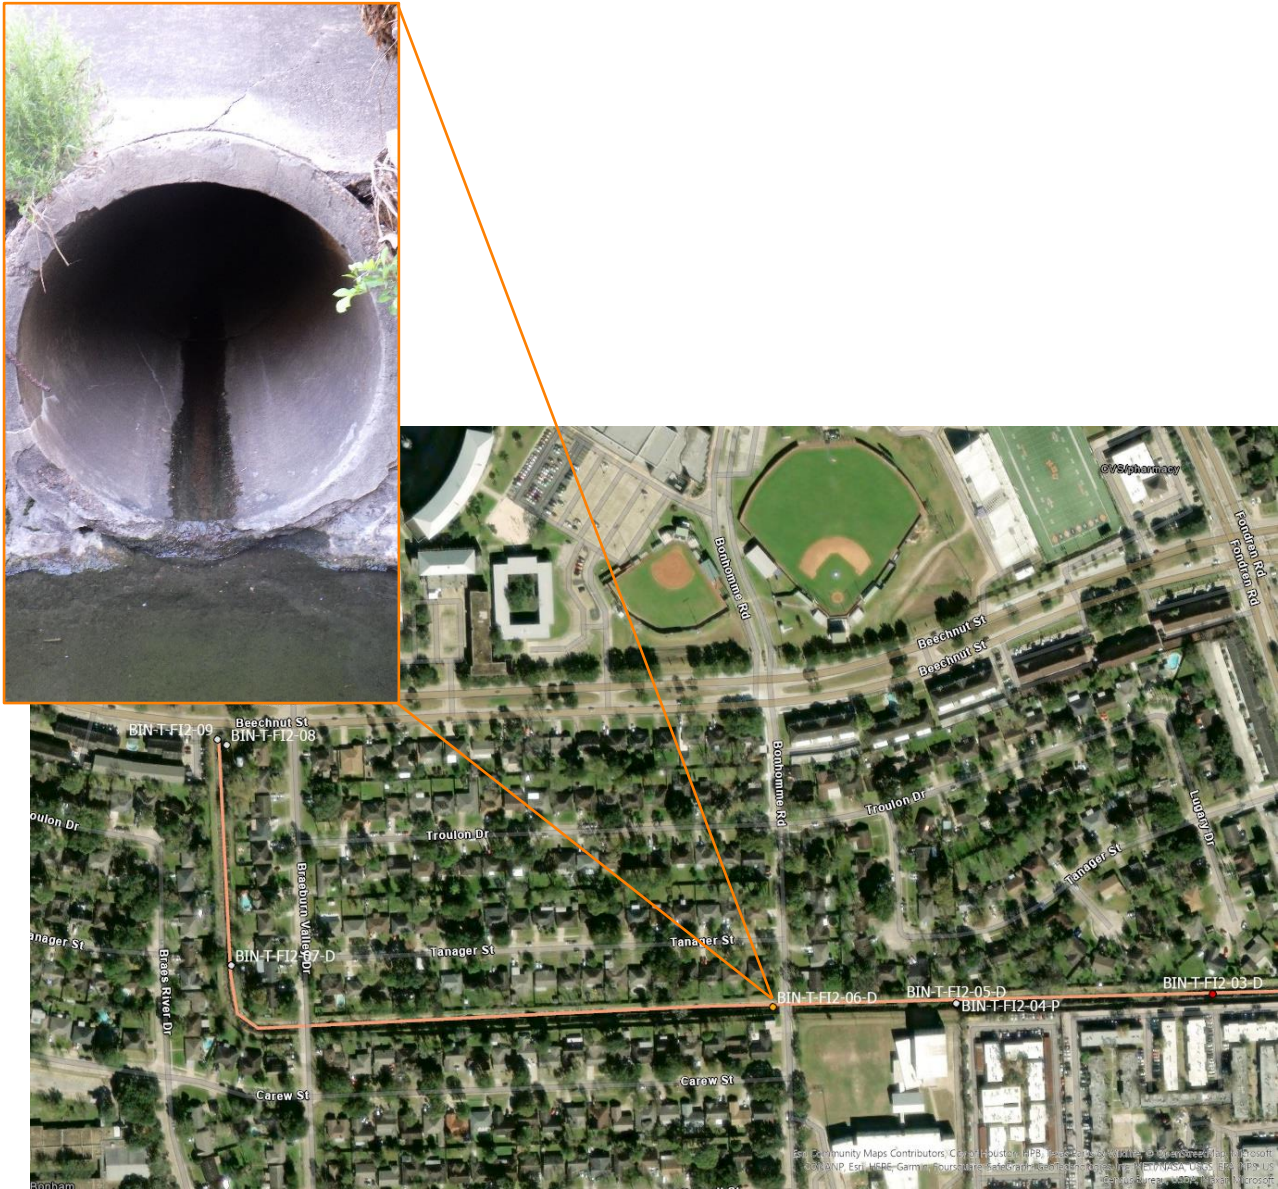
Referral site: BIN-T-FI2-06-D- Low Priority

This is a 42 in. diameter cement pipe located on the left bank of the tributary to Bintliff Ditch. Water within the pipe was 0.5 in. deep and trickling into the segment. There are single-family homes located in the area on the left bank. A sample just 0.2 m downstream of the pipe had a bacteria value of 520 MPN/100 mL. The ambient sample collected upstream of the pipe had a bacteria value of < 100 MPN/100 mL. This pipe is a low priority referral site for the proper local authority.

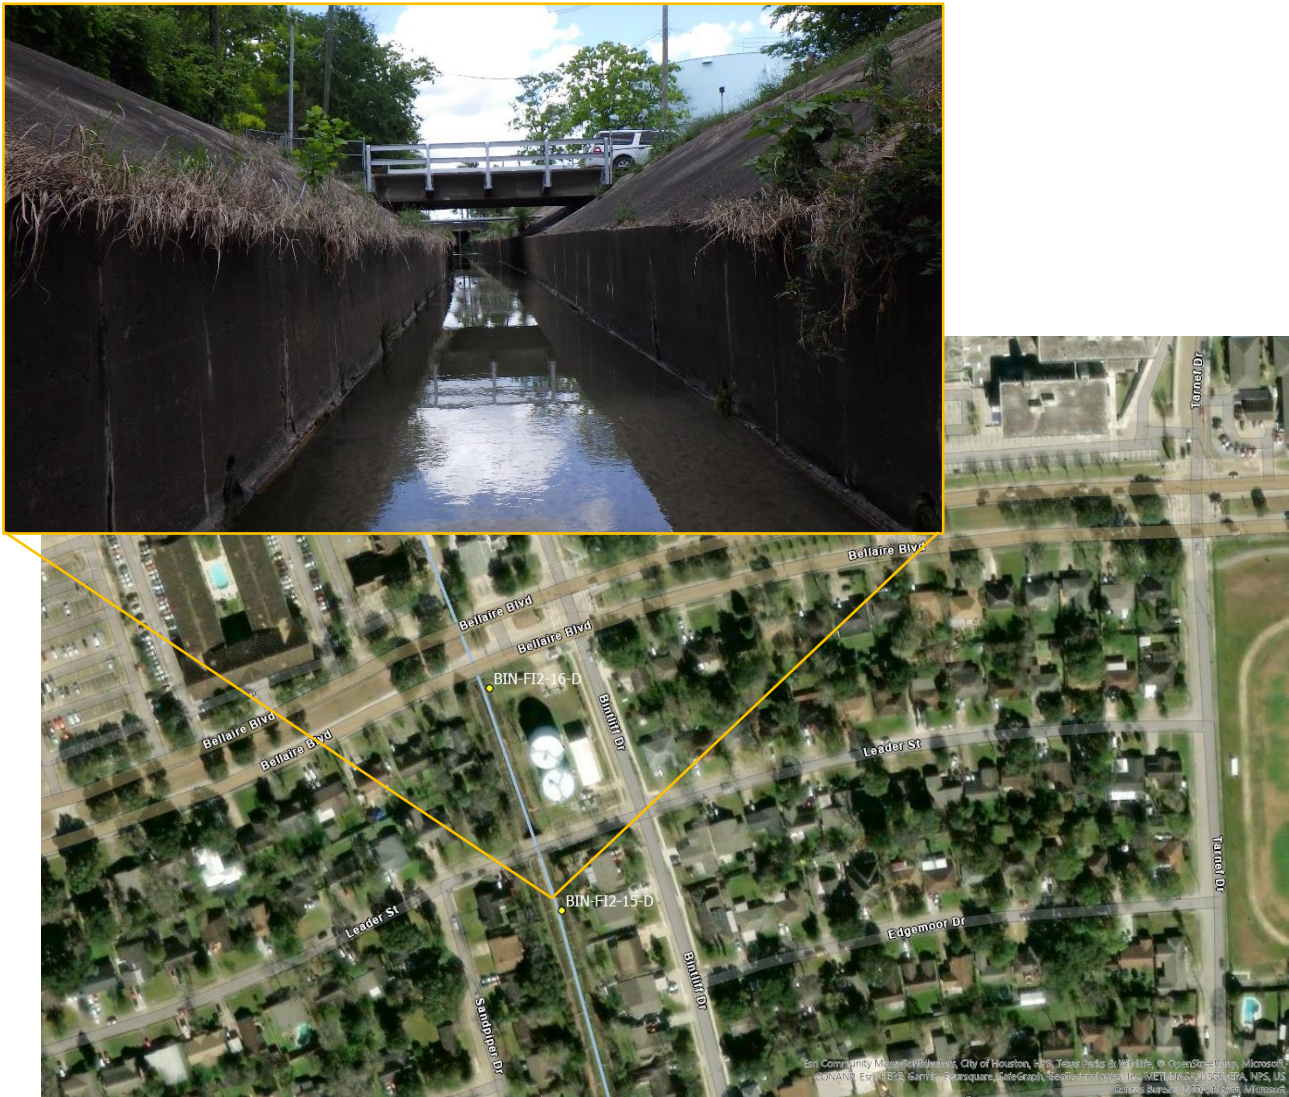
Referral site: BIN-FI2-15-U – Investigate Further

This was an ambient (upstream) sample taken to accompany a sample taken at a trickling weep hole (BIN-FI2-15-D) on Bintliff Ditch. The ambient sample had a bacteria value of > 242,000 MPN/100 mL. The next upstream ambient sample taken at site BIN-FI2-16-U, just before the segment continues underground, had a bacteria value of 850 MPN/100 mL. While there were no obvious pipes flowing into the segment between these two sample points, there is a source of elevated bacteria. There are some kind of large tanks located along the left bank between these two sites as seen in the map and photo facing upstream from site BIN-FI2-15-U below. Further investigation is recommended by the proper local authority to determine the source of elevated bacteria in this small stretch of the segment.
