Targeted Bacteria Monitoring Project Field Investigation Final Report Assessment Unit 1007T _01 Bintliff Ditch

May 8, 2023

Environmental Institute of Houston, University of Houston-Clear Lake

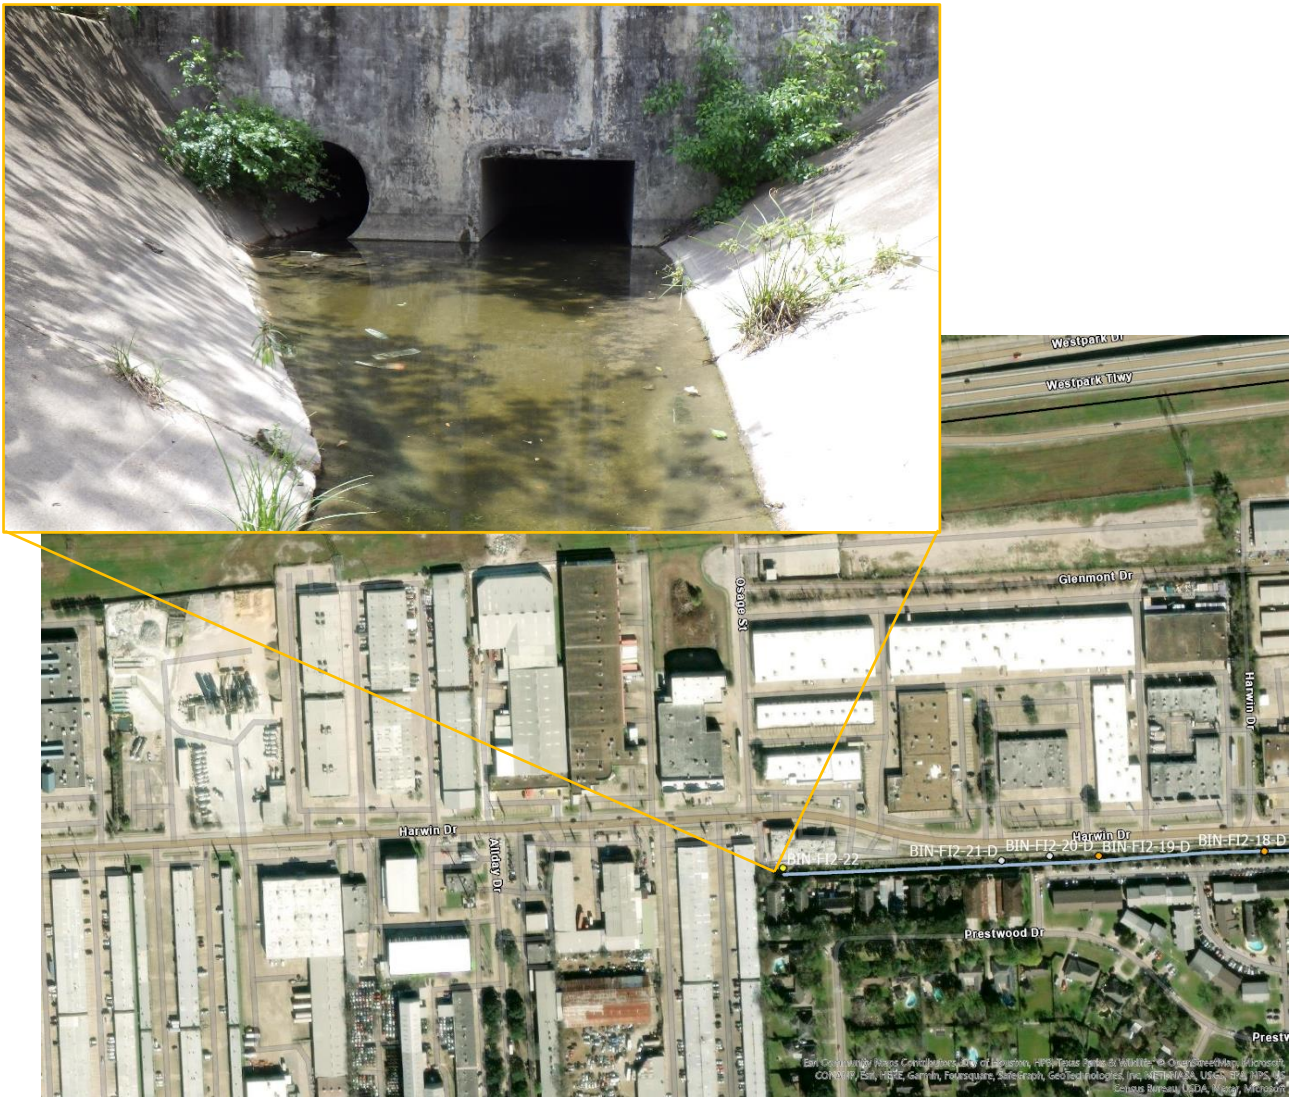
Referral site: BIN-FI2-22 – Investigate Further

This was an ambient sample taken at the most upstream portion of the Bintliff Ditch segment before it goes underground around Osage St. A sample just downstream of the two cement pipes had a bacteria value of > 46,100 MPN/100 mL. Further investigation is recommended by the proper local authority to determine the source of elevated bacteria underground and upstream of the segment.

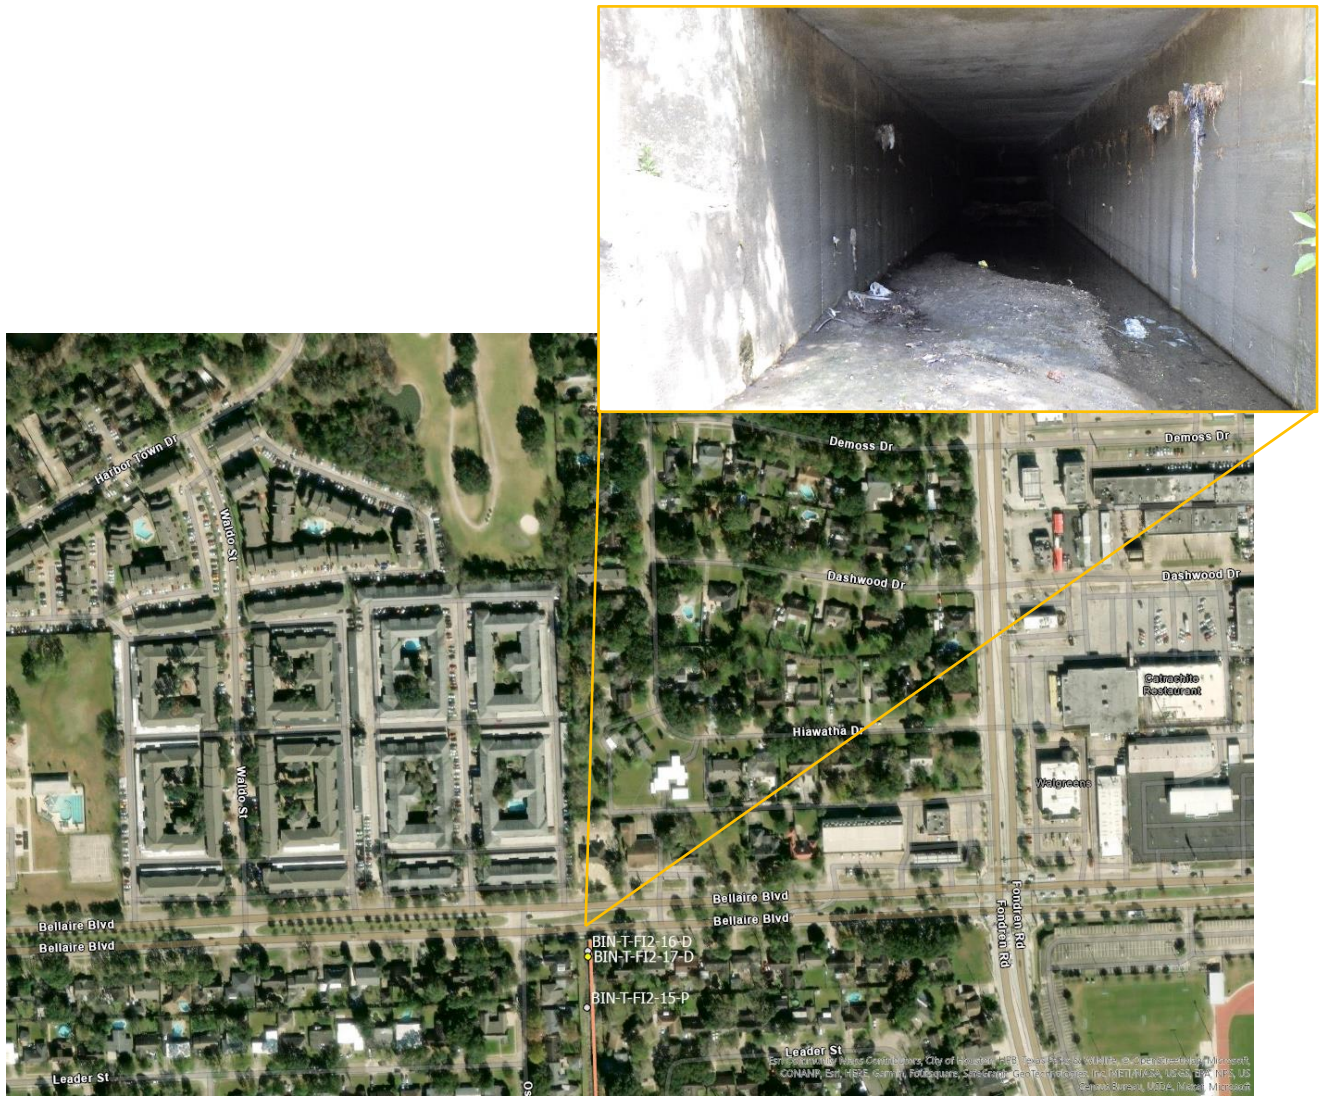
Referral site: BIN-T-FI2-16-U - Investigate Further

This was an ambient upstream sample which accompanied samples BIN-T-FI2-16-D and BIN-T-FI2-17-D, taken at the most upstream portion of the tributary to Bintliff Ditch before it goes underground at Bellaire Blvd. The ambient sample taken just in front of the bridge crossing had a bacteria value of 5,040 MPN/100 mL. Further investigation is recommended by the proper local authority to determine the source of elevated bacteria underground and upstream of the segment. There are apartment and single-family homes located upstream of the site as well as a golf course.
