# Targeted Bacteria Monitoring Project Field Investigation Final Report Assessment Unit 1017A\_01 Brickhouse Gully

May 16, 2023

Environmental Institute of Houston, University of Houston-Clear Lake

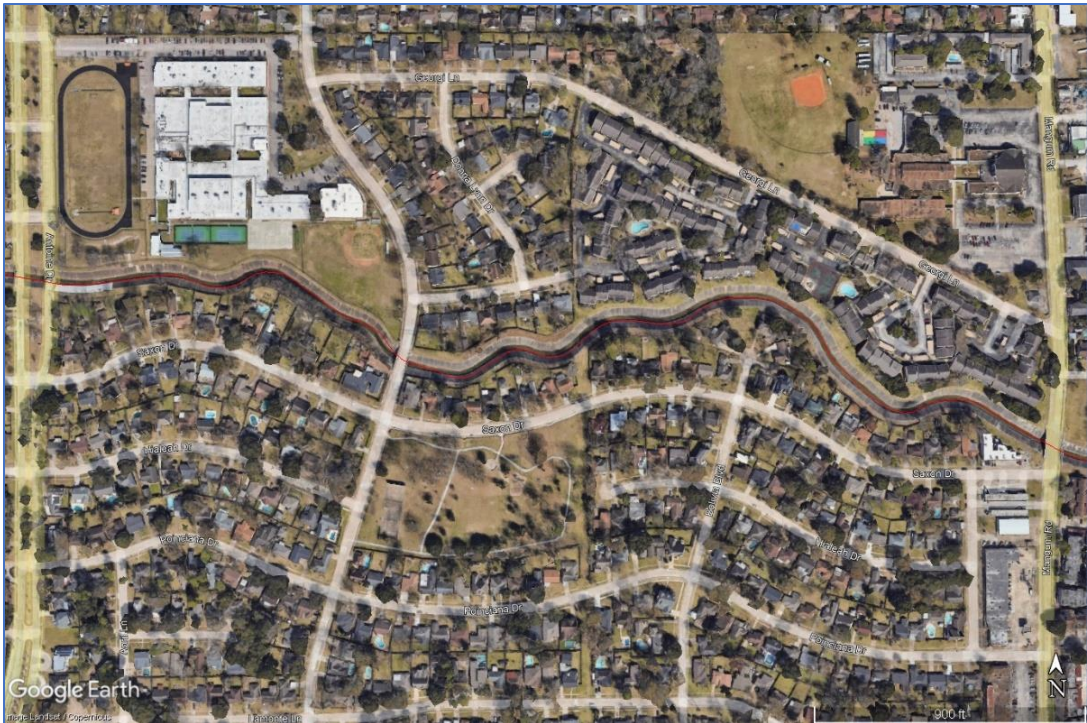
Figure 2: Stretch of the AU bordered by many parks and schoolgrounds. Identified during desktop review as a possible source.

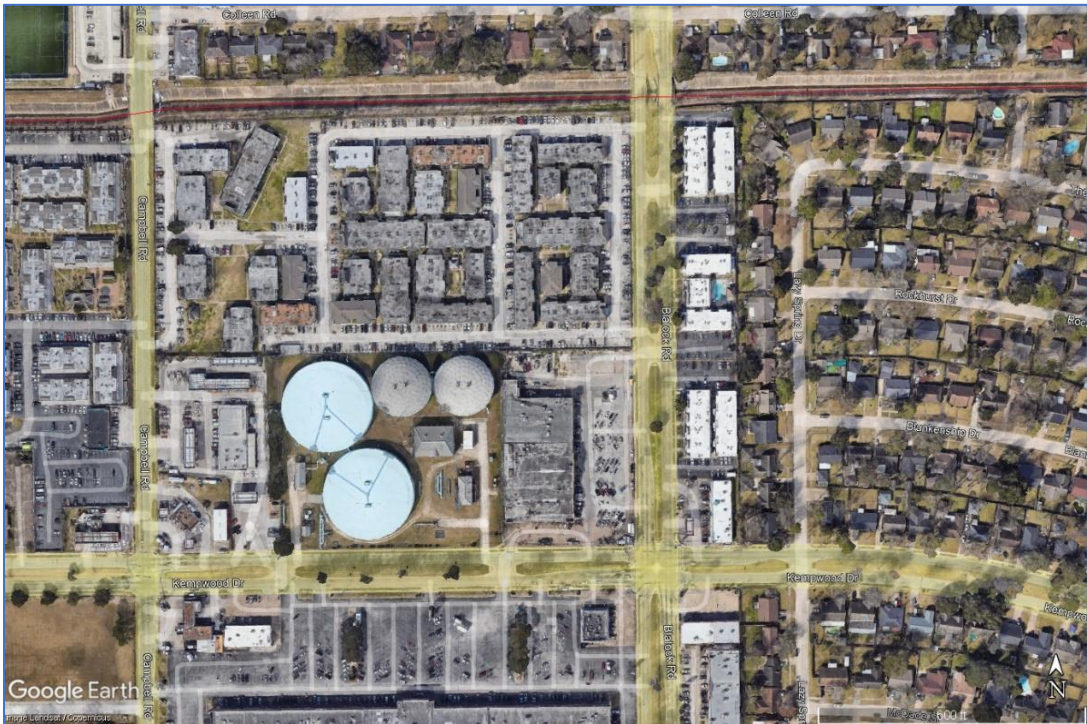
Figure 3: A city water facility near the AU that was not listed under the permitted/unpermitted outfalls provided by H-GAC. Identified during desktop review as a possible source.

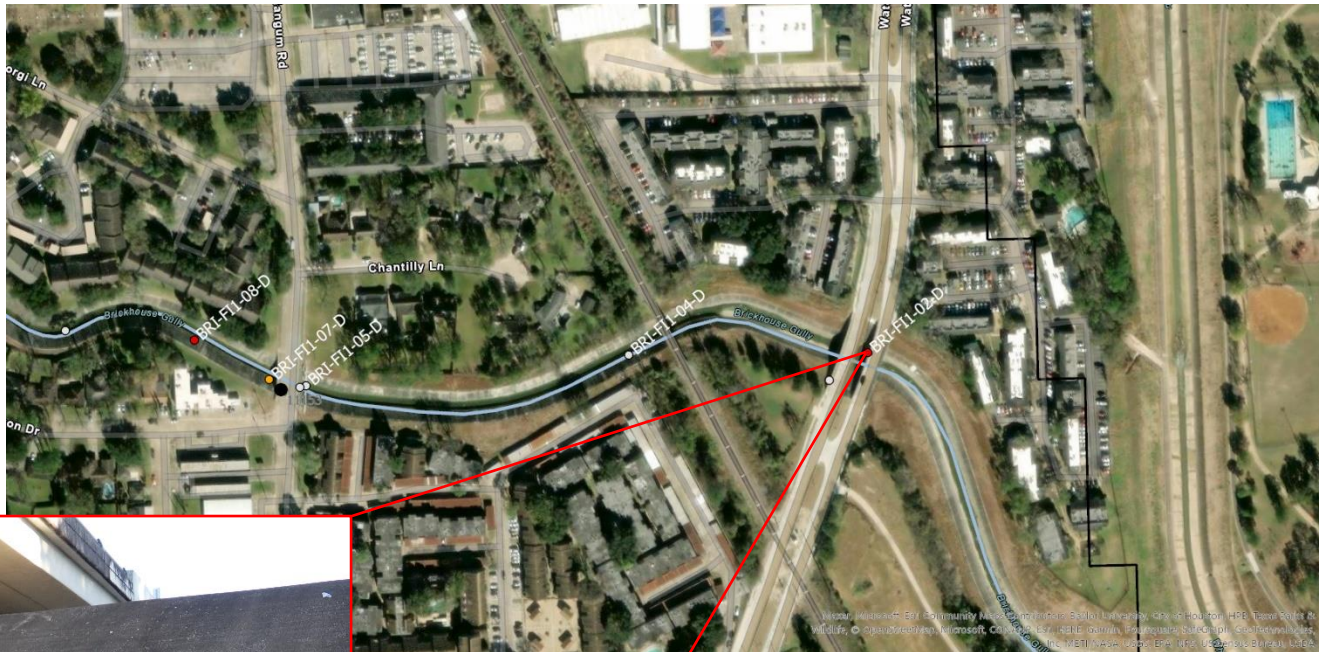
Referral site: BRI-FI1-02-D – High Priority

This is a 36 in. diameter metal pipe located on the left bank of Brickhouse Gully. Water within the pipe was 0.13 in. deep and was barely trickling into the AU. It flowed down the concrete bank where there was a thin layer of algae growing before it entered the channel. There are multiple apartment complexes and a primary school located in the area on the left bank. A sample taken 4 m downstream of the pipe had a bacteria value of > 242,000 MPN/100 mL. The ambient sample collected upstream of the pipe had a bacteria value of 6,370 MPN/100 mL. This pipe is a high priority referral site for the proper local authority.

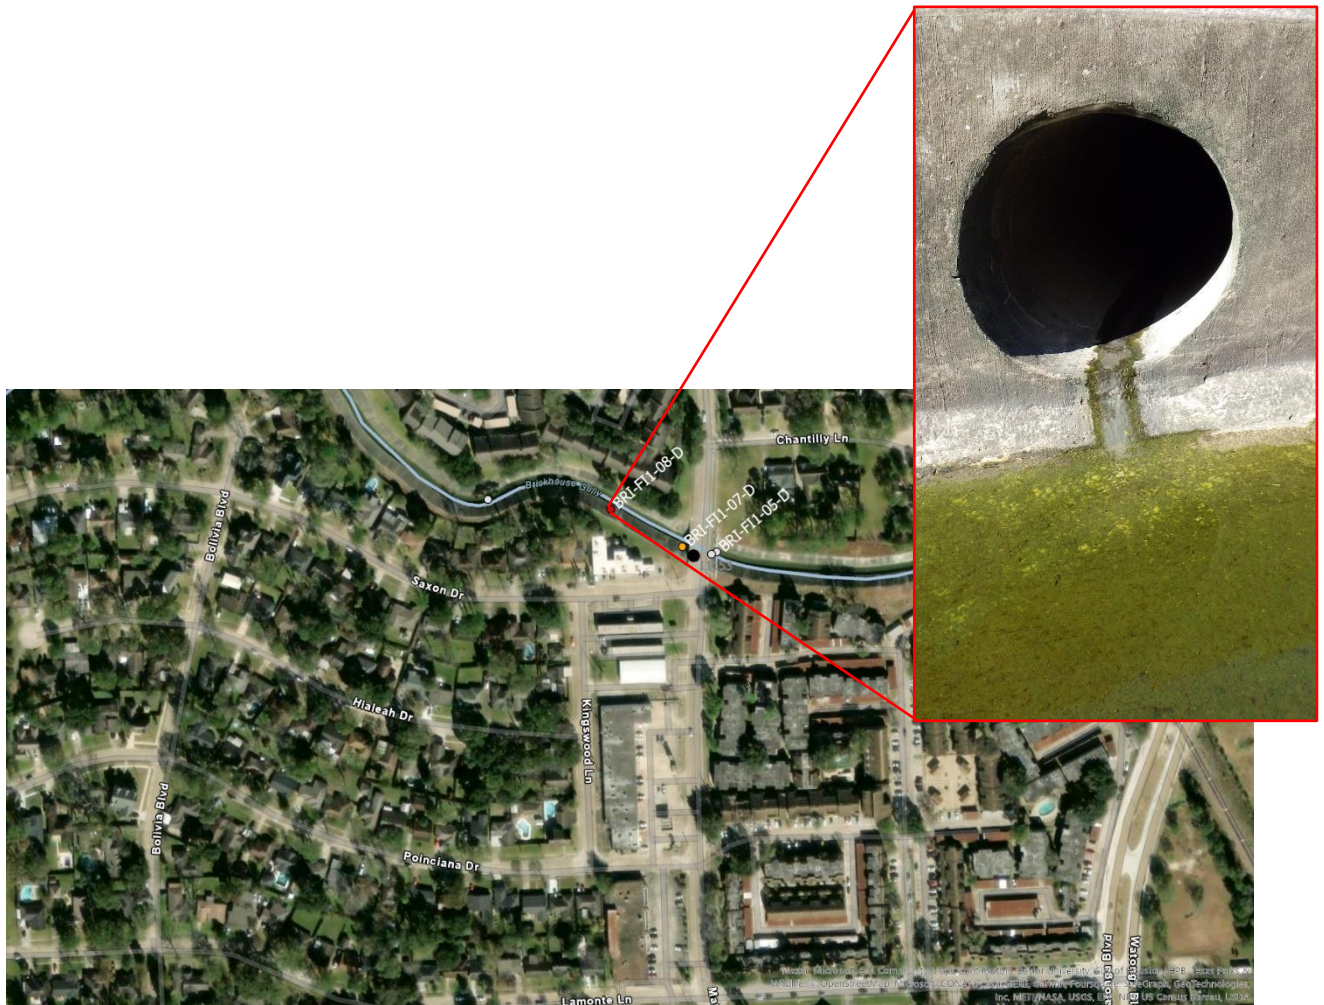
Referral site: BRI-FI1-08-D – High Priority

This is a 31 in. diameter concrete pipe located on the right bank of Brickhouse Gully. Water within the pipe was 0.06 in. deep and barely trickling into the segment. The bottom of the pipe had a thin layer of algae down to the water’s edge and there was a white film on the surface of the water coming out of the pipe. There are apartments and single-family residences located in the area on the right bank, as well as a self-service car wash. A sample taken 0.4 m downstream of the pipe had a bacteria value of > 242,000 MPN/100 mL. The ambient sample collected upstream of the pipe had a bacteria value of 6,700 MPN/100 mL. This pipe is a high priority referral site for the proper local authority.

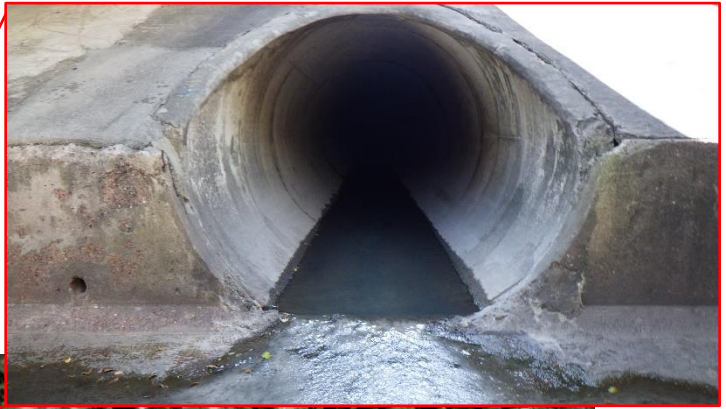
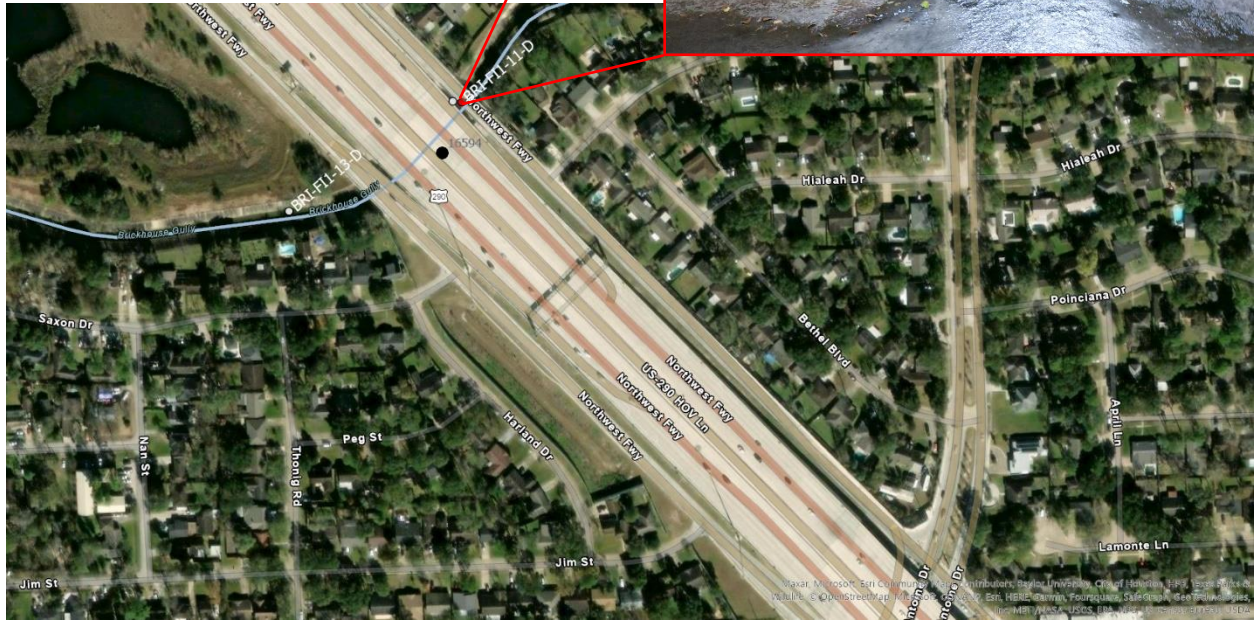
Referral site: BRI-FI1-11-D – High Priority

This is a 102 in. diameter concrete pipe located on the right bank of Brickhouse Gully. Water within the pipe was 5 in. deep and flowing steadily into the segment. There was a strong smell of sewage in the ambient air. This pipe is located under the bridge of U.S. 290. There are single-family residences located in the area on the right bank. A sample taken 2 m downstream of the pipe had a bacteria value of > 242,000 MPN/100 mL. The ambient sample collected upstream of the pipe had a bacteria value of 51,7000 MPN/100 mL. This pipe is a high priority referral site for the proper local authority.

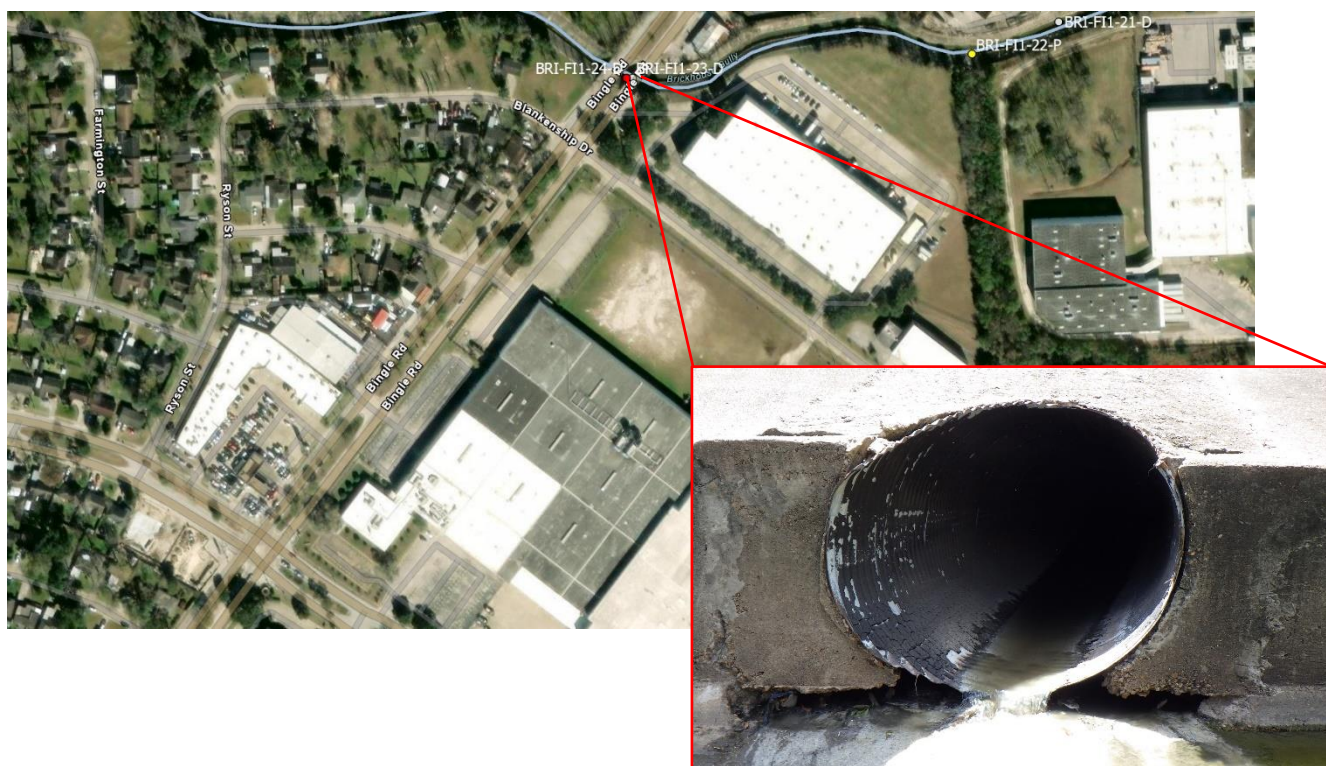
### Referral site: BRI-FI1-24-D – High Priority

This is a 56 in. diameter metal pipe located on the right bank of Brickhouse Gully. Water within the pipe was 2 in. deep and was flowing into the segment. The water was cloudy and there was a smell of effluent in the ambient air. There are single-family homes and commercial buildings in the area. A sample taken 0.6 m downstream of the pipe had a bacteria value of > 242,000 MPN/100 mL. The ambient sample collected upstream of the pipe had a bacteria value of 54,800 MPN/100 mL. This pipe is a high priority referral site for the proper local authority.

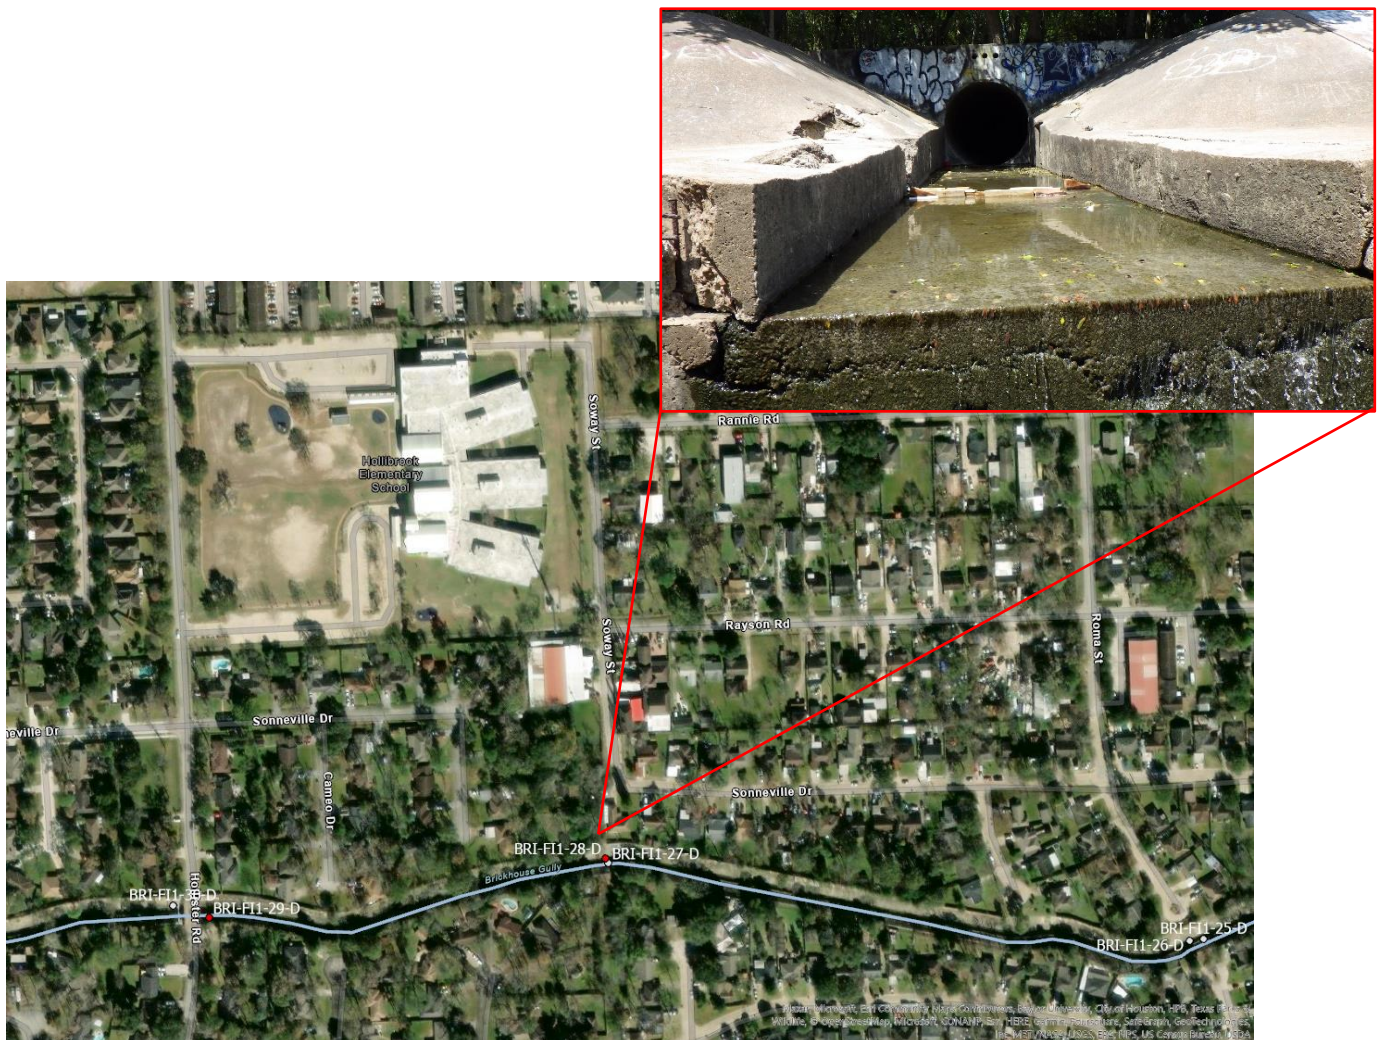
Referral site: BRI-FI1-28-D – High Priority

This is a 75 in. diameter concrete pipe located on the left bank of Brickhouse Gully. Water within the pipe was 0.5 in. deep and was flowing into the segment. There are apartments, single-family homes, commercial buildings and an elementary school in the area. A sample taken 15 m downstream of the pipe had a bacteria value of 242,000 MPN/100 mL. The ambient sample collected upstream of the pipe had a bacteria value of 200 MPN/100 mL. This pipe is a high priority referral site for the proper local authority.

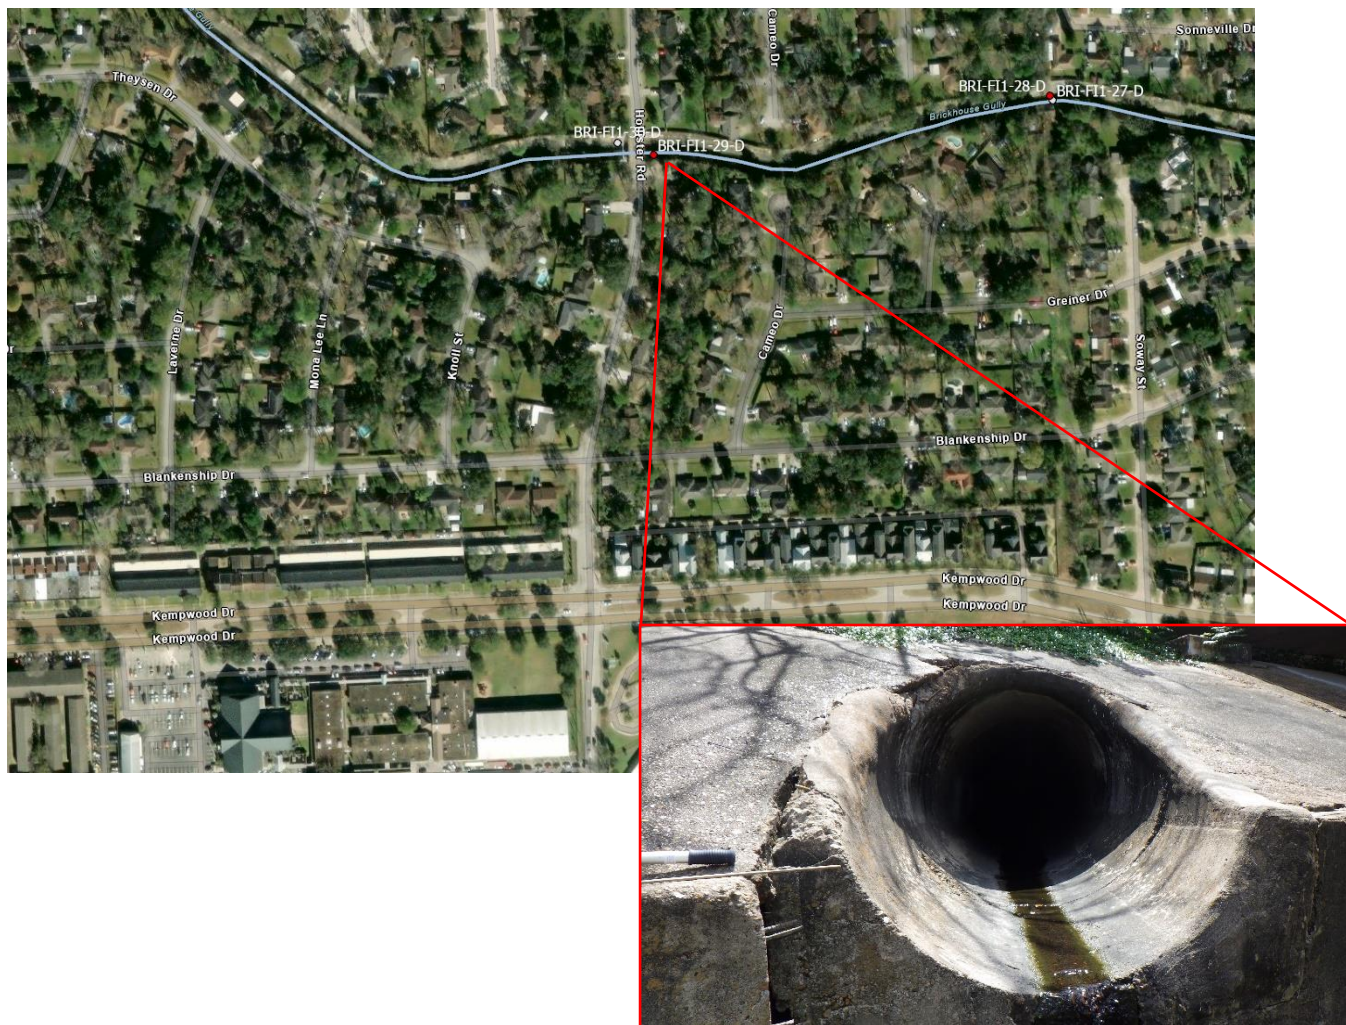
### Referral site: BRI-FI1-29-D – High Priority

This is a 52 in. diameter concrete pipe located on the right bank of Brickhouse Gully. Water within the pipe was 0.5 in. deep and was flowing into the segment. There are single-family homes in the area. A sample taken 1 m downstream of the pipe had a bacteria value of 1,990 MPN/100 mL. The ambient sample collected upstream of the pipe had a bacteria value of 200 MPN/100 mL. This pipe is a high priority referral site for the proper local authority.

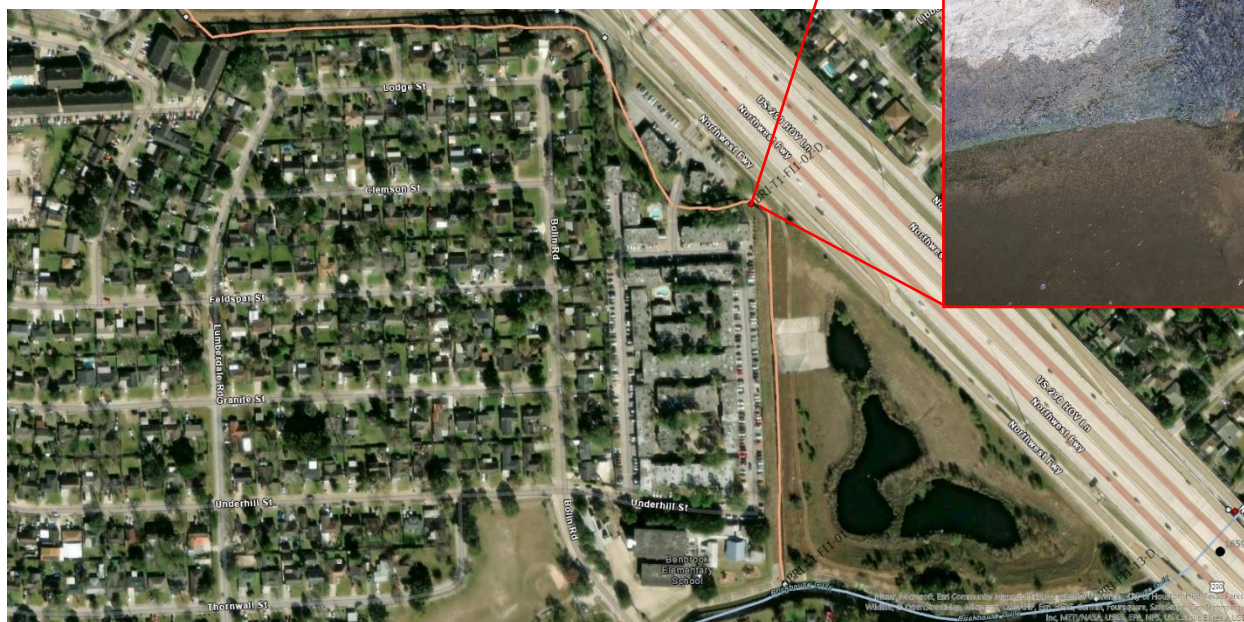
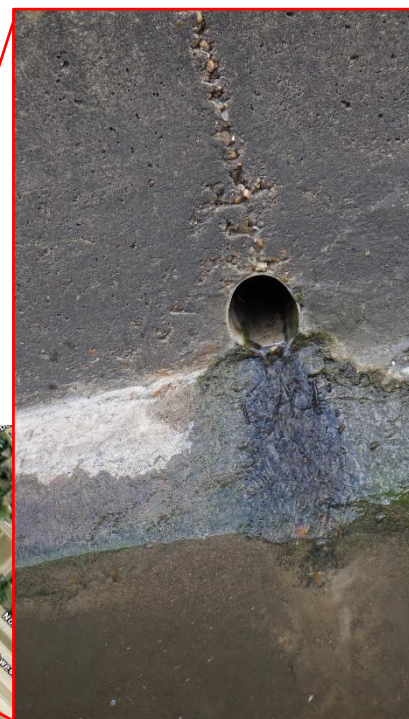
Referral site: BRI-T1-FI1-02-D – High Priority

This is a 4.5 in. diameter concrete pipe (weep hole) located on the right bank of the tributary to Brickhouse Gully. Water within the pipe was 0.25 in. deep and trickling into the segment. There was a rusted-out metal pipe higher up on the right bank likely draining water into the source of this weep hole. There are apartments located in the area on the right bank. A sample taken 0.25 m downstream of the pipe had a bacteria value of 3,450 MPN/100 mL. The ambient sample collected upstream of the pipe had a bacteria value of 300 MPN/100 mL. This pipe is a high priority referral site for the proper local authority.

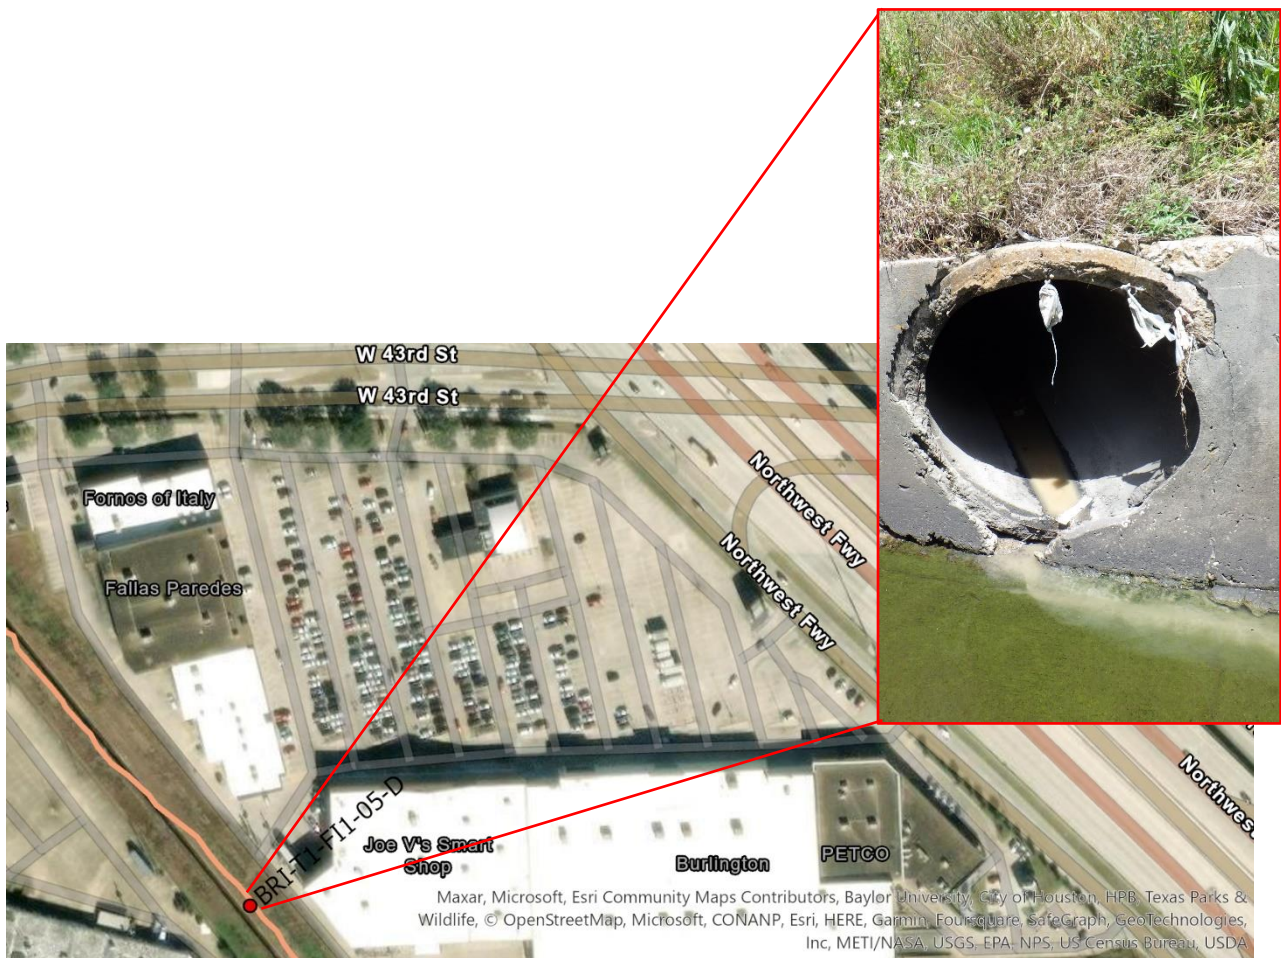
Referral site: BRI-T1-FI1-05-D – High Priority

This is a 40 in. diameter concrete pipe located on the left bank of the tributary to Brickhouse Gully. Water within the pipe was 0.25 in. deep and flowing into the segment. There was a strong fermented odor coming from the pipe and the water that was discharging from the pipe was cloudy and brown. There are commercial buildings in the area on the right bank. A sample taken 0.2 m downstream of the pipe had a bacteria value of 2,990 MPN/100 mL. The ambient sample collected upstream of the pipe had a bacteria value of 310 MPN/100 mL. This pipe is a high priority referral site for the proper local authority.

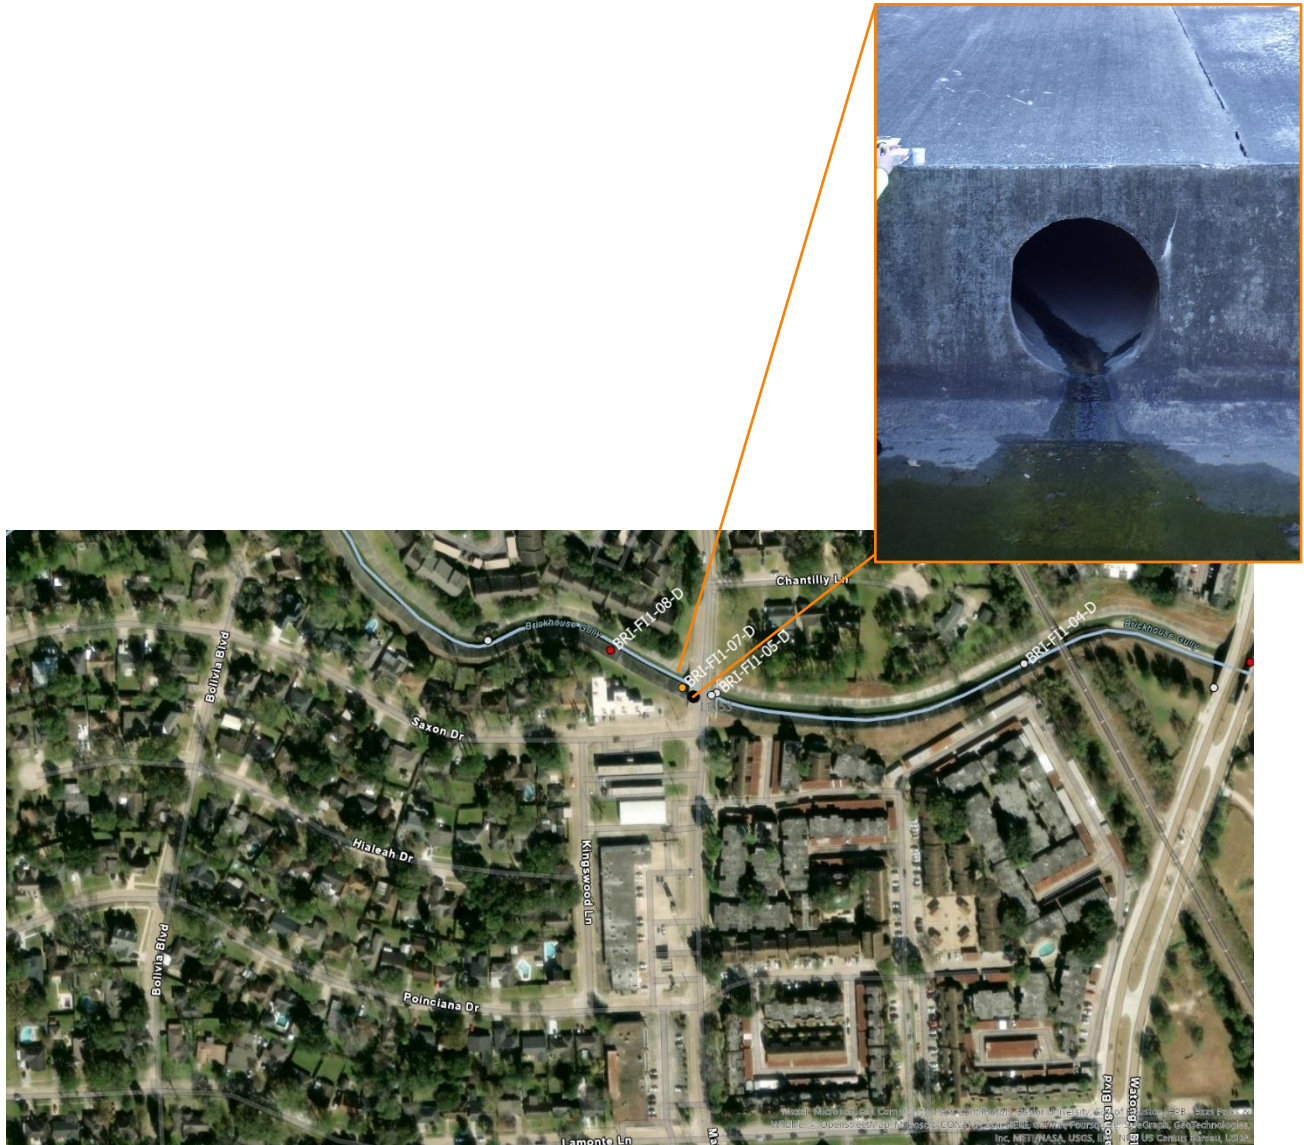
Referral site: BRI-FI1-07-D – Low Priority

This is a 29 in. diameter concrete pipe located on the right bank of Brickhouse Gully. Water within the pipe was 0.06 in. deep and barely trickling into the segment. Algae was present inside the pipe. There are commercial buildings, single-family homes, and apartments in the area. A sample 1 m downstream of the pipe had a bacteria value of 9,090 MPN/100 mL. The ambient sample collected upstream of the pipe had a bacteria value of 8,200 MPN/100 mL. This pipe is a low priority referral site for the proper local authority.

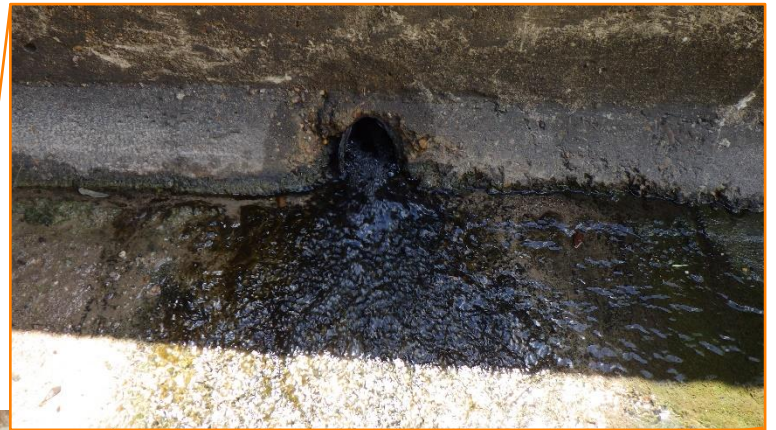
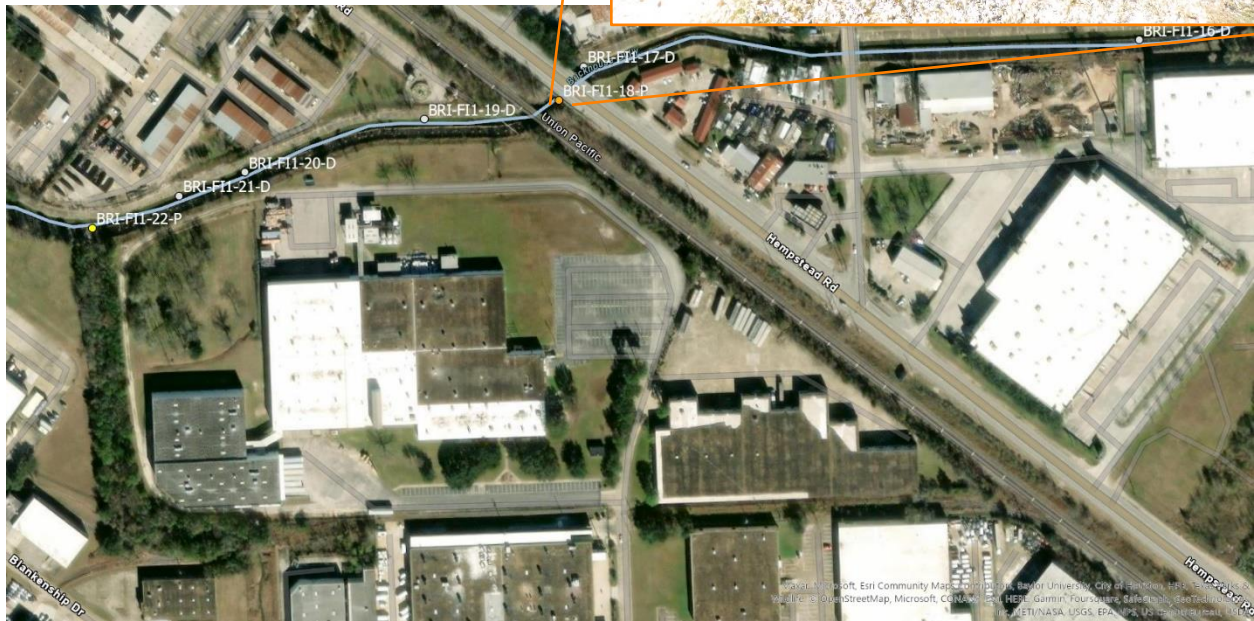
Referral site: BRI-FI1-18-P – Low Priority

This is a 4 in. diameter metal pipe (weep hole) located on the right bank of Brickhouse Gully. Water within the pipe was 1.5 in. deep and was flowing heavily into the segment. Sediment was present in front of the pipe. There are commercial buildings located in the area on the right bank. A sample taken from the pipe had a bacteria value of 300 MPN/100 mL. This pipe is a low priority referral site for the proper local authority.

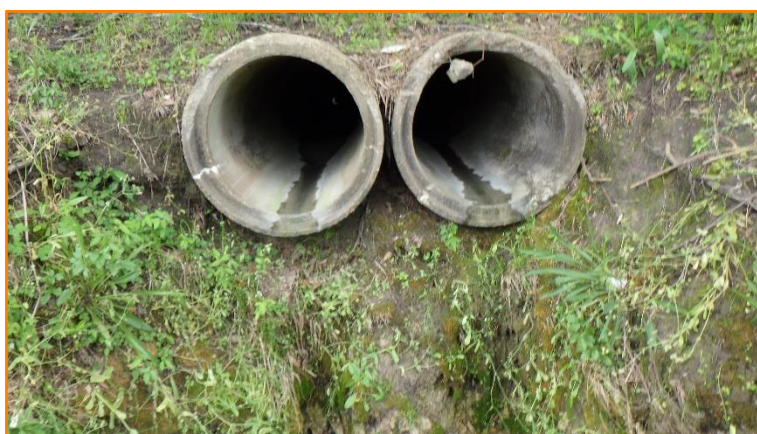
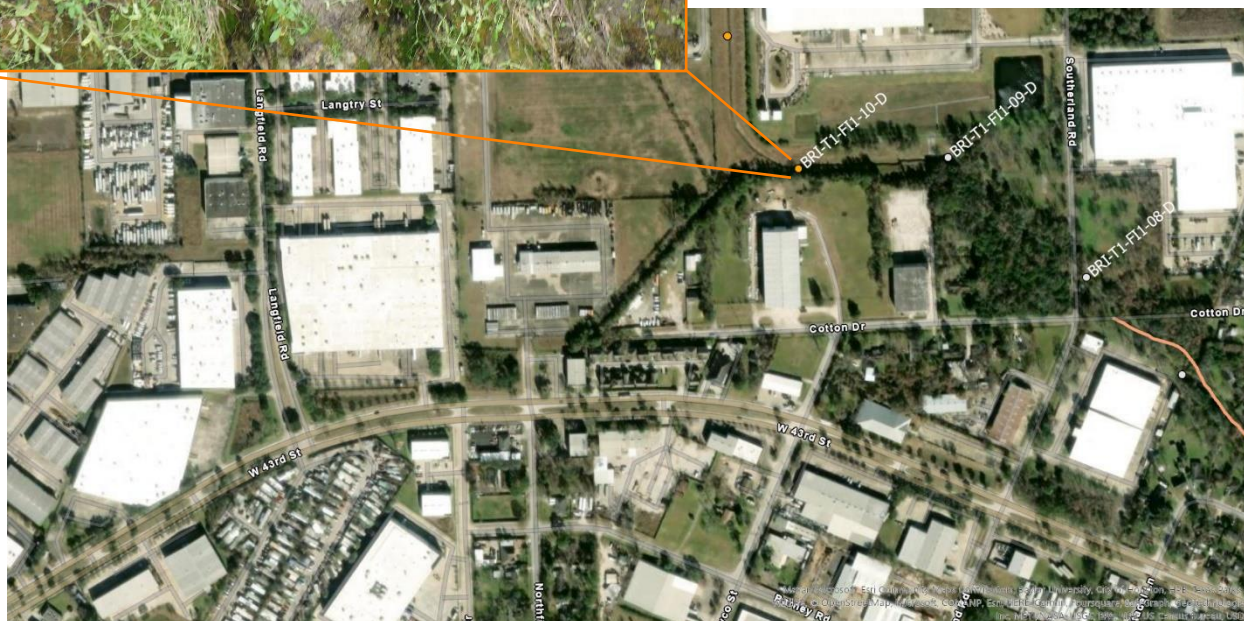
Referral site: BRI-T1-FI1-10-D – Low Priority

These were two identical 23.5 in. diameter concrete pipes located adjacent to each other on the right bank of the tributary to Brickhouse Gully. Water within the pipes was 0.06 in. deep and both were dripping into the segment. There are commercial buildings located in the area on the right bank. A sample taken from a pool that they were dripping into 1.5 m downstream of the pipes had a bacteria value of 410 MPN/100 mL. The ambient sample collected upstream of the pipes had a bacteria value of < 100 MPN/100 mL. This is a low priority referral site for the proper local authority.

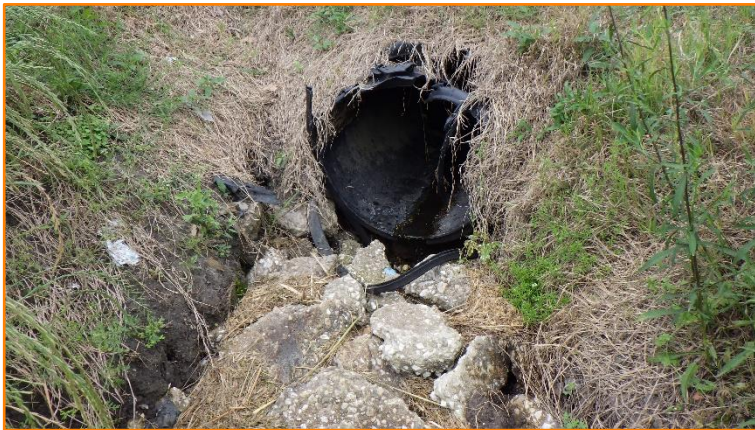
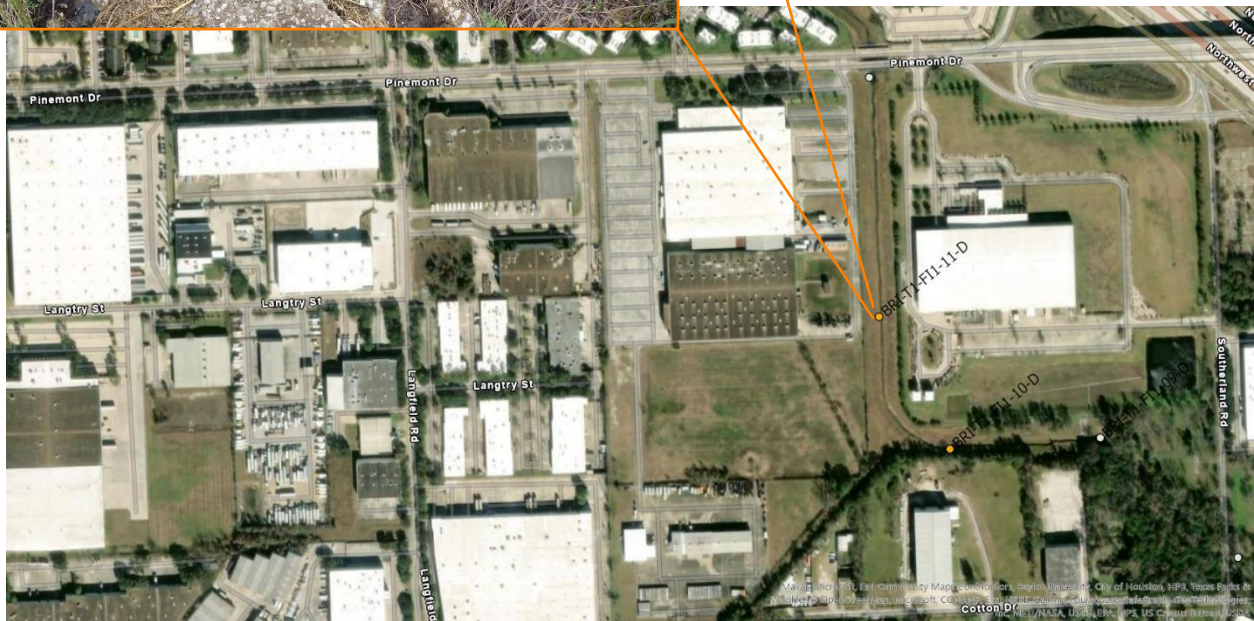
Referral site: BRI-T1-FI1-11-D – Low Priority

This is a 24 in. diameter corrugated plastic pipe located on the right bank of the tributary to Brickhouse Gully. Water within the pipe was 0.25 in. deep and trickling into the segment. There are commercial buildings located in the area on the right bank. A sample 0.2 m downstream of the pipe had a bacteria value of 410 MPN/100 mL. The ambient sample collected upstream of the pipe had a bacteria value of < 100 MPN/100 mL. This pipe is a low priority referral site for the proper local authority.

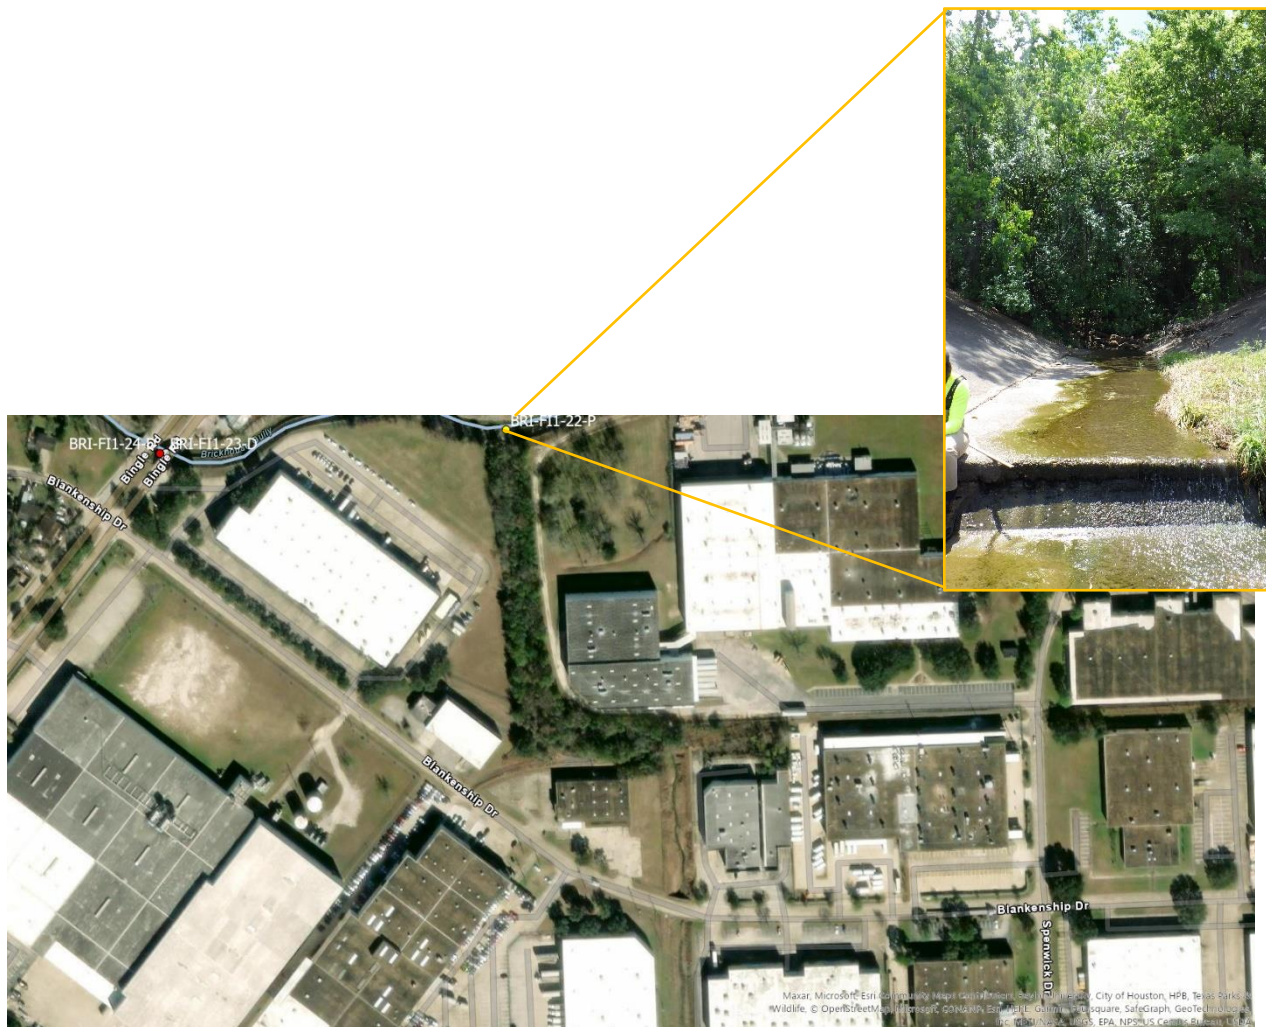
### Referral site: BRI-FI1-22-P – Investigate Further

This was an ambient sample taken from a tributary to Brickhouse Gully on the right bank. The ambient sample had a bacteria value of 520 MPN/100 mL. Further investigation is recommended by the proper local authority to determine the source of elevated bacteria within this tributary. There are commercial buildings surrounding the tributary.

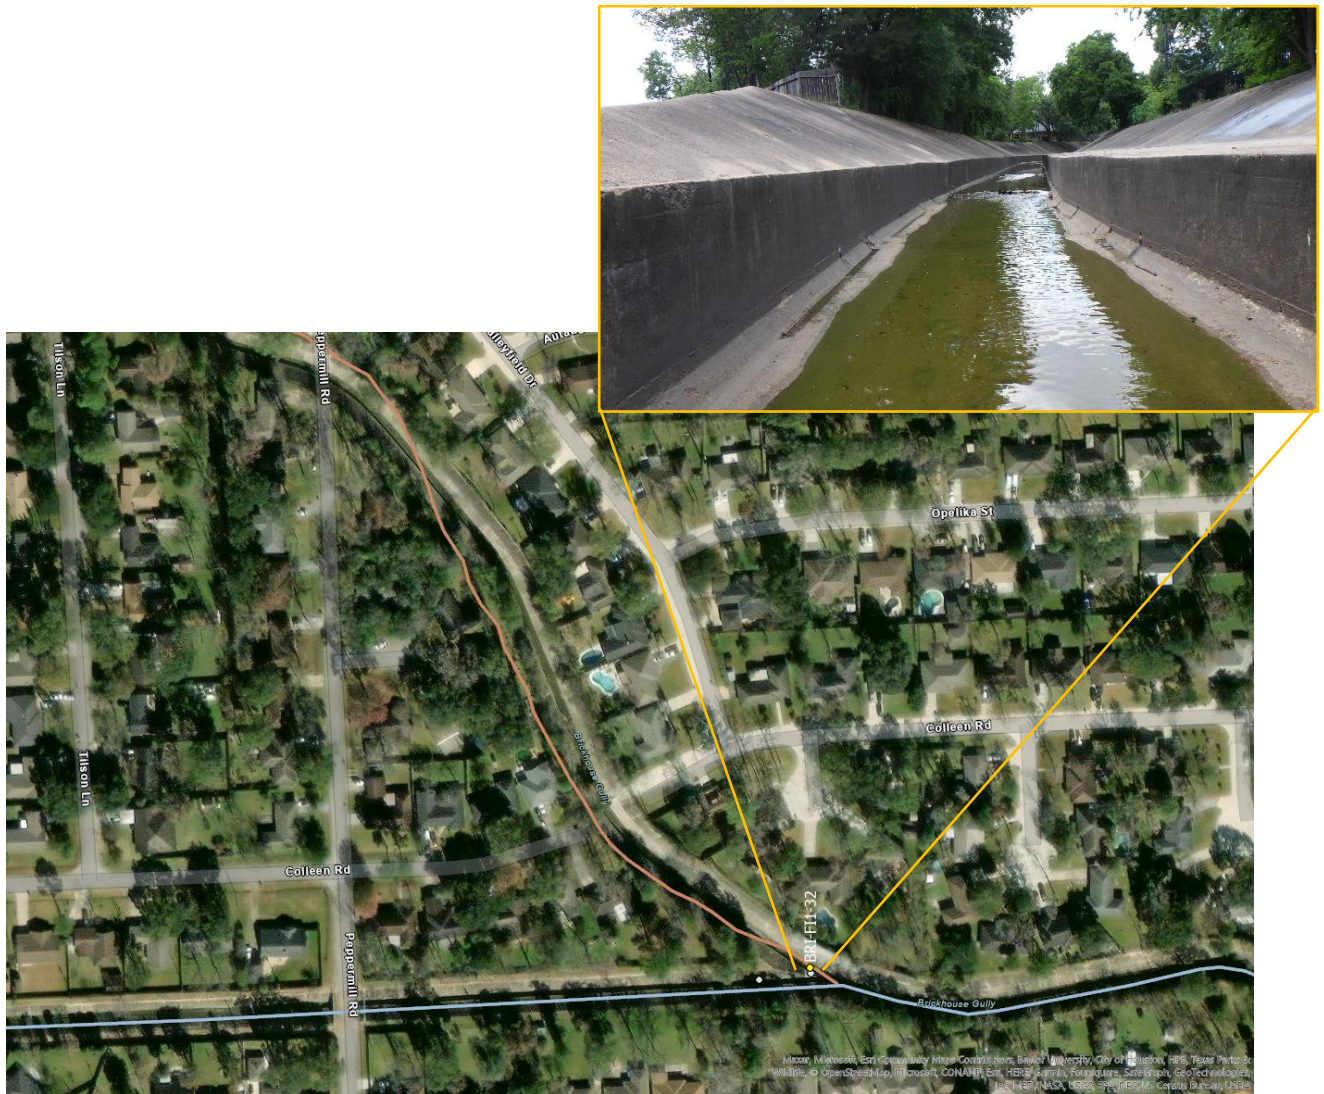
Referral site: BRI-FI1-32 – Investigate Further

This was an ambient sample collected upstream of the confluence with the main AU. The ambient sample taken had a bacteria value of 2,530 MPN/100 mL. Further investigation is recommended by the proper local authority to determine the source of elevated bacteria upstream of the segment. There are single-family homes and a park located upstream of the site.

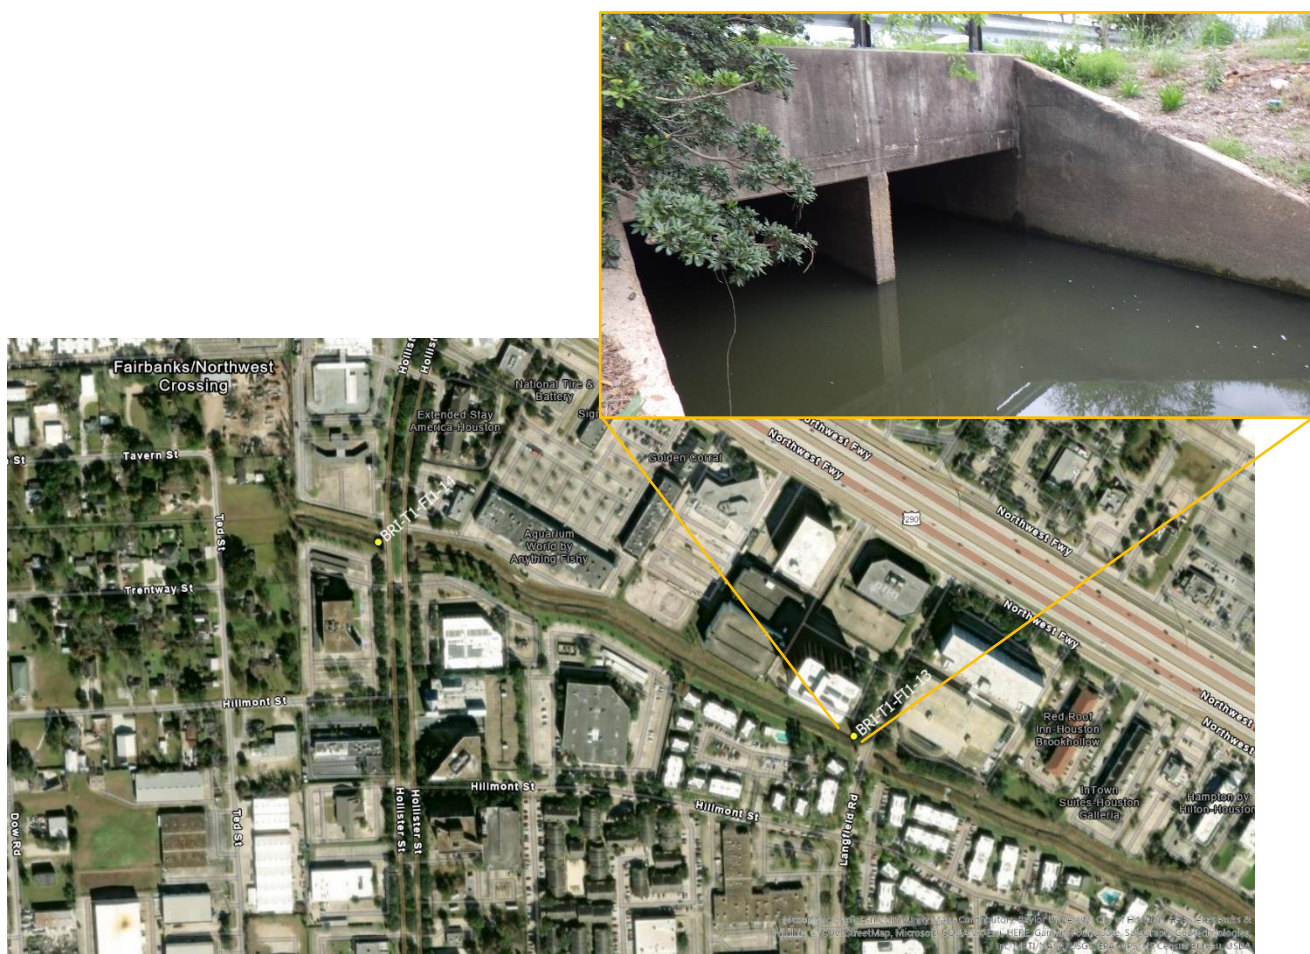
### Referral site: BRI-T1-FI1-13 – Investigate Further

This was an ambient sample taken upstream of the Langfield Road bridge on the tributary of Brickhouse Gully. The ambient sample taken just in front of the bridge crossing had a bacteria value of > 242,000 MPN/100 mL. The next sample taken was an ambient sample taken upstream of the Hollister Road bridge (BRI-T1-FI1-14). This bacteria value was < 100 MPN/100 mL. Further investigation is recommended by the proper local authority to determine the source of elevated bacteria between these two locations as the field crew was unable to walk this portion due to oncoming thunderstorms. There are apartments and commercial businesses located upstream of the site.
