# Targeted Bacteria Monitoring Project Field Investigation Final Report Assessment Unit 1017A\_01 Brickhouse Gully

May 16, 2023

Environmental Institute of Houston, University of Houston-Clear Lake

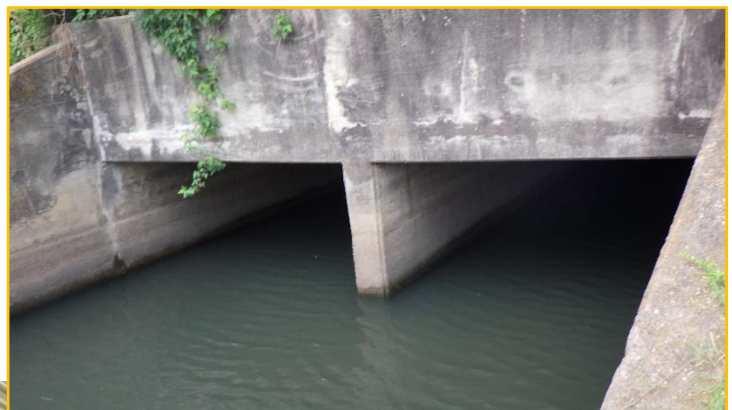
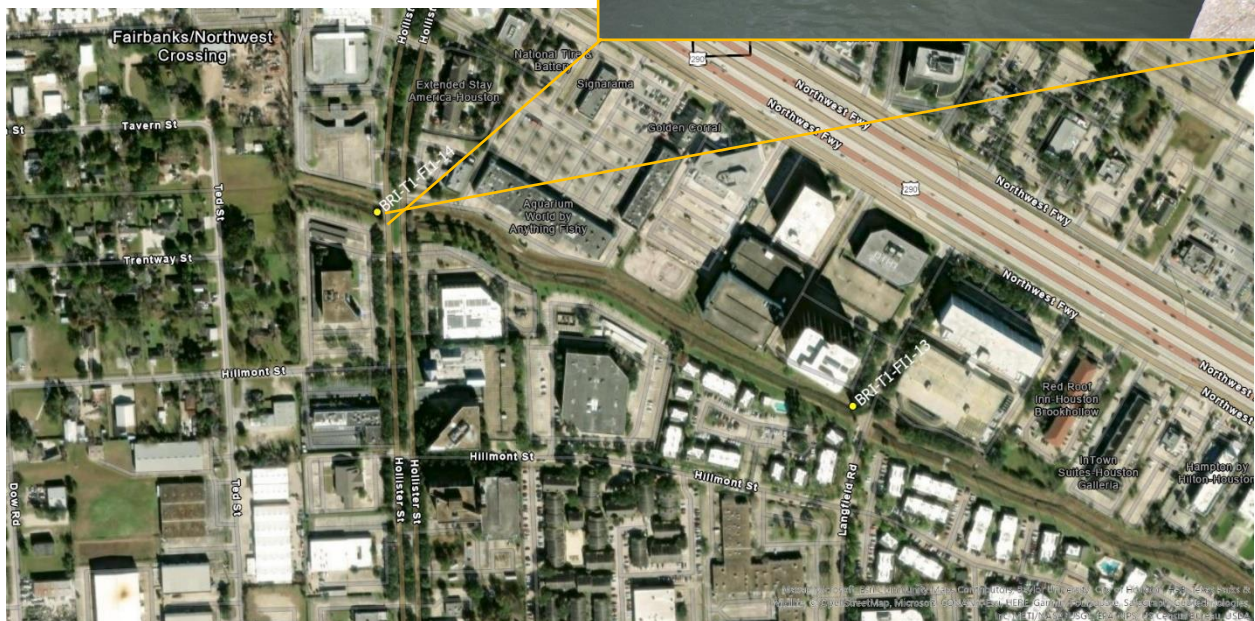
### Referral site: BRI-T1-FI1-14 – Investigate Further

This was an ambient sample taken upstream of the Hollister Road bridge on the tributary of Brickhouse Gully. The ambient sample taken just in front of the bridge crossing had a bacteria value of < 100 MPN/100 mL while the sample taken downstream at Langfield Road had a bacteria value of > 242,000 MPN/100 mL. Further investigation is recommended by the proper local authority to determine the source of elevated bacteria between these two locations as the field crew was unable to walk this portion due to oncoming thunderstorms. There are apartments and commercial businesses located between this location and BRI-T1-FI1-13.
