Targeted Bacteria Monitoring Project Field Investigation Final Report Assessment Unit 1017B_02, Cole Creek

June 2, 2023

Environmental Institute of Houston, University of Houston-Clear Lake

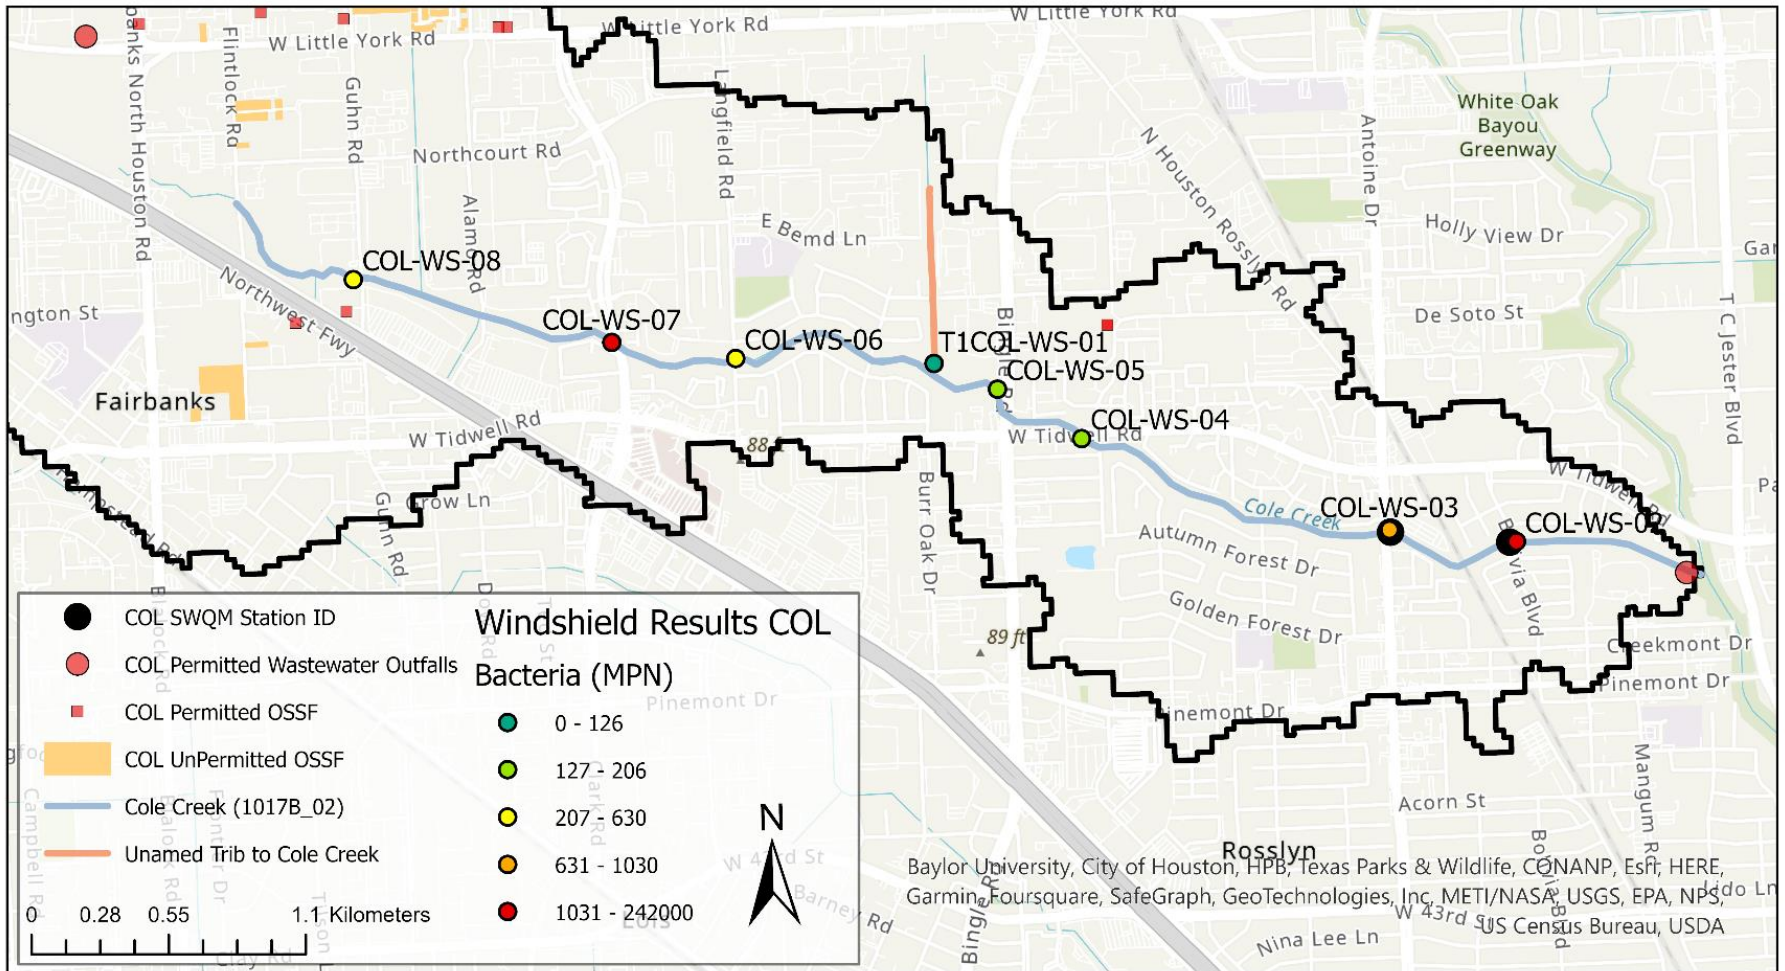
Figure 2: Windshield survey/ground truthing bacteria results from sampling on 03/06/2023 on Cole Creek (AU 1017B_02).

- 1) COL-WS-02, which was collected from the downstream side of the bridge at Bolivia Blvd. This sample had an elevated bacteria result compared to the samples collected upstream and downstream of this area.
- 2) COL-WS-03, which was collected from the downstream side of the bridge at Antoine Dr. This sample had an elevated bacteria result compared to the sample collected ~0.8 mi upstream of this area.
- 3) COL-WS-07, which was collected from the upstream side of the bridge at Hollister Rd. This sample had an elevated bacterial level compared to the sample collected ~0.65 mi upstream of this area.

Based upon the results of the WS and ground-truthing, a FI covering the entire length of the AU was recommended. The unnamed tributary that has a confluence with Cole Creek situated between Pine Grove Drive and Bingle Road had a bacteria level of 31 MPN and therefore was not targeted for a FI. Based on the results of the WS, we expected to identify potential non-point sources or point sources of elevated bacteria near the following portions of the AU:

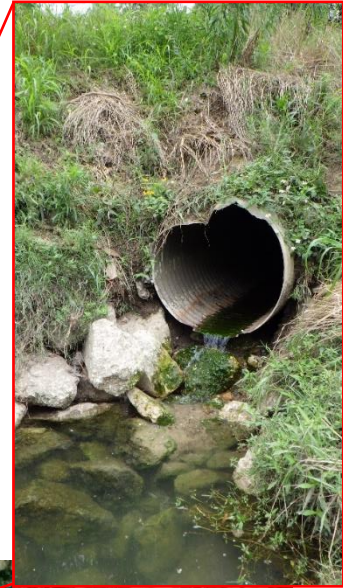
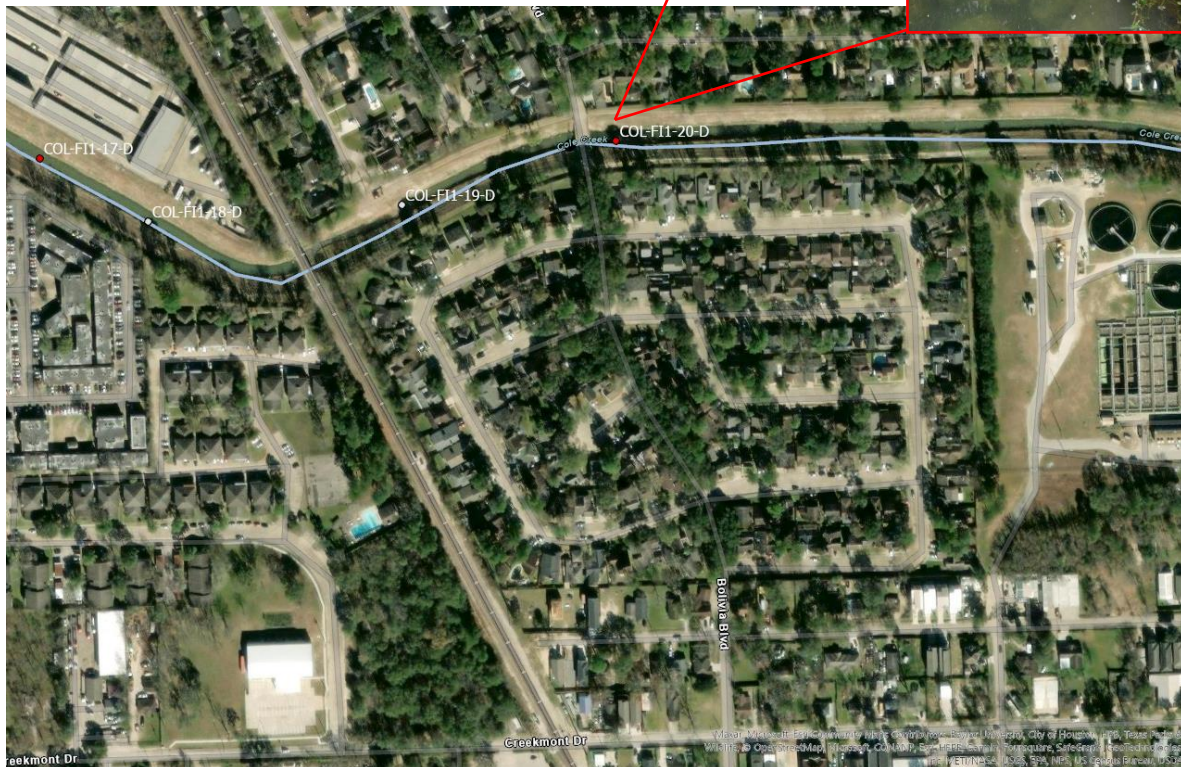
Referral site: COL-FI1-20-D – High Priority

This is a 36 in. diameter metal pipe located on the right bank of Cole Creek. Water within the pipe was 0.5 in. deep and flowing into the segment. The bottom of the pipe is coated in algae. There are single-family homes located in the area on the right bank. A sample taken 0.5 m downstream of the pipe had a bacteria value of 27,200 MPN/100 mL. The ambient sample collected upstream of the pipe had a bacteria value of < 100 MPN/100 mL. This pipe is a high priority referral site for the proper local authority.

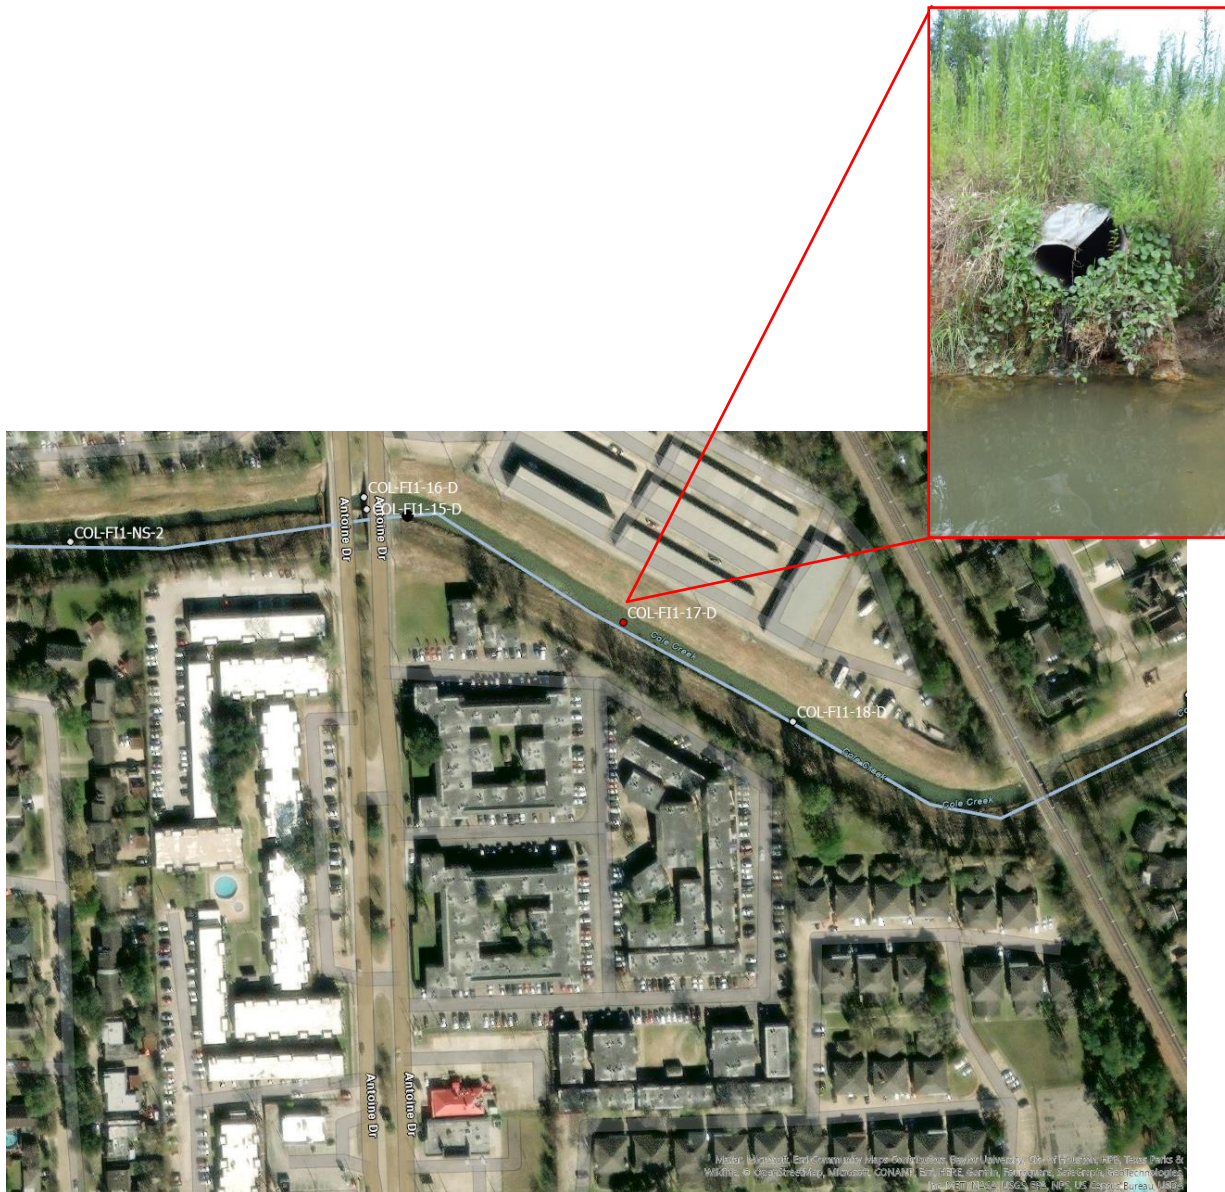
Referral site: COL-FI1-17-D – High Priority

This is a 26 in. diameter metal pipe located on the right bank of Cole Creek. Water within the pipe was 0.25 in. deep, somewhat white, cloudy, and trickling into the segment. There was a smell of effluent in the ambient air. The pipe is smashed at the opening and vegetation is growing thick around it. There are apartments located in the area on the right bank. A sample taken 0.3 m downstream of the pipe had a bacteria value of > 242,000 MPN/100 mL. The ambient sample collected upstream of the pipe had a bacteria value of 98,000 MPN/100 mL. This pipe is a high priority referral site for the proper local authority.

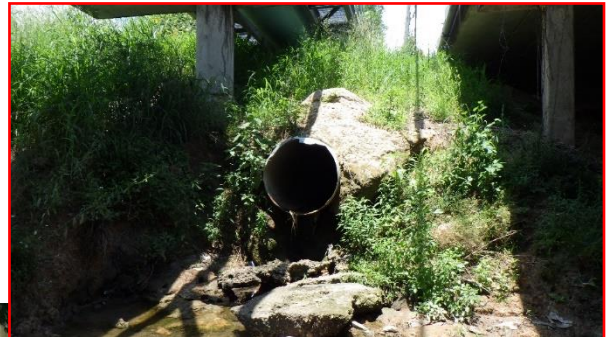
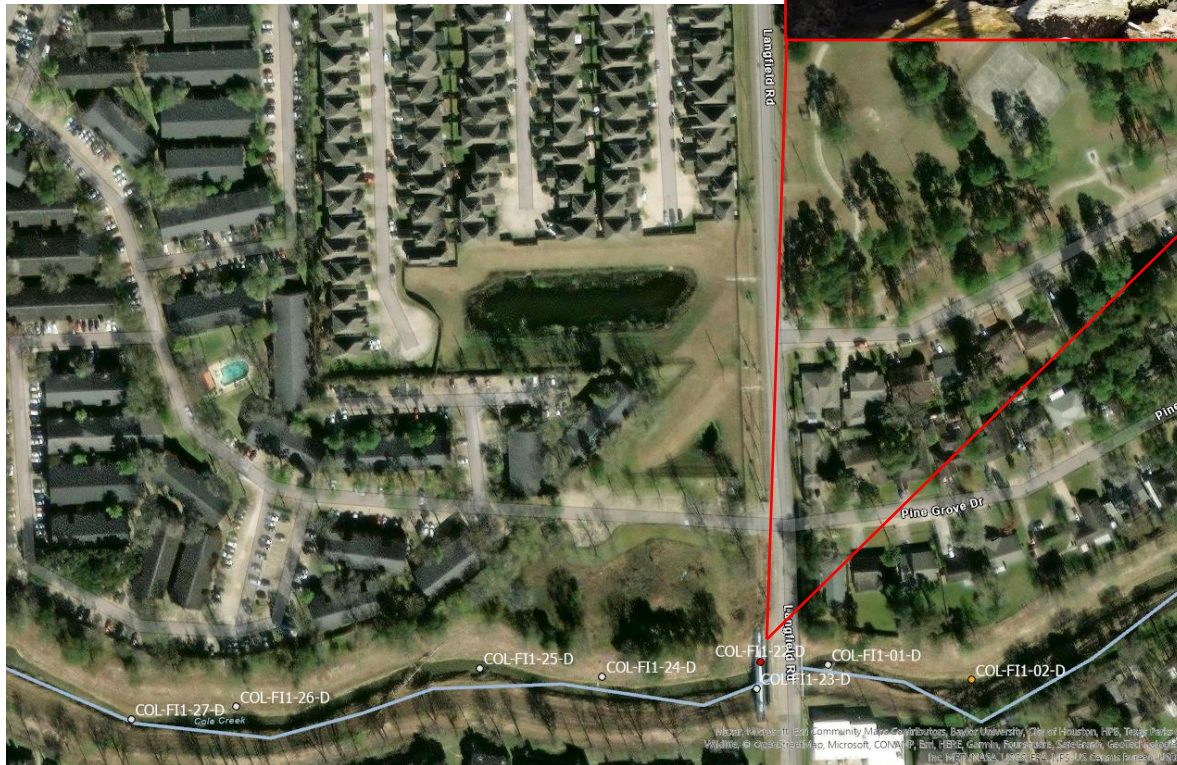
Referral site: COL-FI1-22-D – High Priority

This is a 36 in. diameter metal pipe located on the left bank of Cole Creek. Water within the pipe was 0.5 in. deep and trickling into the segment. There are apartments and single-family homes located in the area on the left bank. A sample taken 1 m downstream of the pipe had a bacteria value of 15,500 MPN/100 mL. The ambient sample collected upstream of the pipe had a bacteria value of 520 MPN/100 mL. This pipe is a high priority referral site for the proper local authority.

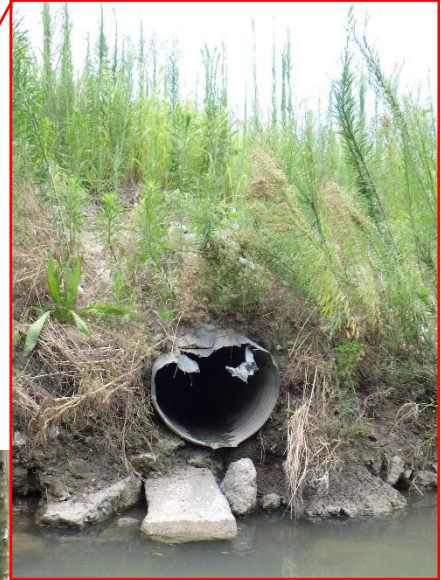
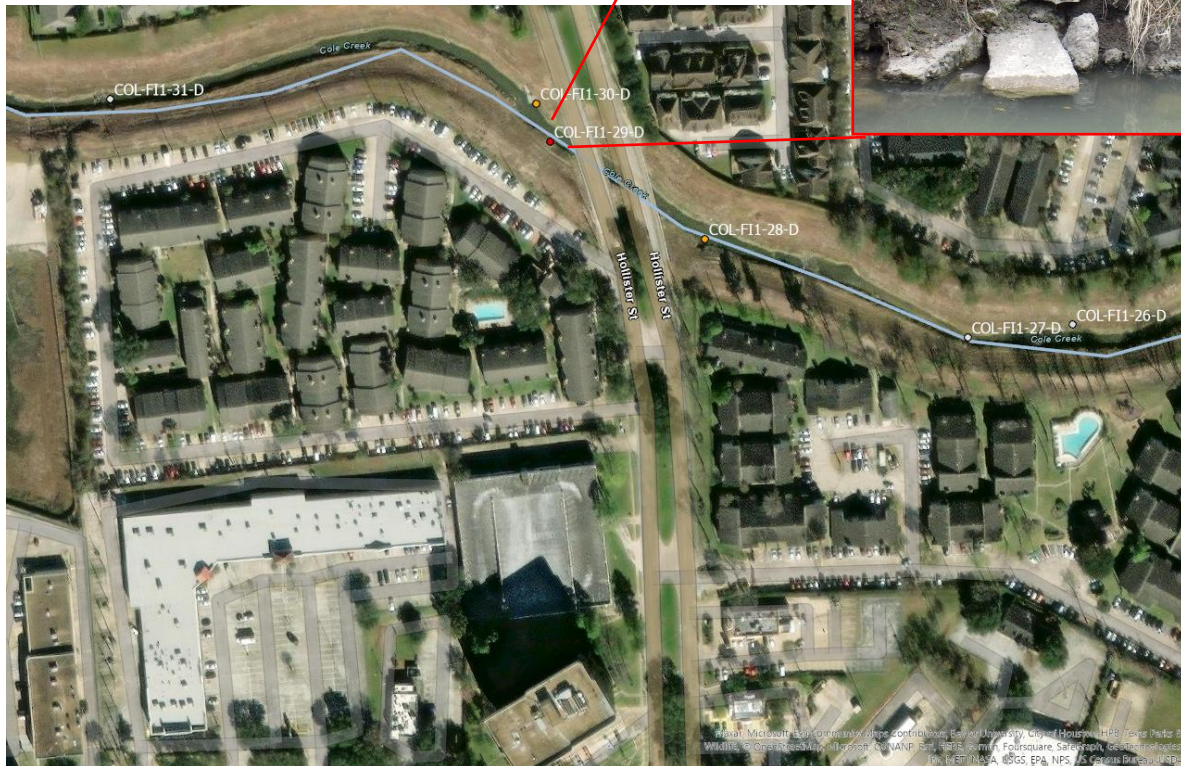
Referral site: COL-FI1-29-D – High Priority

This is a 24 in. diameter metal pipe located on the right bank of Cole Creek. Water within the pipe was 0.06 in. deep and trickling steadily into the segment. There are apartments located in the area on the right bank. A sample taken 0.7 m downstream of the pipe had a bacteria value of 8,390 MPN/100 mL. The ambient sample collected upstream of the pipe had a bacteria value of 2,460 MPN/100 mL. This pipe is a high priority referral site for the proper local authority.

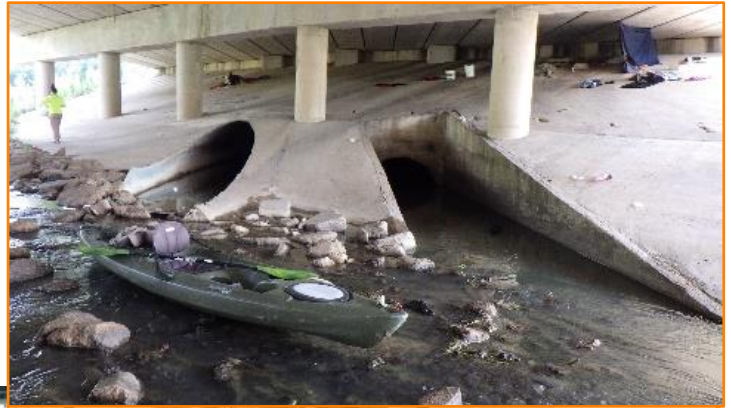
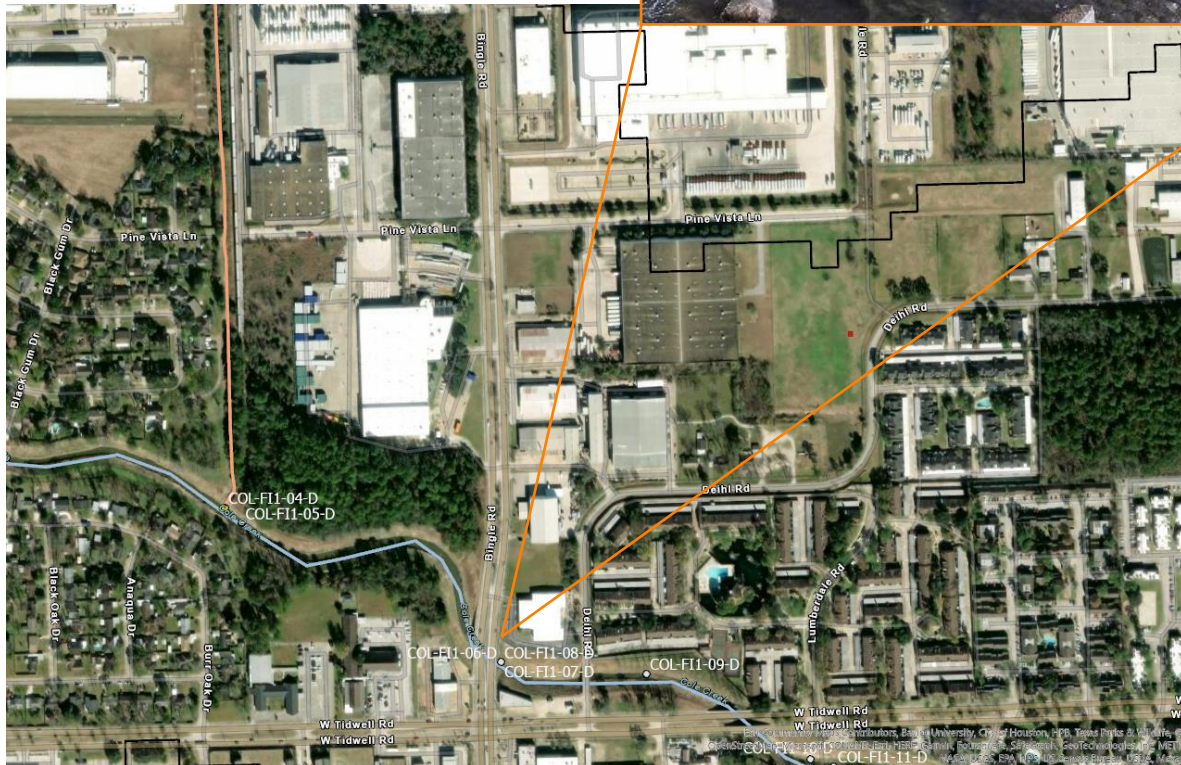
Referral site: COL-FI1-07-D- Low Priority

This is a 66 in. diameter concrete pipe located on the left bank of Cole Creek. This pipe is the second most US pipe at this location. The pipe was submerged and water within the pipe was 8.5 in. deep. There are commercial buildings located in the area on the left bank. A sample taken at the mouth of the submerged pipe had a bacteria value of 4,350 MPN/100 mL. The ambient sample collected upstream of the pipe had a bacteria value of 1,480 MPN/100 mL. This pipe is a low priority referral site for the proper local authority.

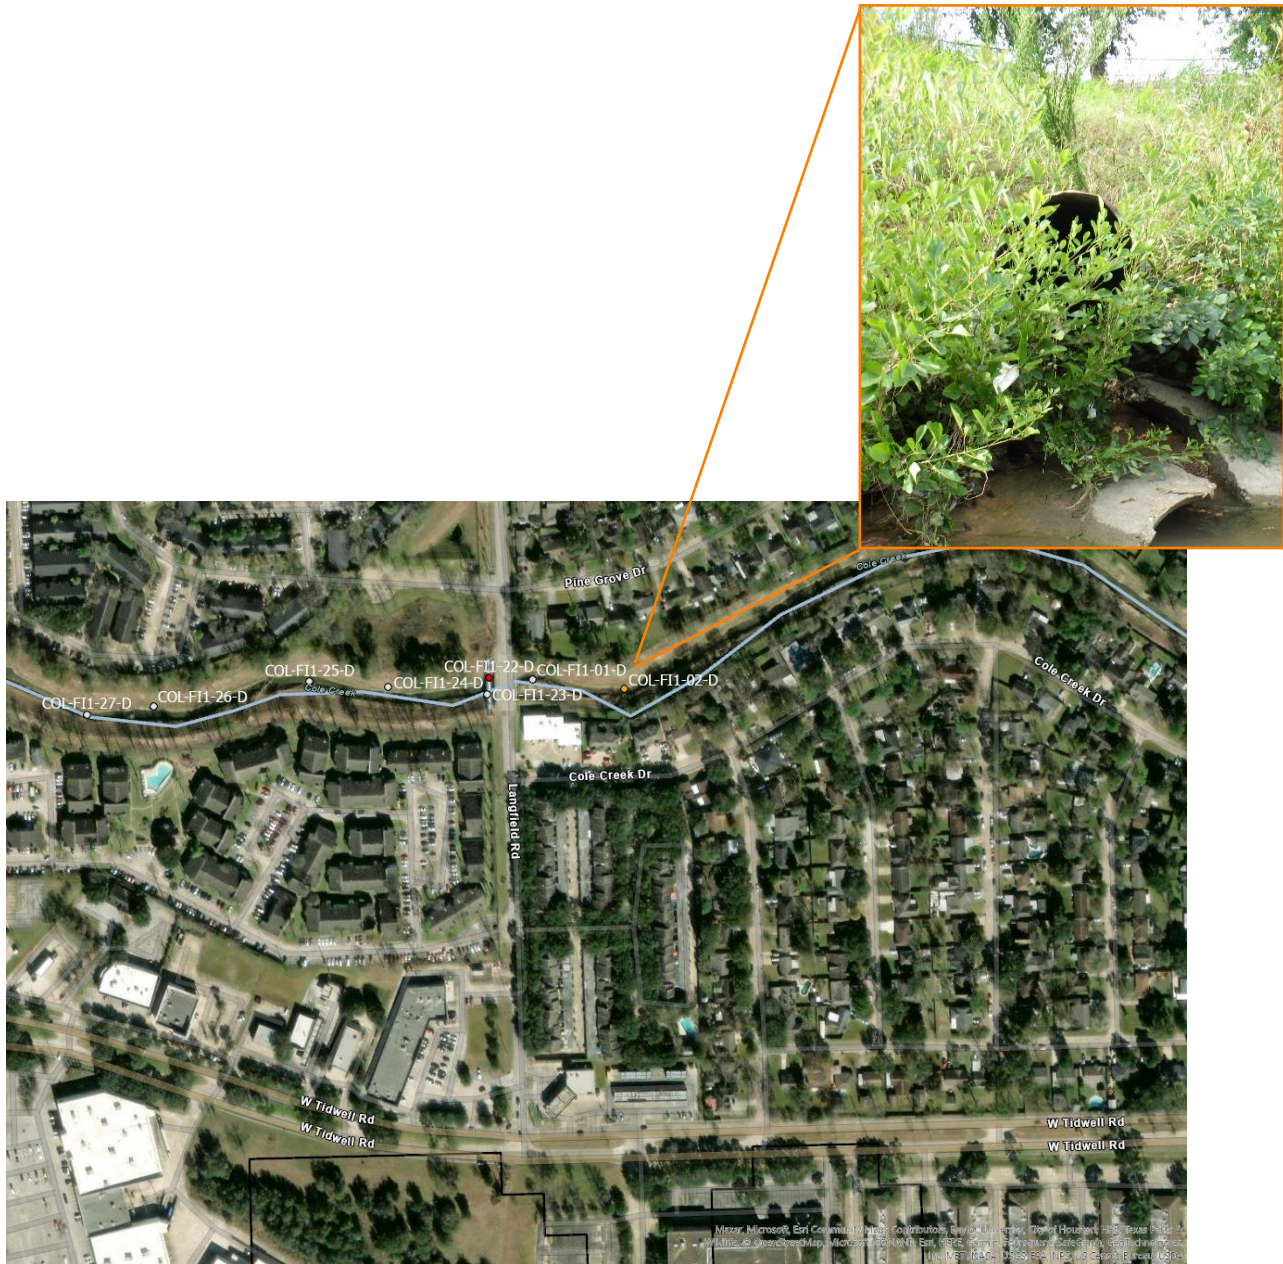
Referral site: COL-FI1-02-D- Low Priority

This is a 28 in. diameter metal pipe located on the right bank of Cole Creek. Water within the pipe was 0.06 in. deep and trickling into the segment. There are commercial buildings, single-family homes, and apartments located in the area on the right bank. A sample taken 1 m downstream of the pipe had a bacteria value of 1,100 MPN/100 mL. The ambient sample collected upstream of the pipe had a bacteria value of 310 MPN/100 mL. This pipe is a low priority referral site for the proper local authority.

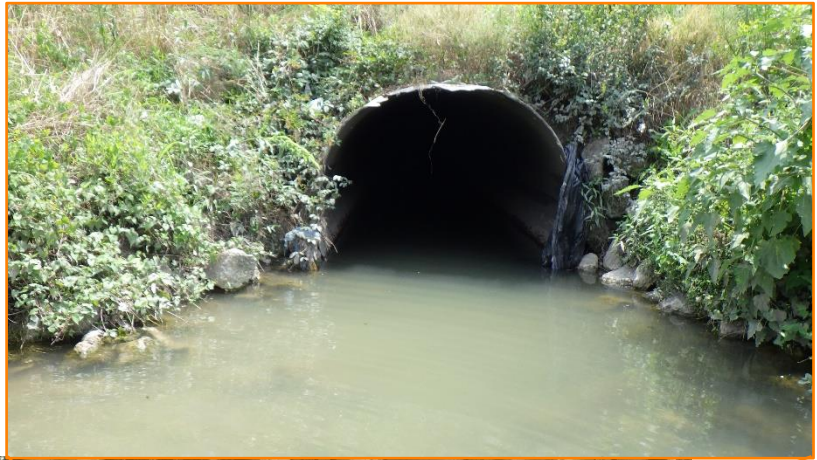
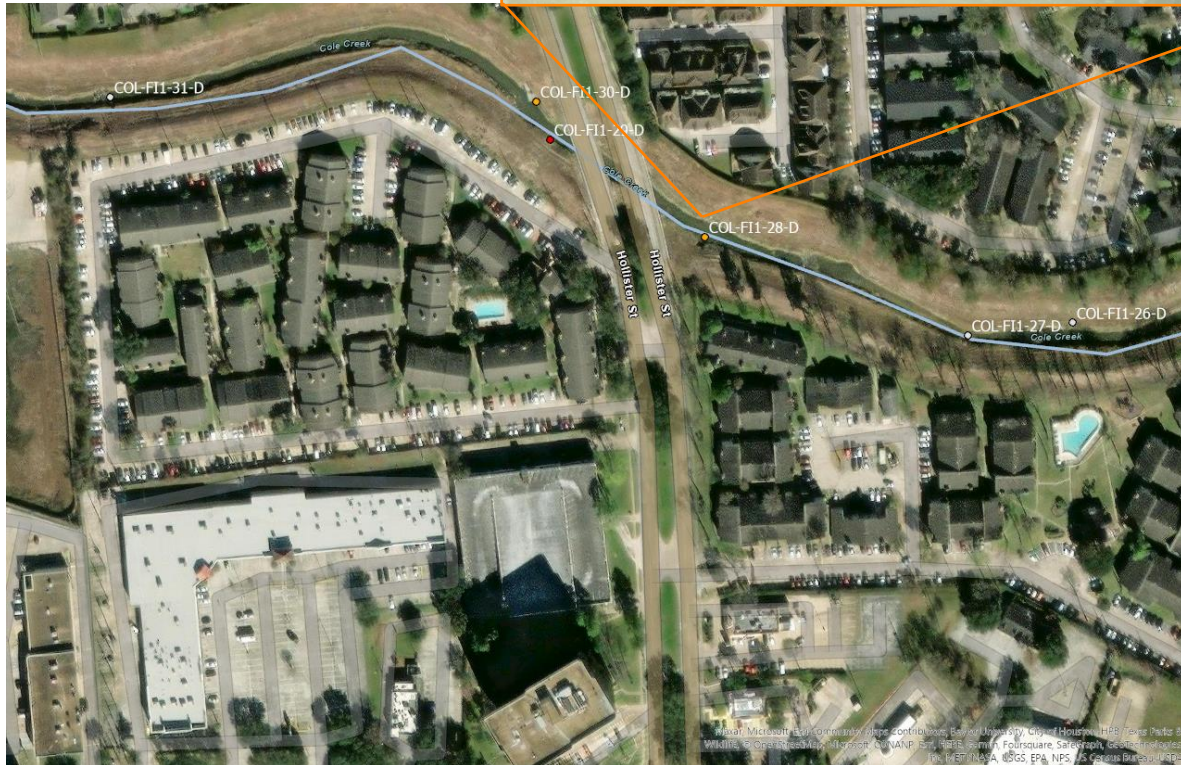
Referral site: COL-FI1-28-D- Low Priority

This is a 66 in. diameter metal pipe located on the right bank of Cole Creek. The pipe was submerged and water within the pipe was 15 in. deep. There are apartment buildings located in the area on the right bank. A sample taken at the mouth of the submerged pipe had a bacteria value of 2,130 MPN/100 mL. The ambient sample collected upstream of the pipe had a bacteria value of 970 MPN/100 mL. This pipe is a low priority referral site for the proper local authority.

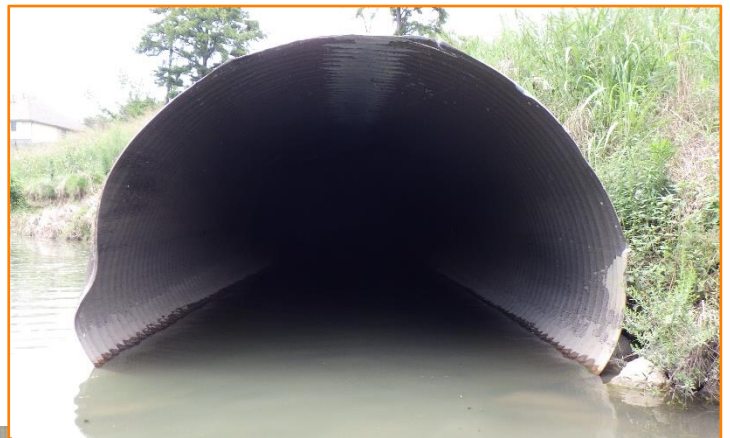
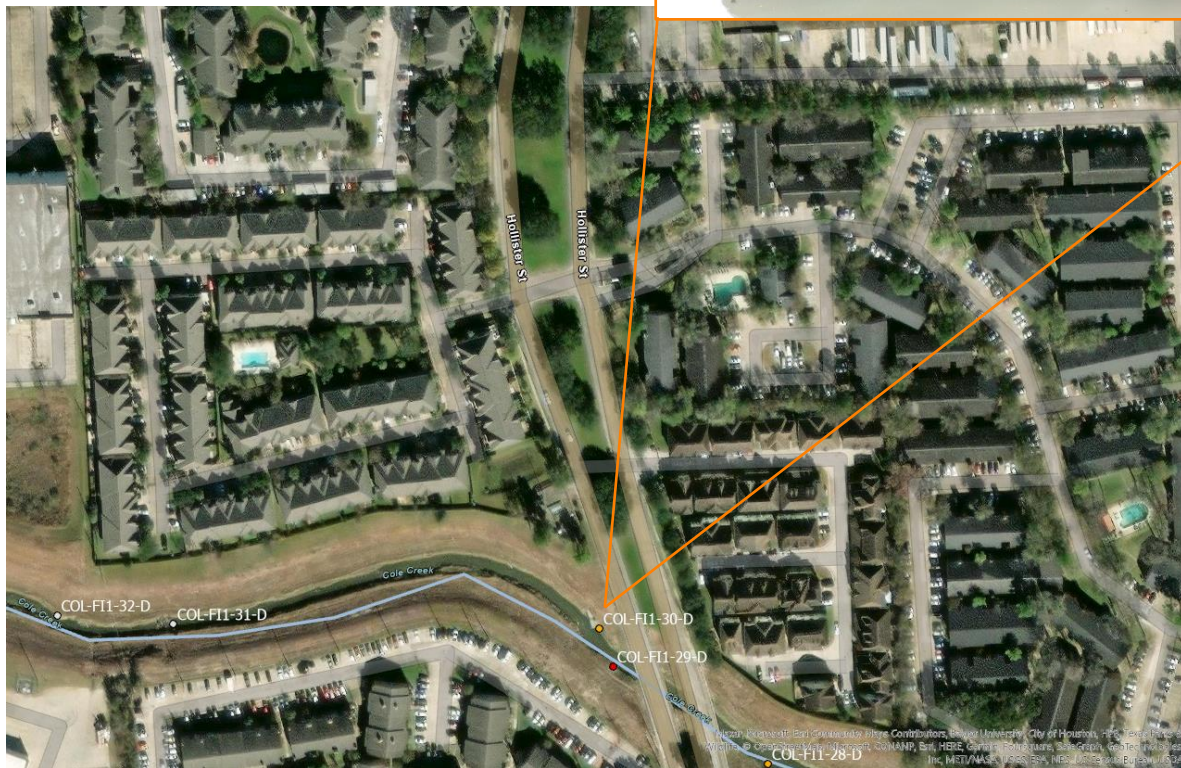
Referral site: COL-FI1-30-D- Low Priority

This is a 78 in. diameter metal pipe located on the left bank of Cole Creek. The pipe was submerged and water within the pipe was 12 in. deep. There are apartment buildings located in the area on the left bank. The sample was taken at the mouth of the submerged pipe and had a bacteria value of 2,460 MPN/100 mL. The ambient sample collected upstream of the pipe had a bacteria value of 1,310 MPN/100 mL. This pipe is a low priority referral site for the proper local authority.

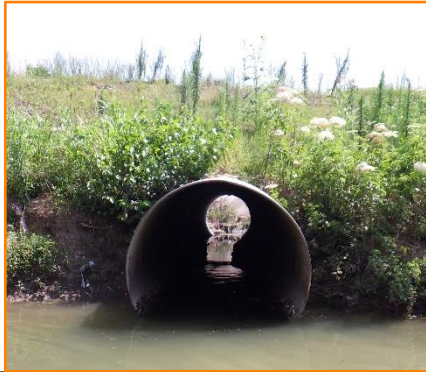
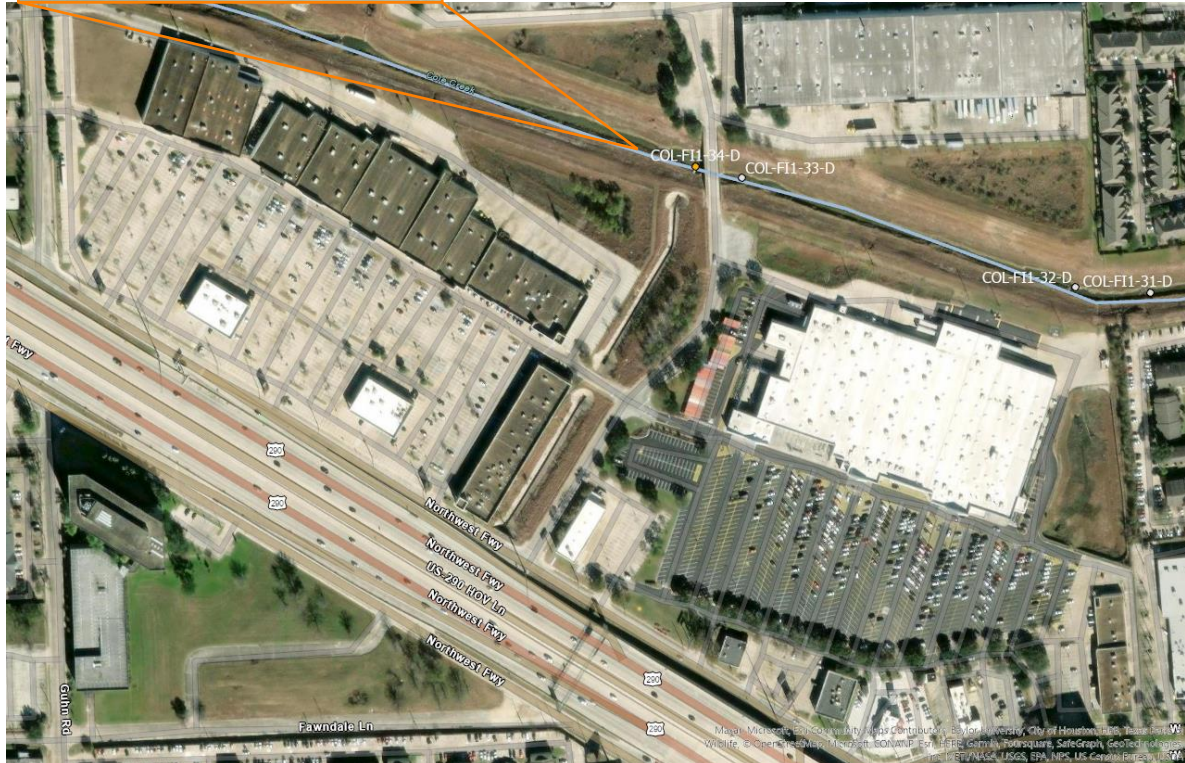
Referral site: COL-FI1-34-D- Low Priority

This is an 82 in. diameter metal pipe located on the right bank of Cole Creek. The pipe was submerged and water within the pipe was 22 in. deep. There are commercial buildings located in the area on the right bank. The sample was taken at the mouth of the submerged pipe and had a bacteria value of 1,560 MPN/100 mL. The ambient sample collected upstream of the pipe had a bacteria value of 520 MPN/100 mL. This pipe is a low priority referral site for the proper local authority.

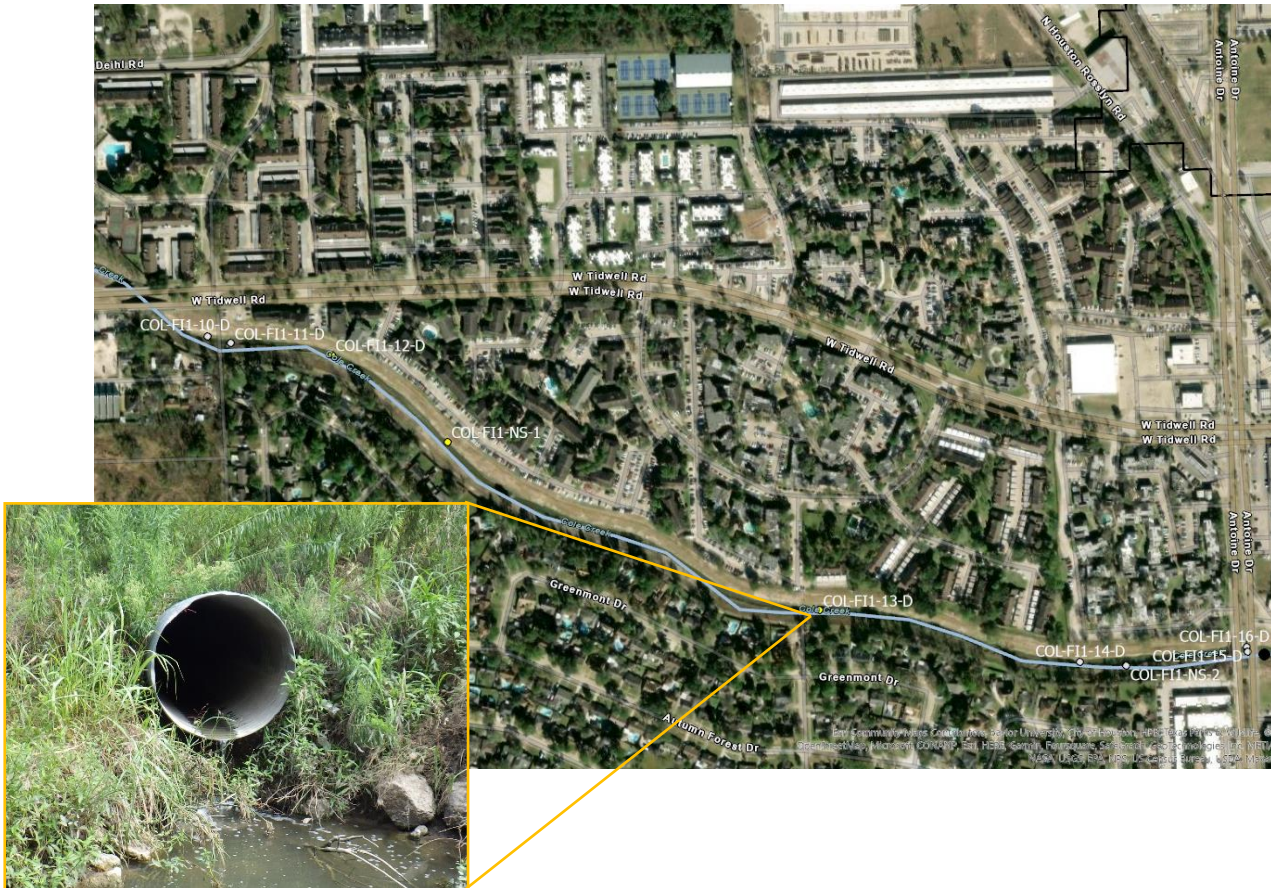
Referral site: COL-FI1-13-D – Investigate Further

This is a 36 in. diameter metal pipe located on the left bank of Cole Creek. When sampled on May 24, 2023, the water in the pipe was 0.5 in. deep and was flowing into the segment. Although the water in the pipe was cloudy and smelled like effluent, a sample taken 0.3 m downstream of the pipe had a bacteria value of < 100 MPN/100 mL. The ambient sample collected upstream of the pipe had a bacteria value of > 242,000 MPN/100 mL. These results seemed suspicious and the pipe was revisited on June 14, 2023 to take additional samples but the pipe was not discharging into the segment at that time. On the revisit, a sample was taken from a pool below the pipe and from a riffle upstream of the pipe. Both of those samples resulted in bacteria values of < 100 MPN/100 mL. On May 24, 2023, a pipe about 460 m upstream of this pipe on the left bank was observed dripping about once every 30 seconds and was not sampled. The unsampled pipe (COL-FI1-NS-1) could have potentially been the source of the elevated bacteria for this site if it had been flowing heavier prior to the field team observing it only dripping during the time of the FI. Further investigation is recommended by the proper local authority to determine the source of elevated bacteria in this section of the segment. There are apartments and single-family homes located upstream of the site.

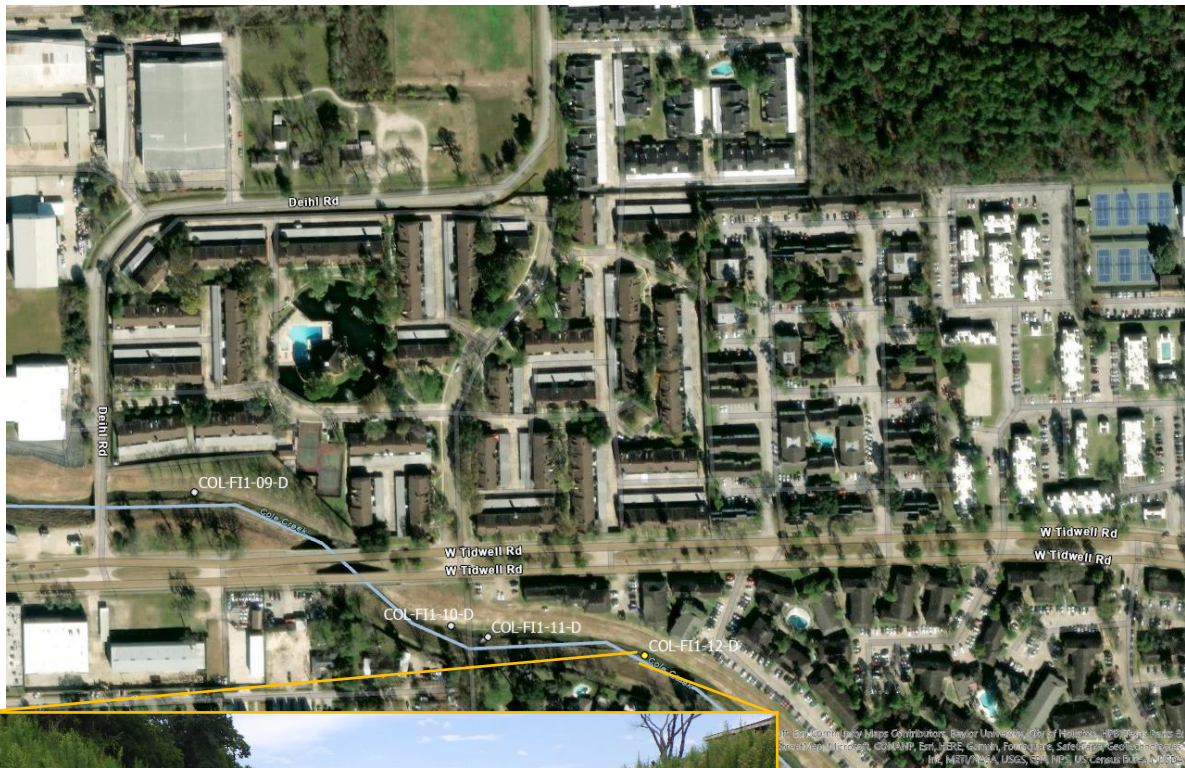
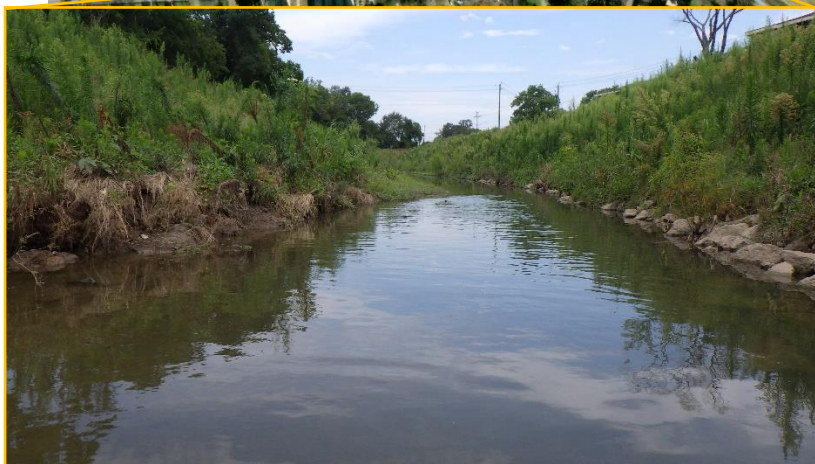
Referral site: COL-FI1-12-D – Investigate Further

This is a 38 in. diameter metal pipe located on the left bank of Cole Creek. A sample taken 1 m downstream of the pipe had a bacteria value of < 100 MPN/100 mL. The ambient sample collected upstream of the pipe had a bacteria value of 3,170 MPN/100 mL. The next sample taken about 100 m upstream (COL-FI1-11-D) of this location had a value of 1,460 MPN/100 mL. It was not apparent during the FI where the elevated bacteria were sourced from. Further investigation is recommended by the proper local authority to determine the source of elevated bacteria between the two locations. There are apartments and single-family homes located upstream of the site.

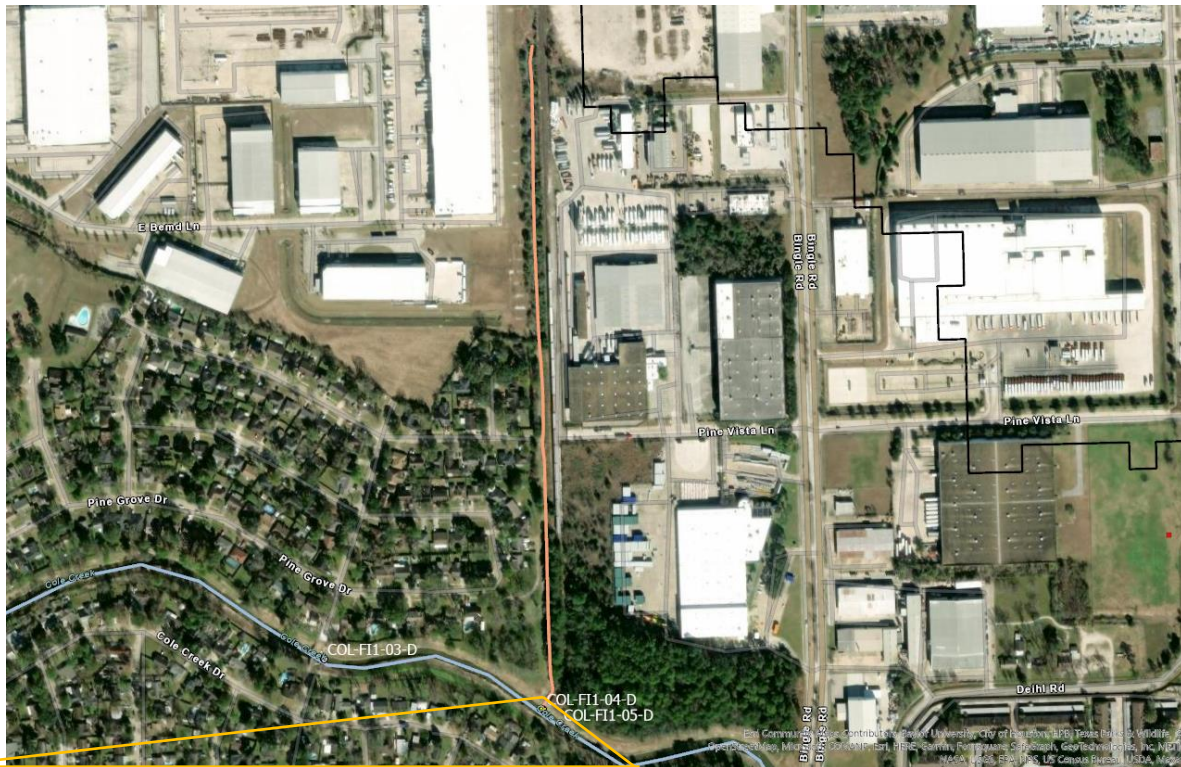
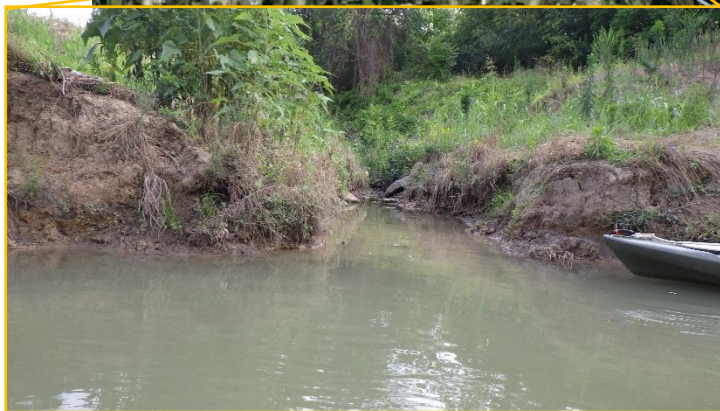
Referral site: COL-FI1-04-D- Investigate Further

This is an earthen tributary of Cole Creek on the left bank. An ambient sample taken within the tributary had a bacteria value of 750 MPN/100 mL and a sample taken upstream of the tributary had a bacteria value of 630 MPN/100 mL. During the WS, the tributary was not flowing but it was trickling during the FI. Further investigation is recommended by the proper local authority to determine the source of elevated bacteria within the tributary. There are single-family homes and commercial buildings located in the area of the tributary.
