Targeted Bacteria Monitoring Project Field Investigation Final Report Assessment Unit 1007U_01 Mimosa Ditch

May 12, 2023

Environmental Institute of Houston, University of Houston-Clear Lake

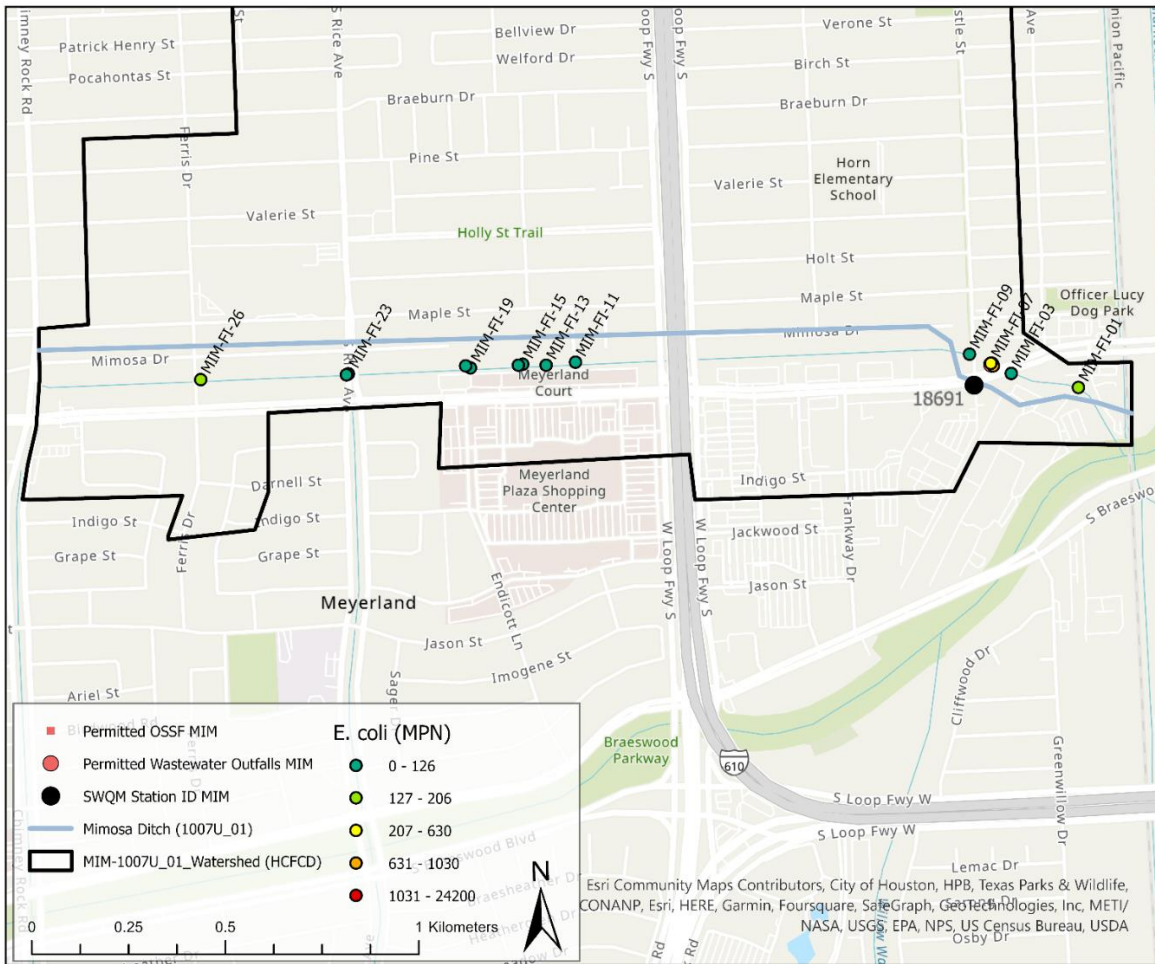
Figure 2: Field investigation results from 03/12/2021 on Mimosa Ditch (AU 1007U_01).

The 2021 FI was conducted on March 12, 2021 (11 days since last significant rainfall) and a total of 26 bacteria samples were collected. The values of the bacteria samples collected from downstream of permitted outfalls, or directly from unpermitted outfalls are illustrated in Figure 2. A total of four referral locations with elevated *E. coli* bacteria levels measured during the FI in 2021 were recommended for further investigation by the proper authorities (Oakley and Leshar 2021).

A leaking metal pipe was present within the wastewater treatment facility property downstream of Beechnut Street (referral site: MIM-FI-01). A sample was collected where the leaking/spraying water was entering the segment and a bacteria value of 169 MPN/100ML was recorded. The ambient sample collected just upstream of the bridge outside of the influence of the leaking pipe had a bacteria value of 108 MPN/100 mL (MIM-FI-02) indicating that the leaking pipe may be a source of elevated bacteria. Water from an additional metal pipe downstream of the permitted wastewater treatment facility outfall between Newcastle St. and Beechnut St. was sampled in 2021 (Referral site: MIM-FI-05). The sample collected in the mixing zone, just downstream of the outfall, had a bacteria value of 683 MPN/100 mL, and the ambient sample collected just upstream of the outfall (mid channel) had a bacteria value of 119 MPN/100 mL indicating that the outfall is likely a source of elevated bacteria. Another metal pipe discharging water in the segment is believed to be the permitted wastewater treatment facility outfall between Newcastle St. and Beechnut St. (Referral site: MIM-FI-07). The sample collected in the mixing zone, just downstream of the outfall had a bacteria value of 313 MPN/100 mL, and the ambient sample collected just upstream of the outfall (mid channel) had a bacteria value of 160 MPN/100 mL indicating that the outfall is most likely a source of elevated bacteria. It is important to note that the field crew made a remark on the field datasheet that they did not observe any aquatic vegetation, fish, or invertebrates in the downstream of the permitted wastewater treatment facility outfall, but that all of those things were observed upstream of it. Chlorine levels were not tested. Based on these results, a second FI on this segment was recommended to be sampled in 2023.

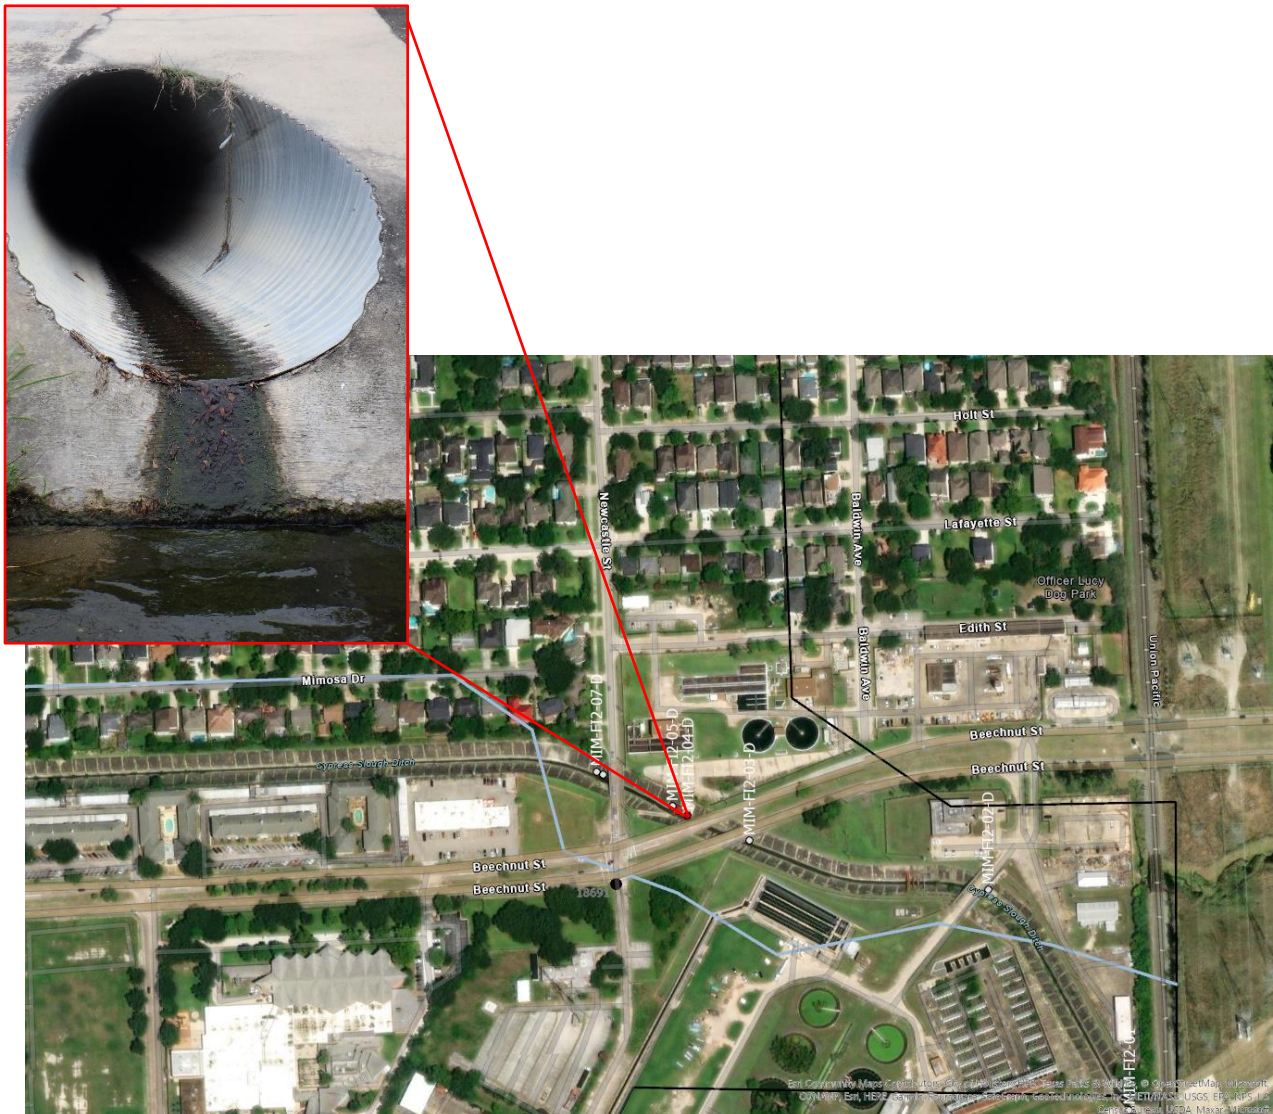
Referral site: MIM-FI2-04-D - High Priority

This is a 78 in. diameter metal pipe located on the left bank of Mimosa Ditch. Water within the pipe was 1.0 in. deep and flowing down algae-coated concrete before entering the segment. There is a permitted wastewater treatment discharge located in the area on the left bank. A sample taken 0.2 m downstream of the pipe had a bacteria value of 1,690 MPN/100 mL. The ambient sample collected upstream of the pipe had a bacteria value of 100 MPN/100 mL. This pipe is a high priority referral site for the proper local authority.

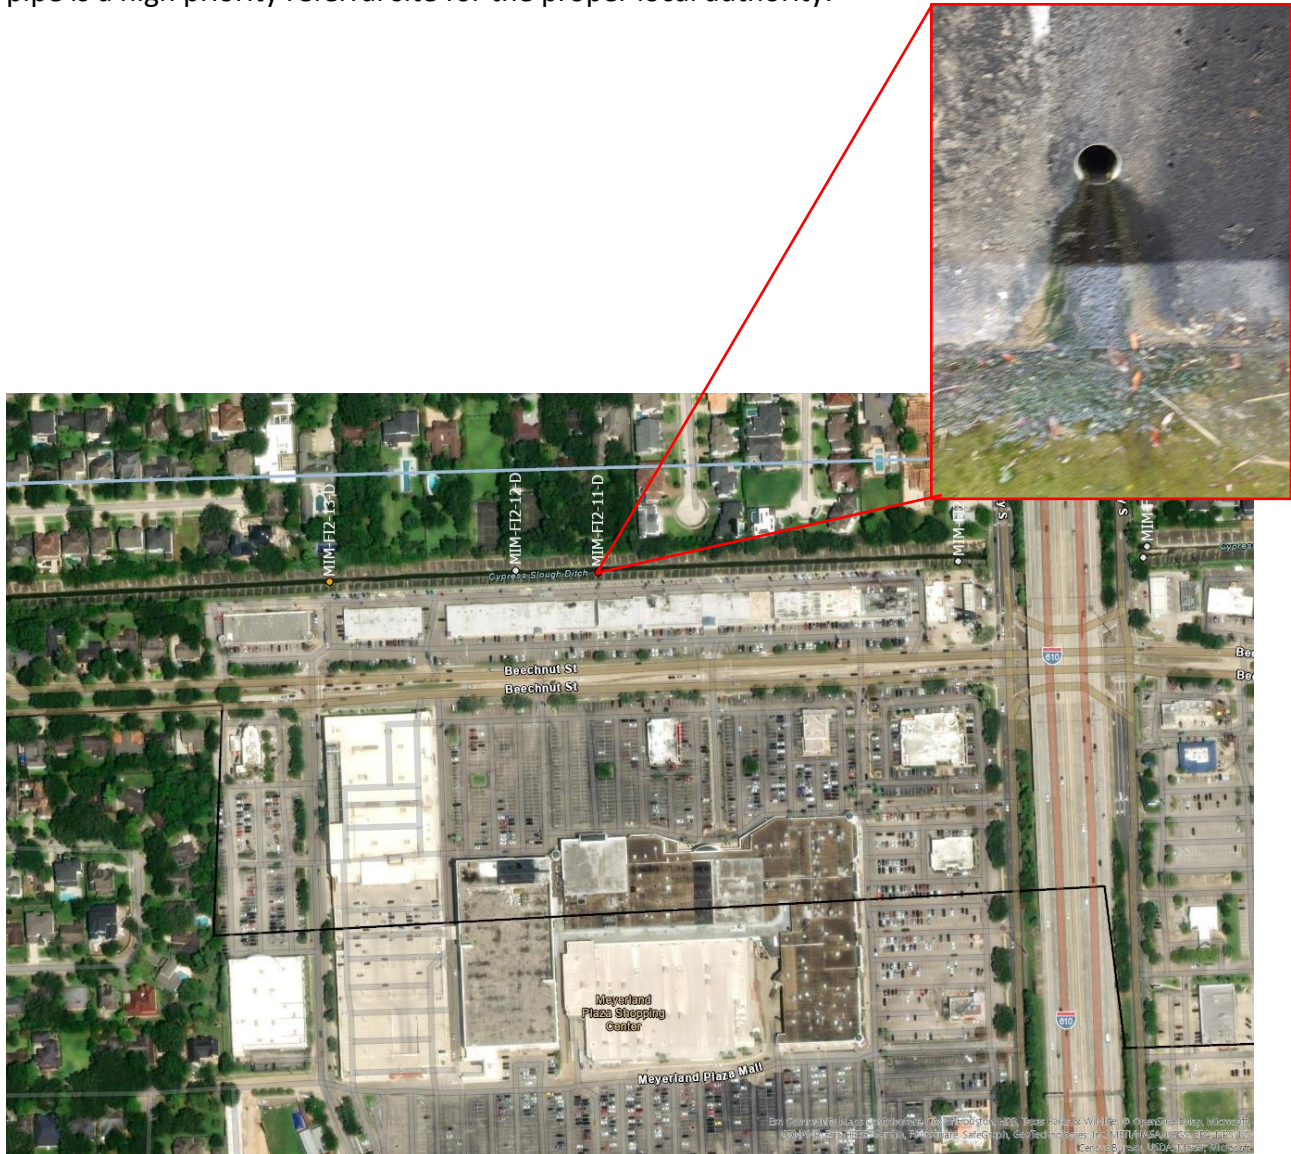
Referral site: MIM-FI2-11-D – High Priority

This is a 4 in. diameter PVC pipe located on the right bank of Mimosa Ditch. Water within the pipe was 0.25 in. deep and flowing down algae-coated concrete before entering the segment. There are multiple restaurants and a shopping plaza located in the area on the right bank. A sample taken 1.0 m downstream of the pipe had a bacteria value of 970 MPN/100 mL. The ambient sample collected upstream of the pipe had a bacteria value of 100 MPN/100 mL. This pipe is a high priority referral site for the proper local authority.

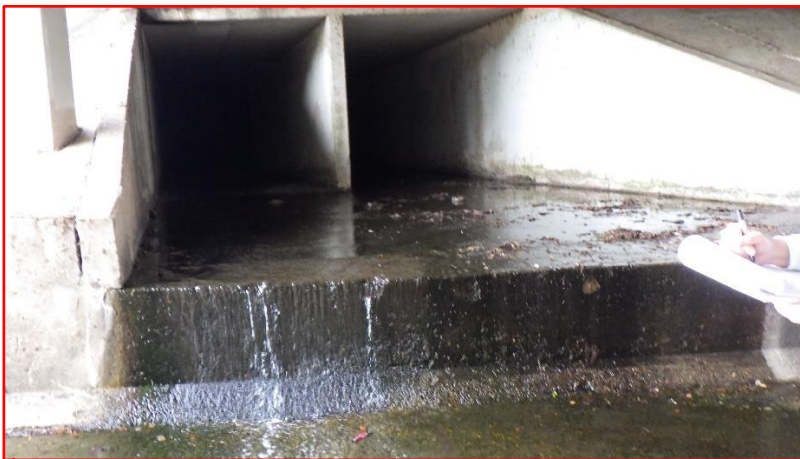
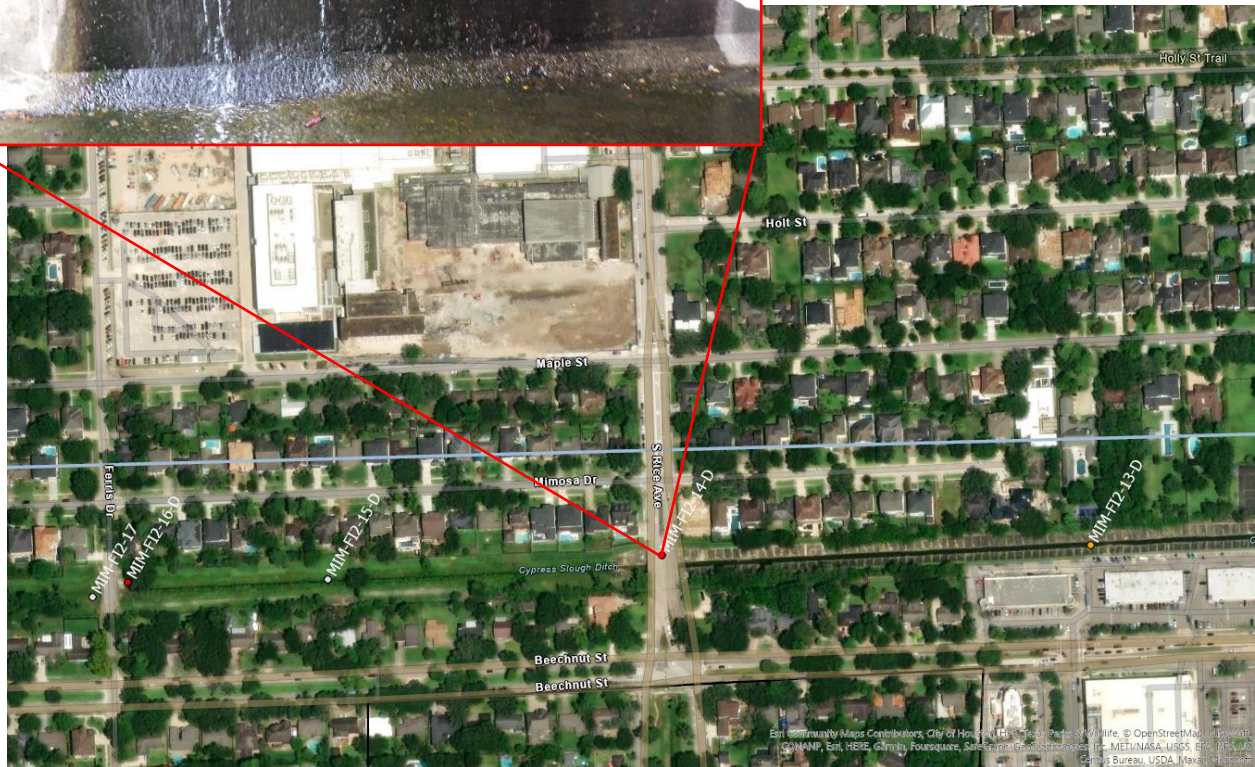
Referral site: MIM-FI2-14-D - High Priority

This is a 98 in. wide, square concrete pipe located under the bridge of S. Rice Ave. on the left bank of Mimosa Ditch. Water within the pipe was 0.25 in. deep and flowing into the segment. The area is mostly residential around this site, but there is a high school undergoing construction about 200 m north of the bridge on S Rice Avenue. A sample taken 0.6 m downstream of the pipe had a bacteria value of 9,330 MPN/100 mL. The ambient sample collected upstream of the pipe had a bacteria value of 630 MPN/100 mL. This pipe is a high priority referral site for the proper local authority.

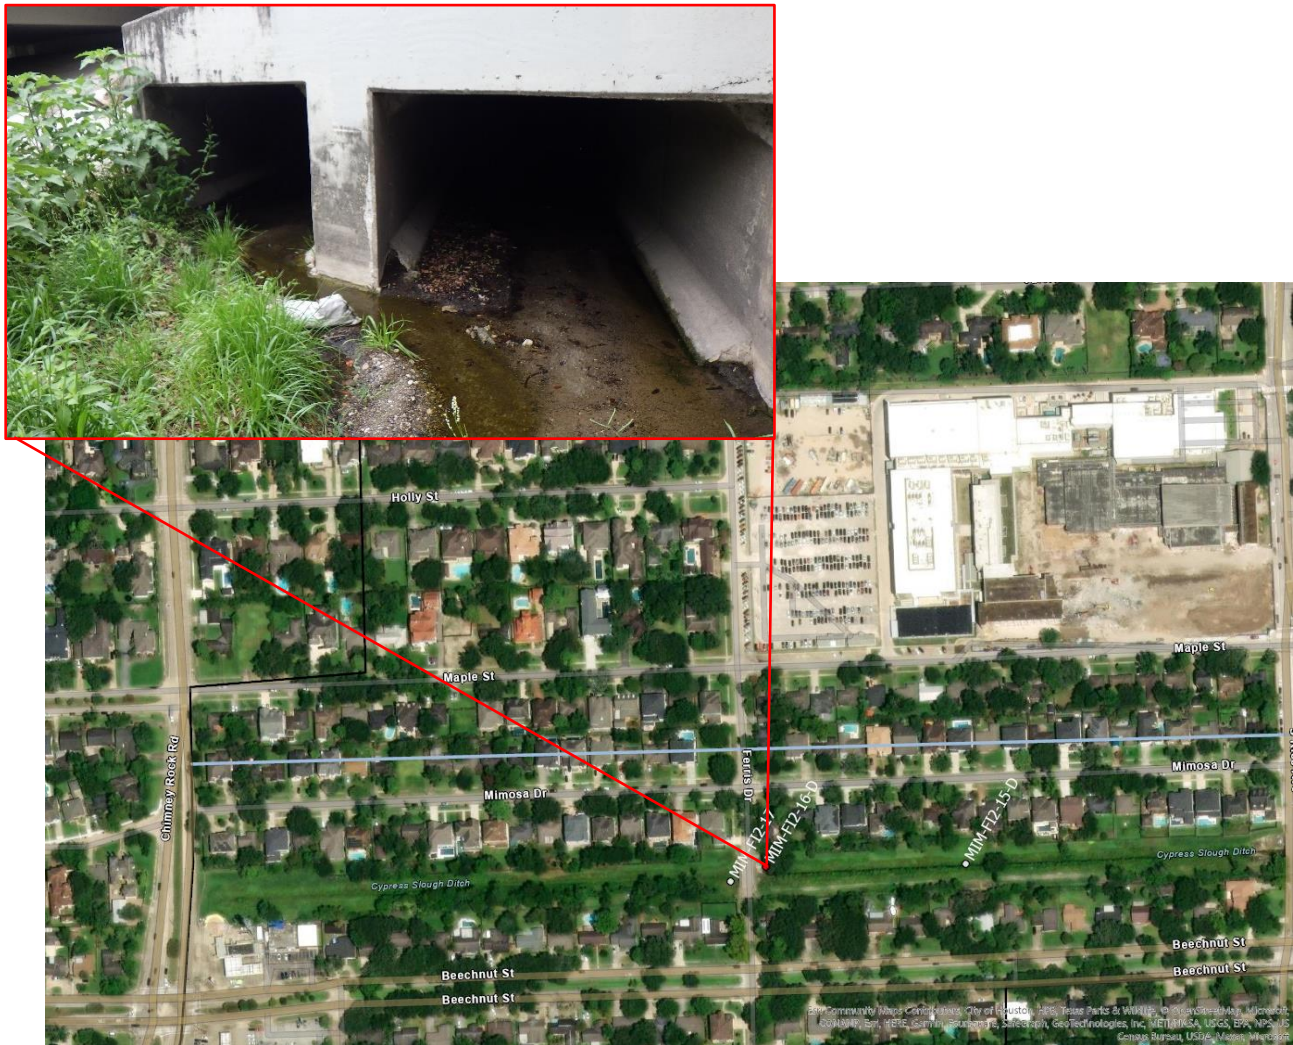
Referral site: MIM-FI2-16-D - High Priority

This is a 72 in. diameter square cement pipe located on the left bank of Mimosa Ditch. Water within the pipe was 0.13 in. deep and flowing into the AU. The pipe that was flowing at the time of samples was the most upstream of the two pipes at this location. A sample taken 0.1 m downstream of the pipe had a bacteria value of 2,990 MPN/100 mL. The ambient sample collected upstream of the pipe had a bacteria value of 1,200 MPN/100 mL. This pipe is a high priority referral site for the proper local authority.

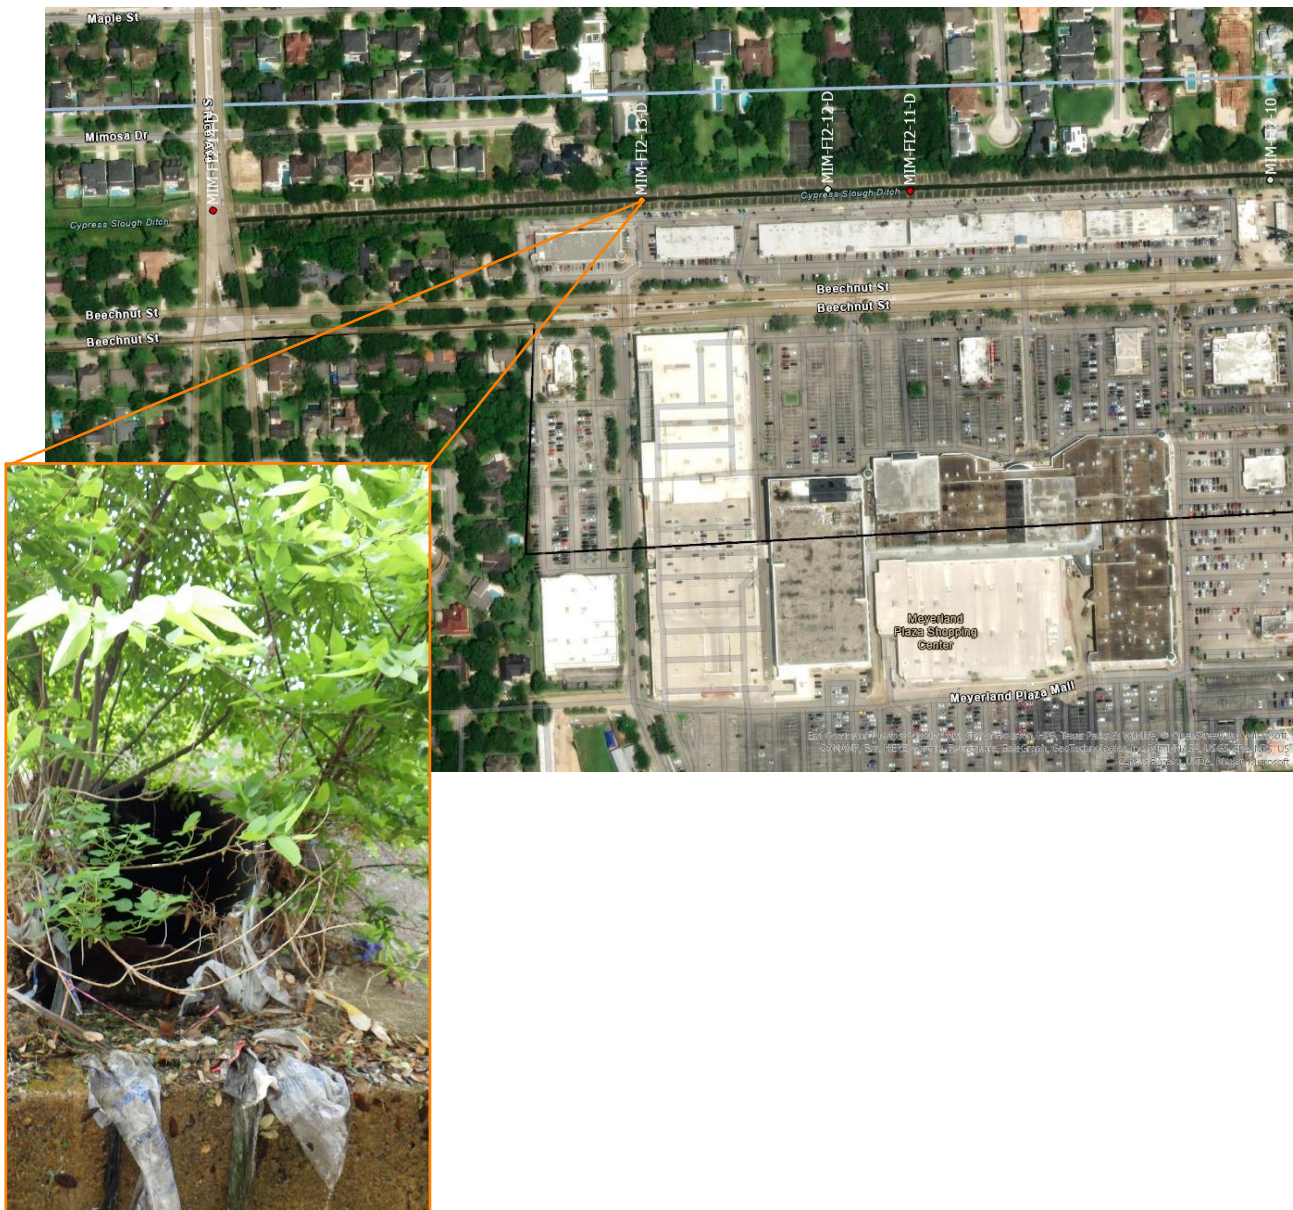
Referral site: MIM-FI2-13-D- Low Priority

This is a 36 in. diameter metal pipe located on the right bank of Mimosa Ditch. Water within the pipe was 6.0 in. deep and flowing down the vertical concrete bank and into the segment. There was vegetation growing and trash around the pipe at the time of sampling. There are several restaurants and a shopping plaza located in the area on the right bank. A sample 1.25 m downstream of the pipe had a bacteria value of 410 MPN/100 mL. The ambient sample collected upstream of the pipe had a bacteria value of 200 MPN/100 mL. This pipe is a low priority referral site for the proper local authority.
