Targeted Bacteria Monitoring Project

Field Investigation Draft Report

Assessment Unit 1101D_01, Unnamed Tributary of Robinson

May 9, 2023

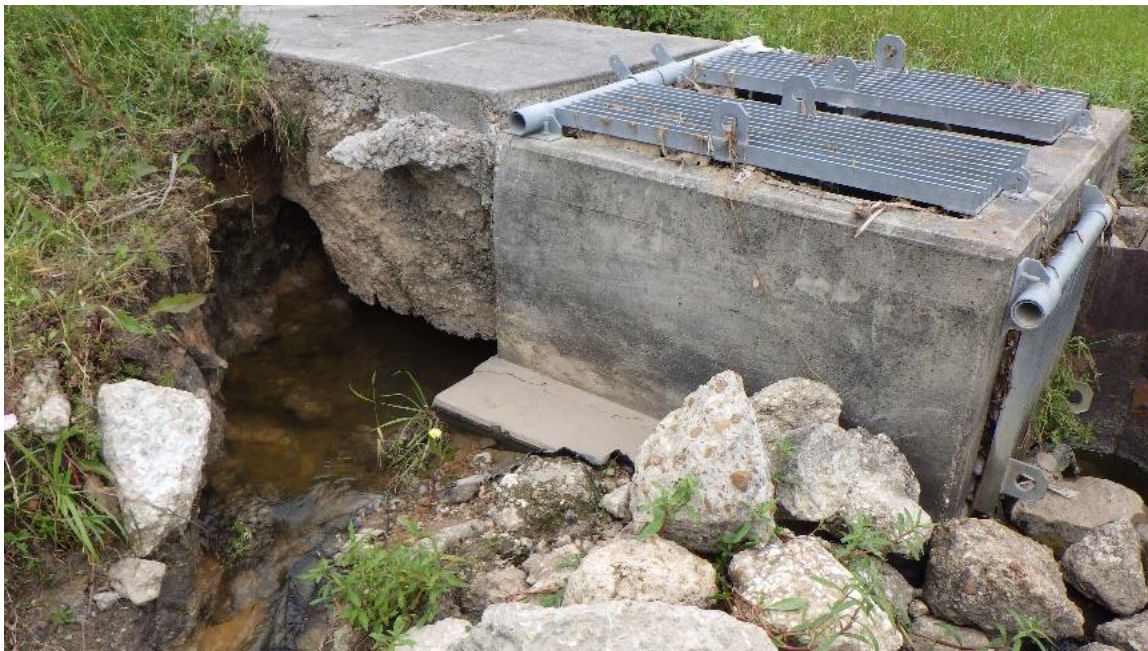
Figure 5. Bank collapse at water diversion structure.

While not related to bacteria, the field crew observed a flow diversion structure that is washing out and causing a bank failure just upstream of Louisiana Ave and the Unnamed Tributary #2 bridge crossing at approximately 29.50854, -95.06004. If the proper authorities are not aware of this infrastructure failure it is recommended that they investigate this further.

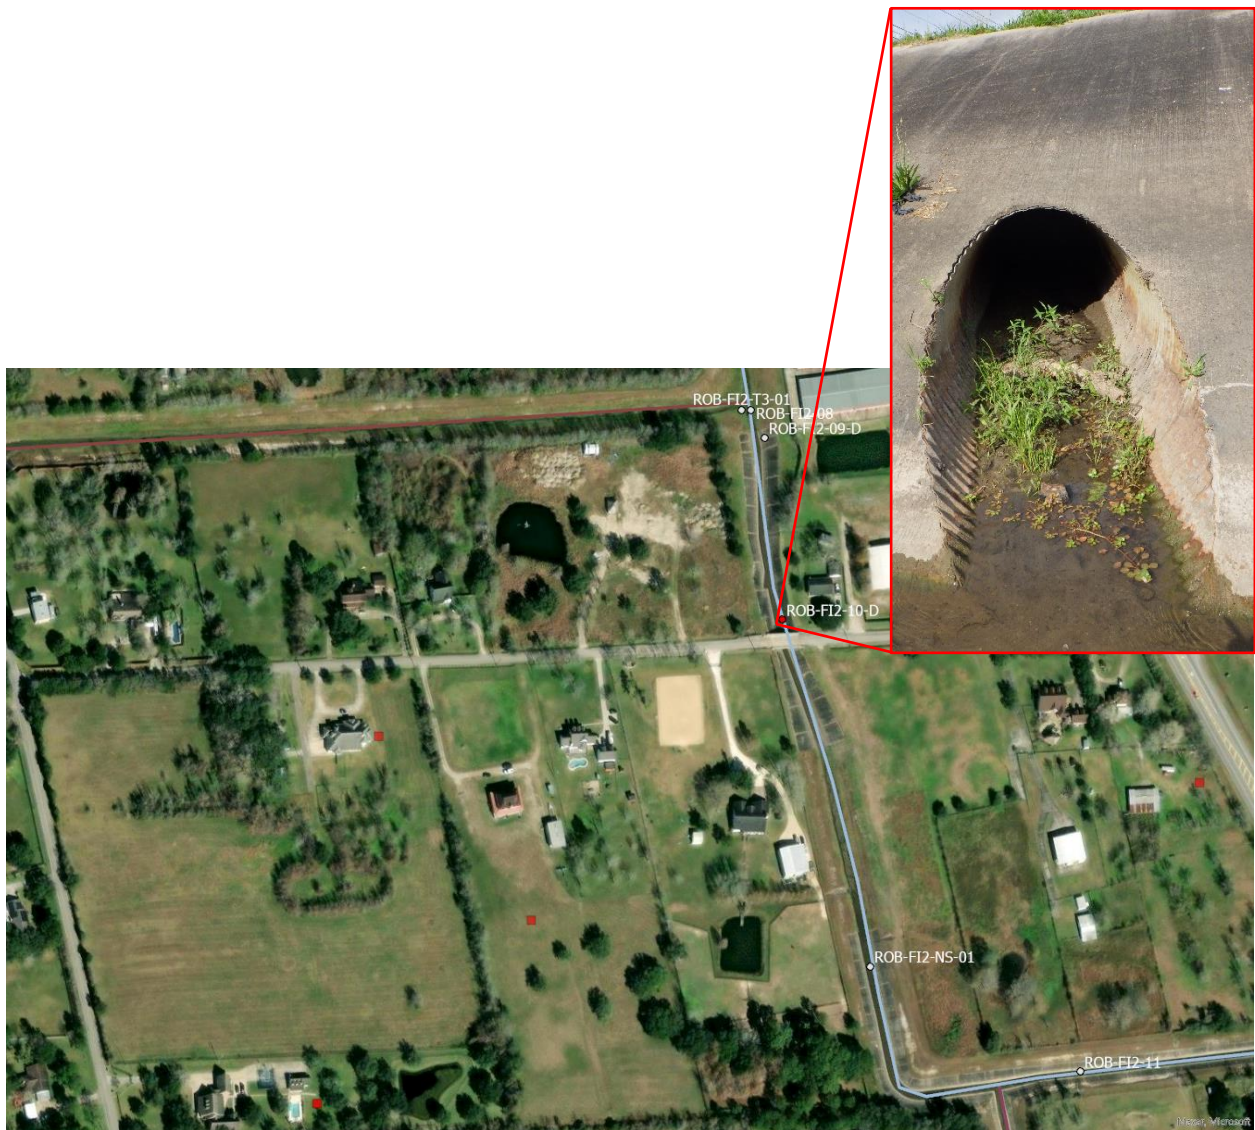
Referral site: ROB-FI2-10-D- High Priority

This is a 45 in. diameter metal pipe located on the left bank of Robinson Bayou. Water within the partially submerged pipe was 2 in. deep and trickling into the segment. There was a pipe on the right bank across from the sampled pipe that had a very small trickle but was not sampled. There are large lot single-family homes located in the area on the left bank, several of which have permitted OSSFs. A sample taken at the mouth of the submerged pipe had a bacteria value of 850 MPN/100 mL. The ambient sample collected upstream of the pipe had a bacteria value of < 100 MPN/100 mL. This pipe is a high priority referral site for the proper local authority.

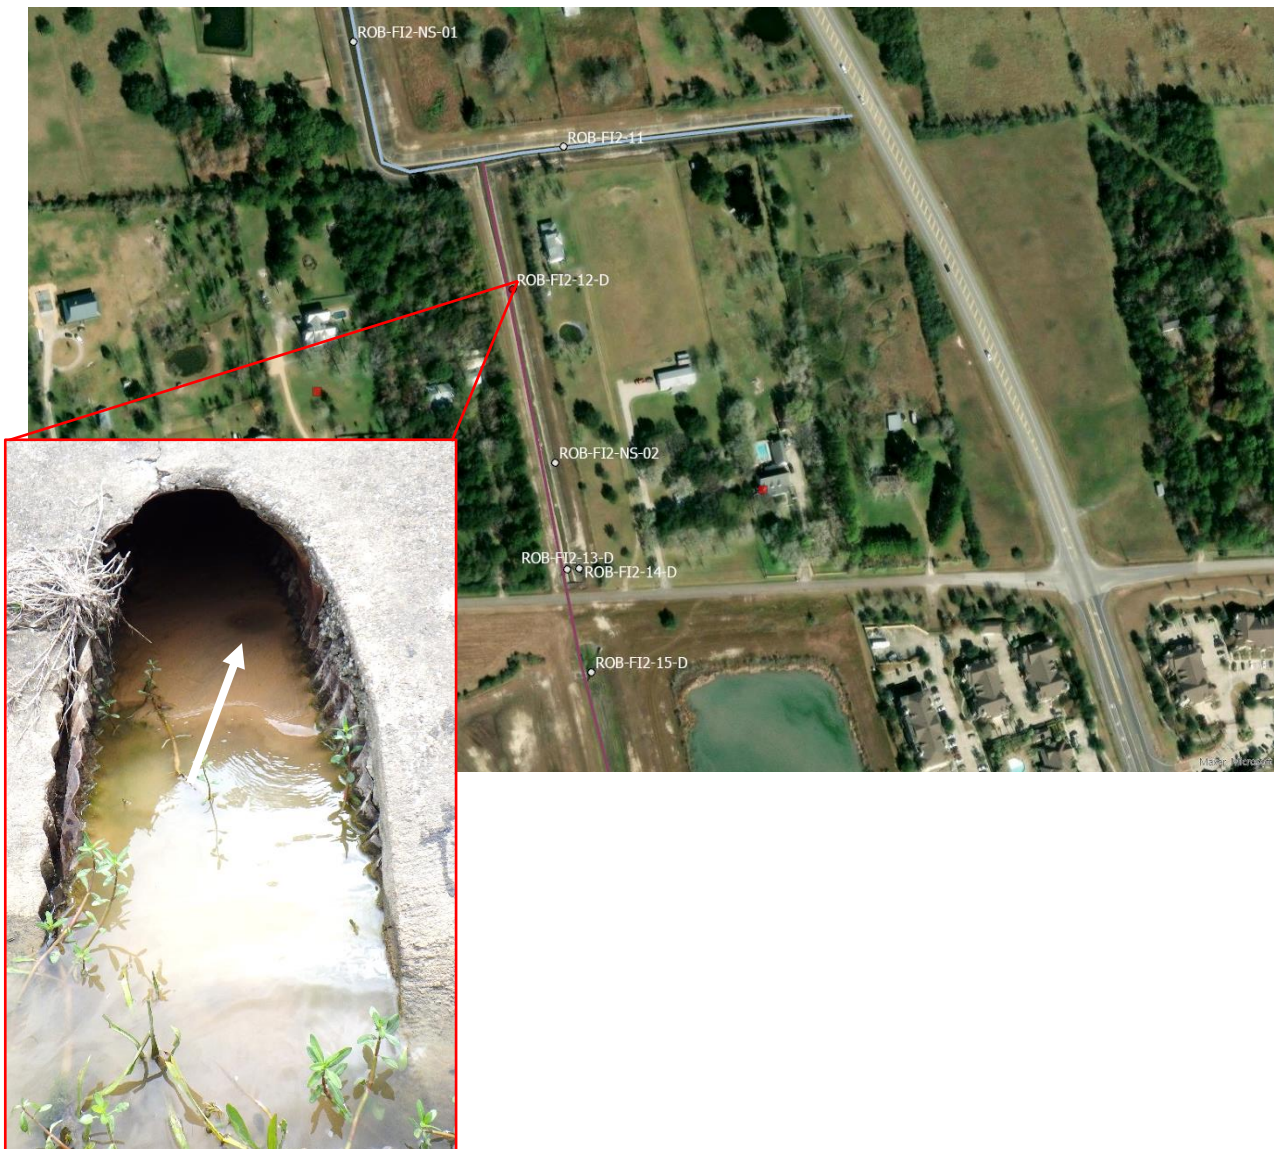
Referral site: ROB-FI2-12-D- High Priority

This is a 24 in. diameter metal pipe located on the right bank of Robinson Bayou. Water within the partially submerged pipe was 5 in. deep and flow was observed to be “bubbling” up from the substrate into the segment (white arrow). The substrate in the pipe was reddish in color. There was a pipe across the bayou (left bank) that was moist but not flowing which was not sampled. There are large lot single-family homes located in the area on the right bank. A sample taken at the mouth of the submerged pipe had a bacteria value of 510 MPN/100 mL. The ambient sample collected upstream of the pipe had a bacteria value of 100 MPN/100 mL. This pipe is a high priority referral site for the proper local authority.

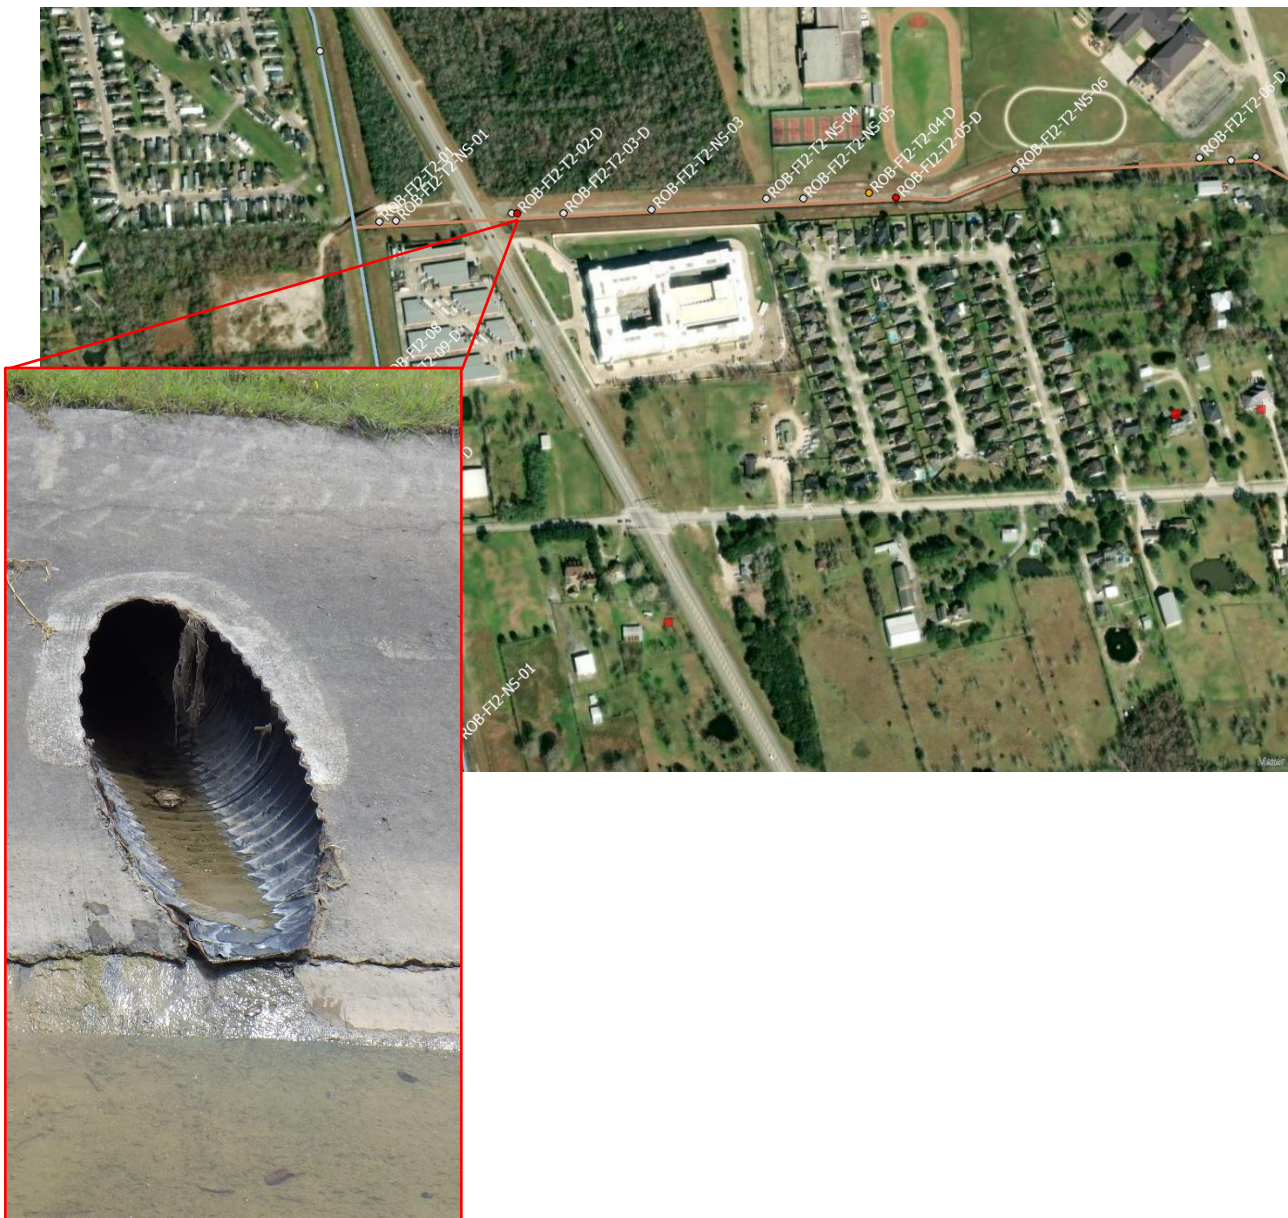
Referral site: ROB-FI2-T2-02-D- High Priority

This is a 24 in. diameter corrugated plastic coated pipe located on the left bank of Unnamed Tributary #2 to Robinson Bayou. Water within the pipe was 0.25 in. deep and dripping into the segment. There is a condominium complex located in the area on the left bank. A sample taken 0.1 m downstream of the pipe had a bacteria value of 410 MPN/100 mL. The ambient sample collected upstream of the pipe had a bacteria value of 100 MPN/100 mL. This pipe is a high priority referral site for the proper local authority.

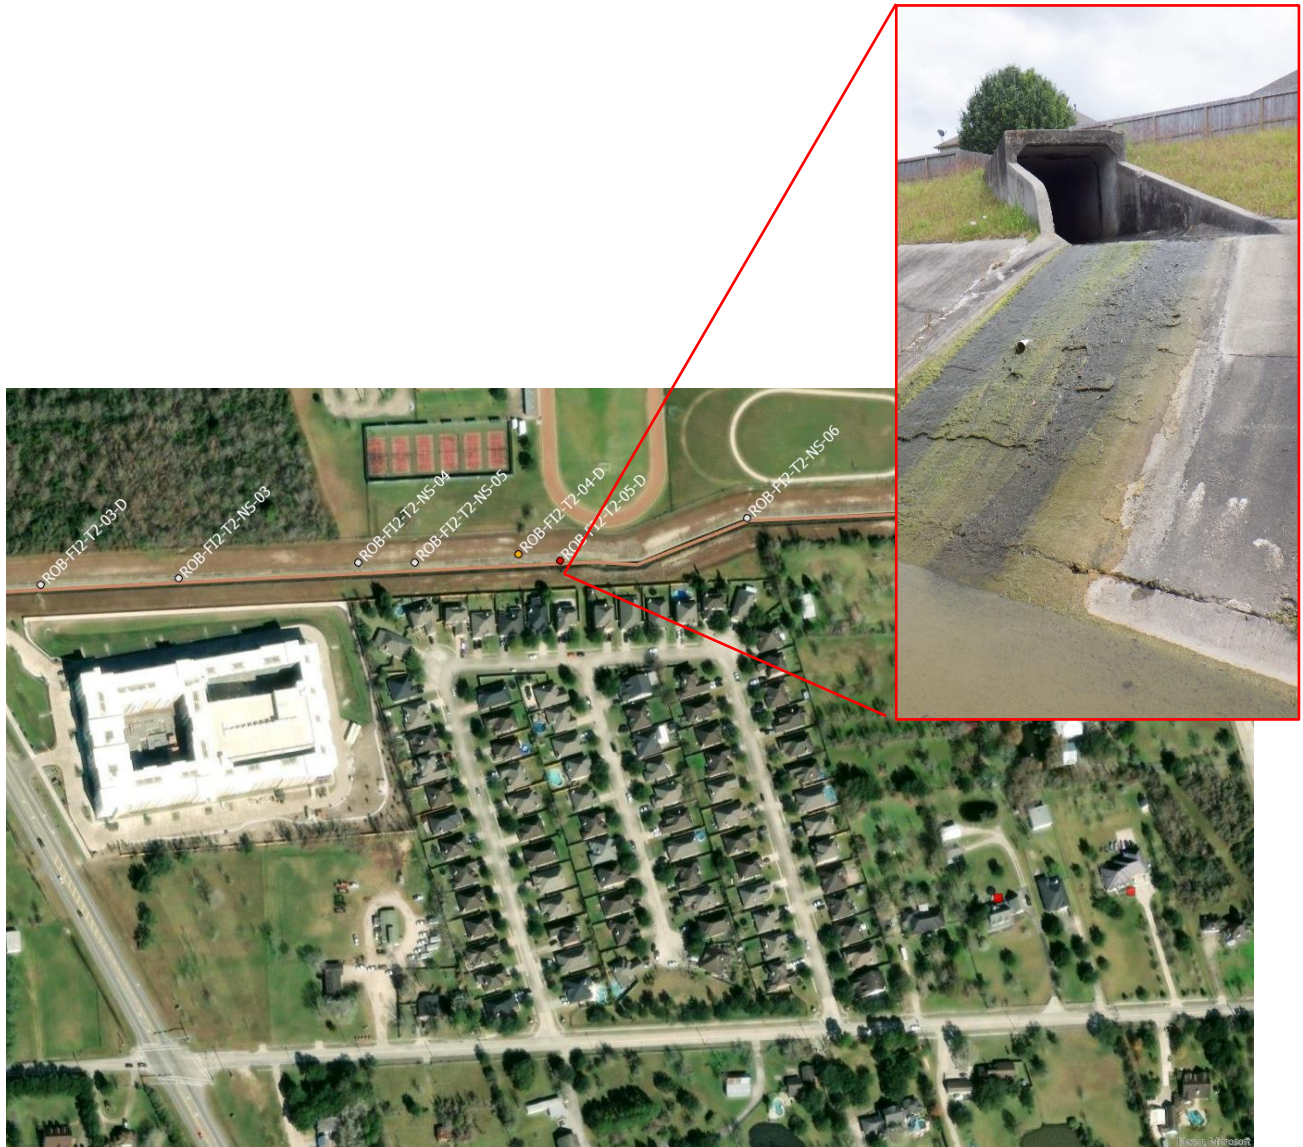
Referral site: ROB-FI2-T2-05-D- High Priority

This is an approximately 60 in. diameter square concrete pipe located on the left bank of Unnamed Tributary #2 to Robinson Bayou. Water within the pipe was 0.25 in. deep and steadily flowing into the segment. There are single-family homes located in the area on the left bank. A sample taken 3 m downstream of the pipe had a bacteria value of 6,700 MPN/100 mL. The ambient sample collected upstream of the pipe had a bacteria value of < 100 MPN/100 mL. This pipe is a high priority referral site for the proper local authority.

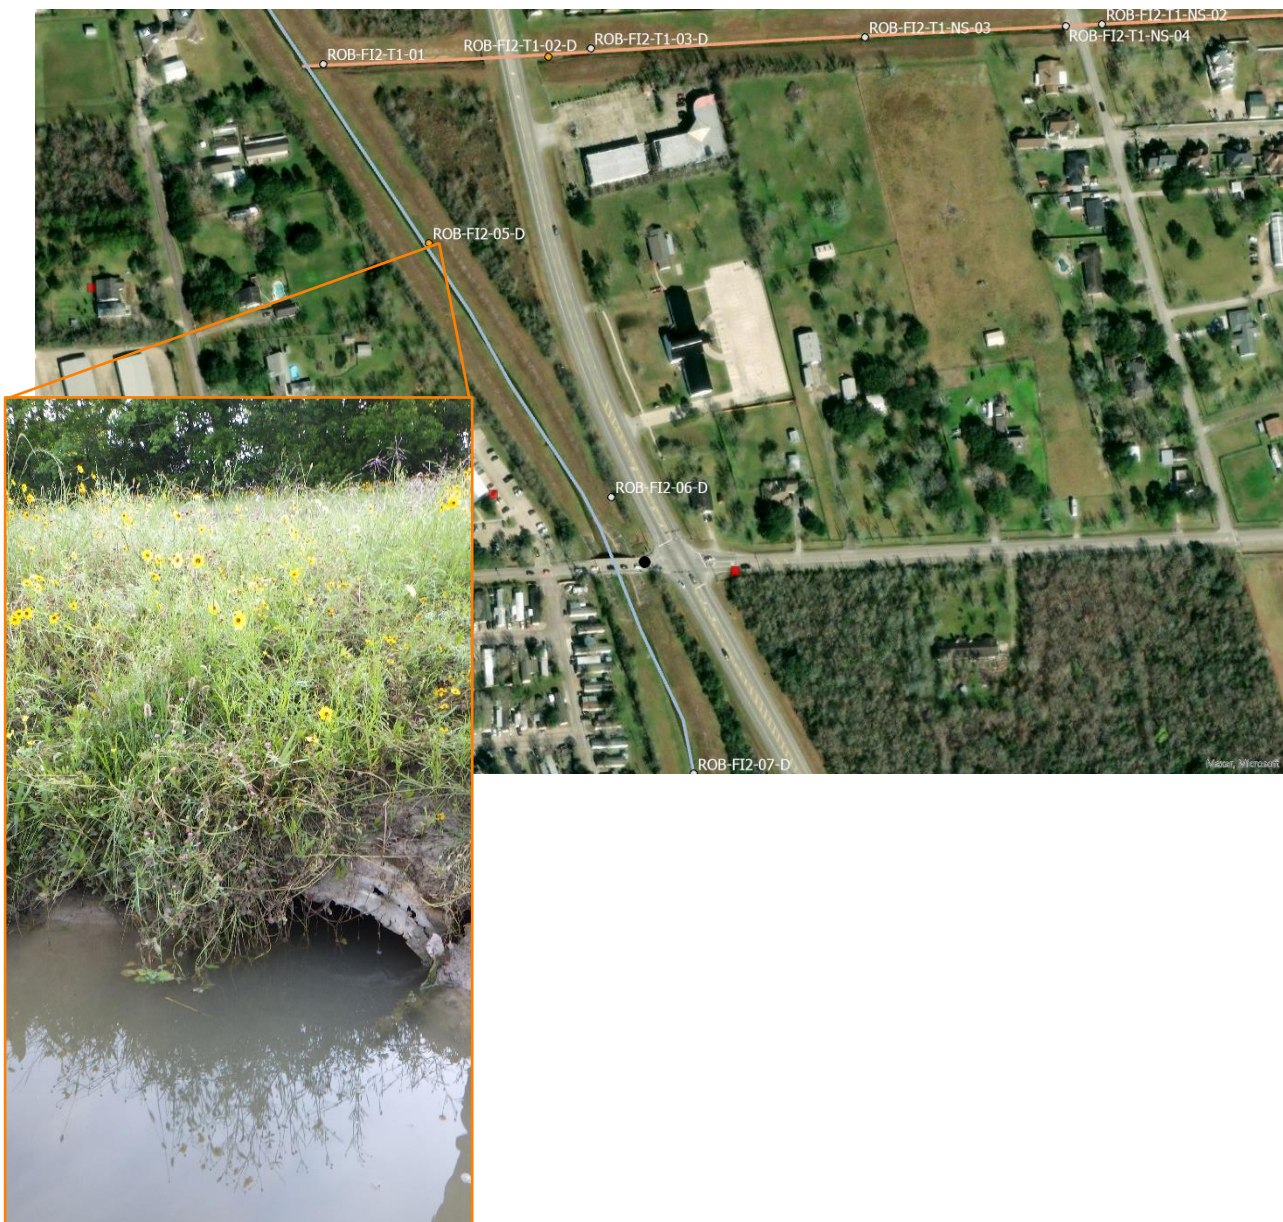
Referral site: ROB-FI2-05-D- Low Priority

This is a 12 in. diameter rusted metal pipe located on the right bank of Robinson Bayou. Water within the partially submerged pipe was 8.5 in. deep and the field crew was unable to tell if it was flowing into the segment. There is an undeveloped tract of land located in the immediate area on the right bank. A sample taken at the mouth of the submerged pipe had a bacteria value of 410 MPN/100 mL. The ambient sample collected upstream of the pipe had a bacteria value of 200 MPN/100 mL. This pipe is a low priority referral site for the proper local authority.

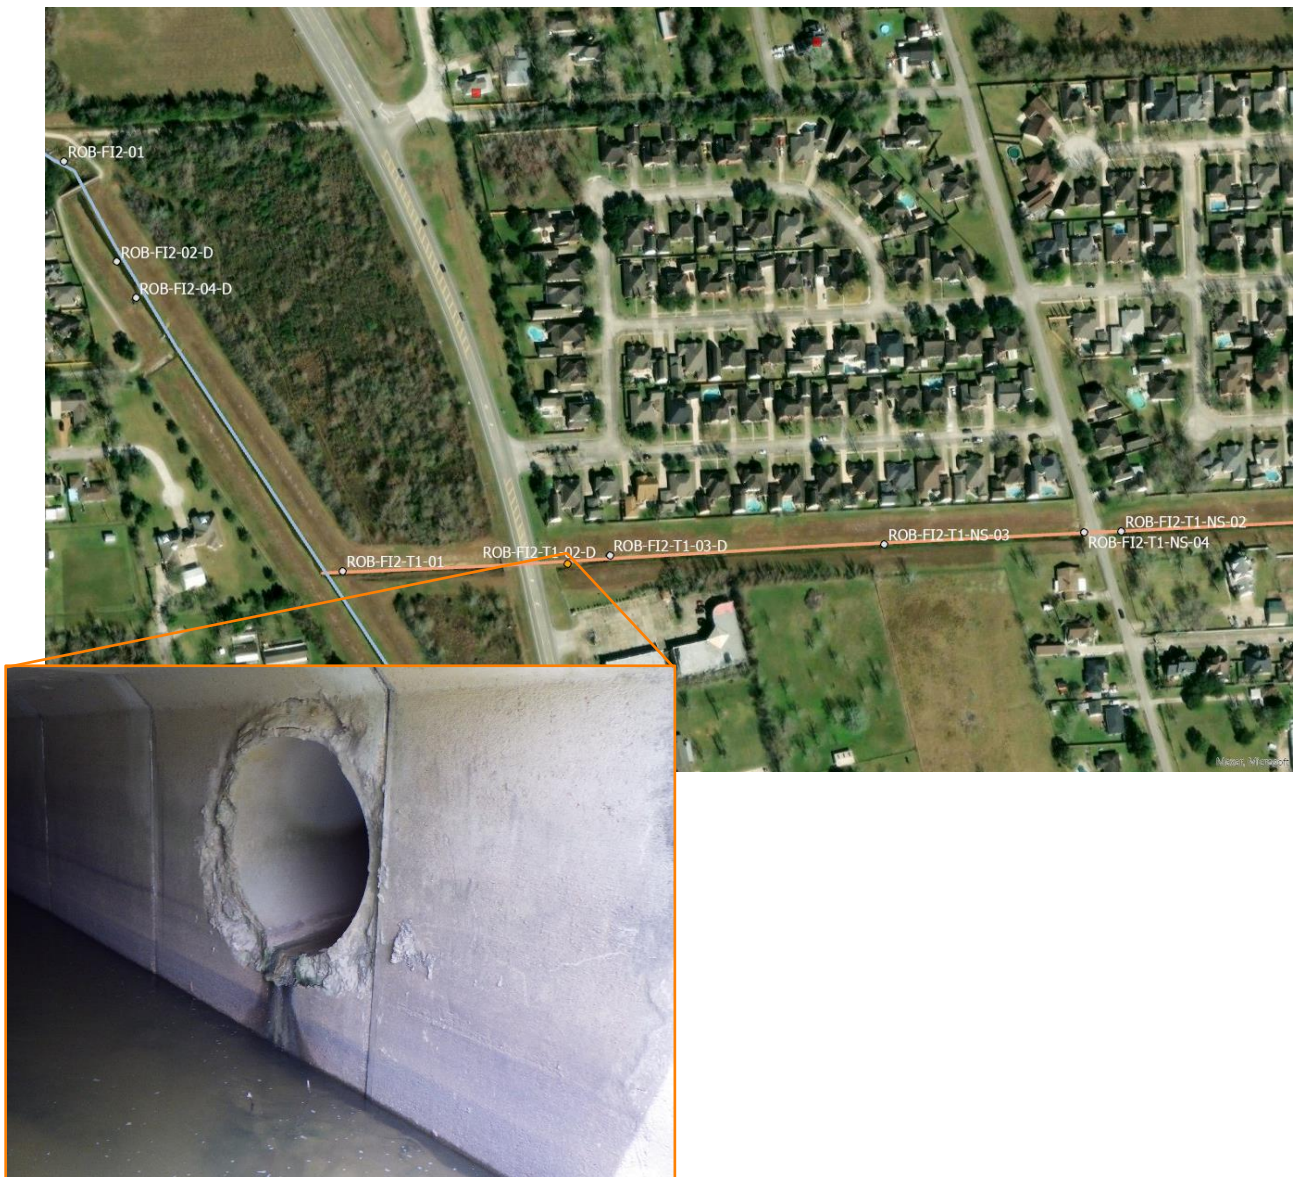
Referral site: ROB-FI2-T1-02-D- Low Priority

This is a 54 in. diameter cement pipe located under the 270 bridge, approximately 3 m from the upstream side of the bridge on the right bank of the Unnamed Tributary #1 to Robinson Bayou. Water within the pipe was 0.1 in. deep and trickling into the segment. There are single-family homes and a roadway located in the area on the right bank. A sample 0.5 m downstream of the pipe had a bacteria value of 310 MPN/100 mL. The ambient sample collected upstream of the pipe had a bacteria value of 200 MPN/100 mL. This pipe is a low priority referral site for the proper local authority.

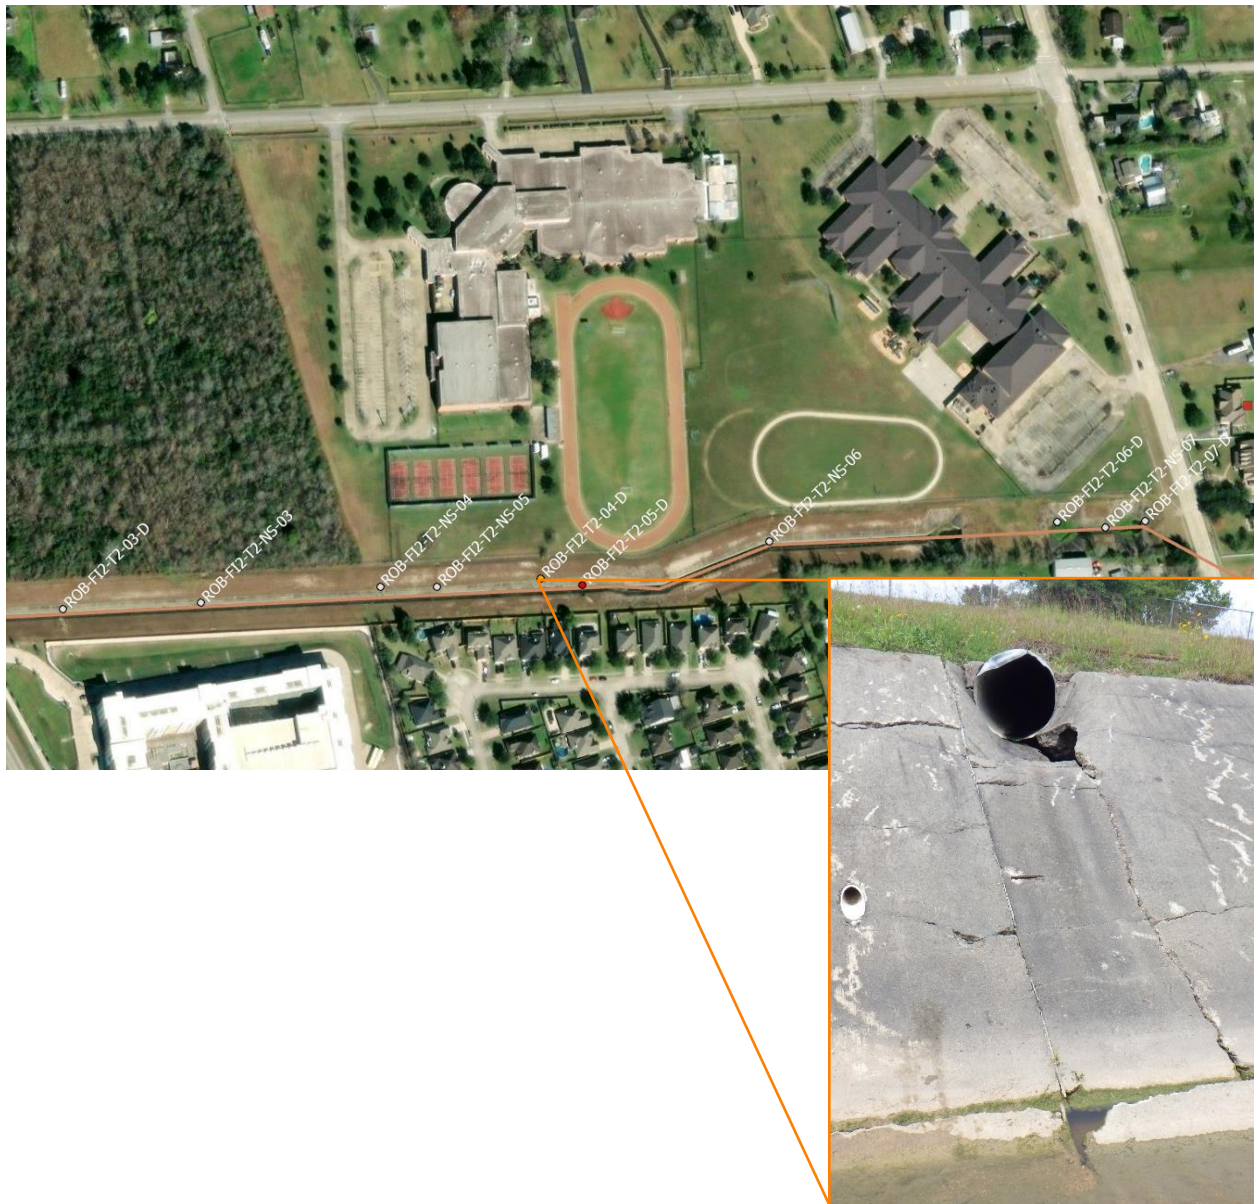
Referral site: ROB-FI2-T2-04-D- Low Priority

This is a 28 in. diameter metal pipe located on the right bank of the Unnamed Tributary #2 to Robinson Bayou. The cement apron around the pipe is broken and the sediment underneath is washed out creating a void where the water was flowing into. Water within the pipe was 0.5 in. deep and trickling behind the broken cement wall and then into the segment. League City Intermediate School is in the area on the right bank. A sample was taken where the water that is flowing behind the broken concrete meets the stream, approximately 3.5 m downstream of the pipe outfall and it had a bacteria value of 310 MPN/100 mL. The ambient sample collected upstream of the pipe had a bacteria value of 200 MPN/100 mL. This pipe is a low priority referral site for the proper local authority.

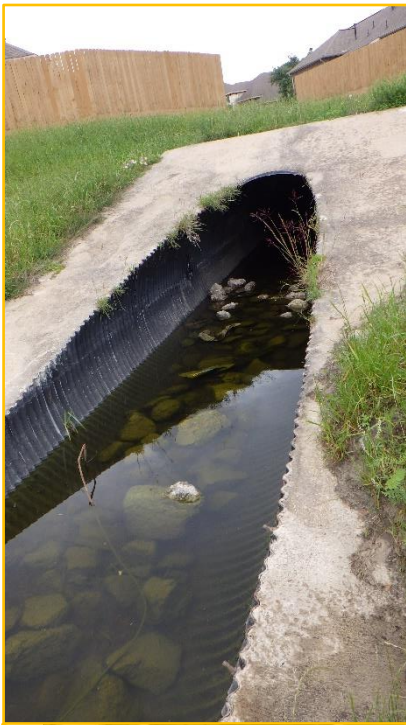
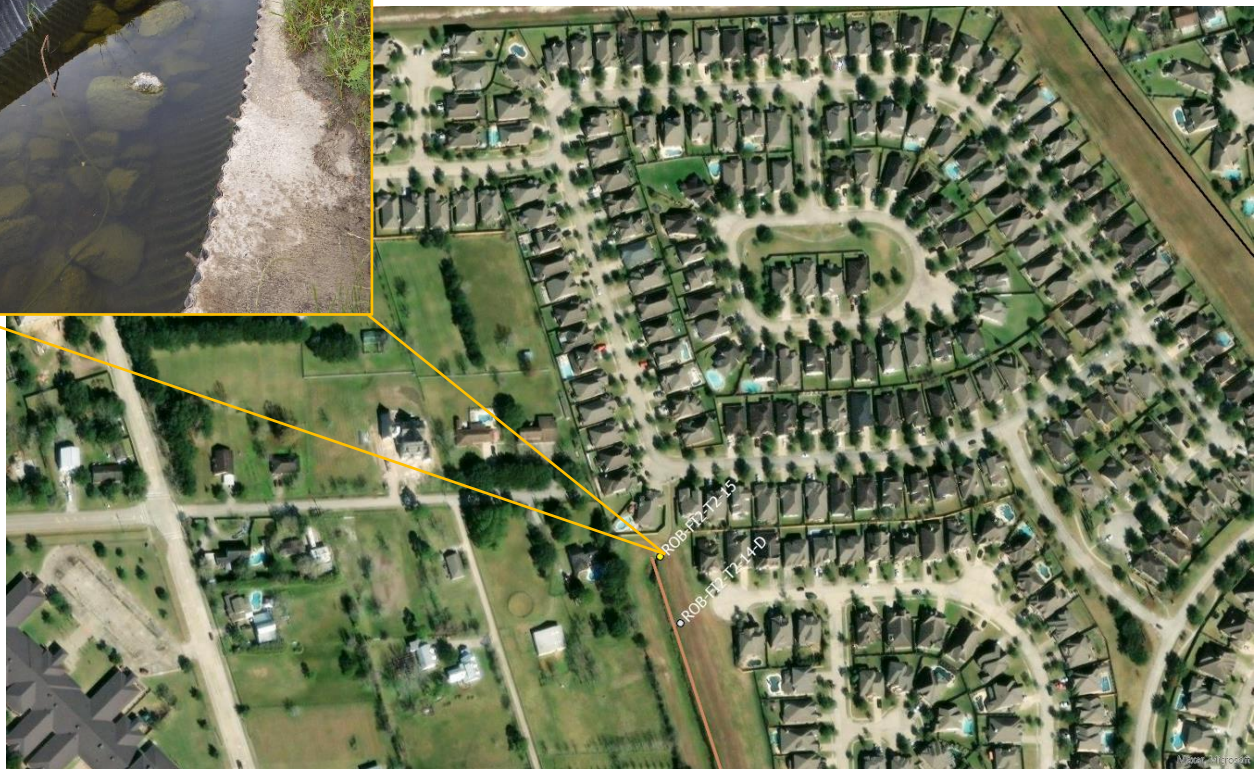
Referral site: ROB-FI2-T2-15 –Investigate Further

This was a single sample taken at the mouth of a partially submerged corrugated plastic-coated pipe at the most upstream portion of the Unnamed Tributary #2 to Robinson Bayou before the pipe goes underground. The ambient sample taken at the pipe had a bacteria value of 1,560 MPN/100 mL. Further investigation is recommended by the proper local authority to determine the source of elevated bacteria underground and upstream of the segment. There are single-family homes located upstream of the site.
