Targeted Bacteria Monitoring Project

Field Investigation Final Report

Assessment Unit 1017D_01,
Unnamed Tributary of White Oak Bayou

May 10, 2023

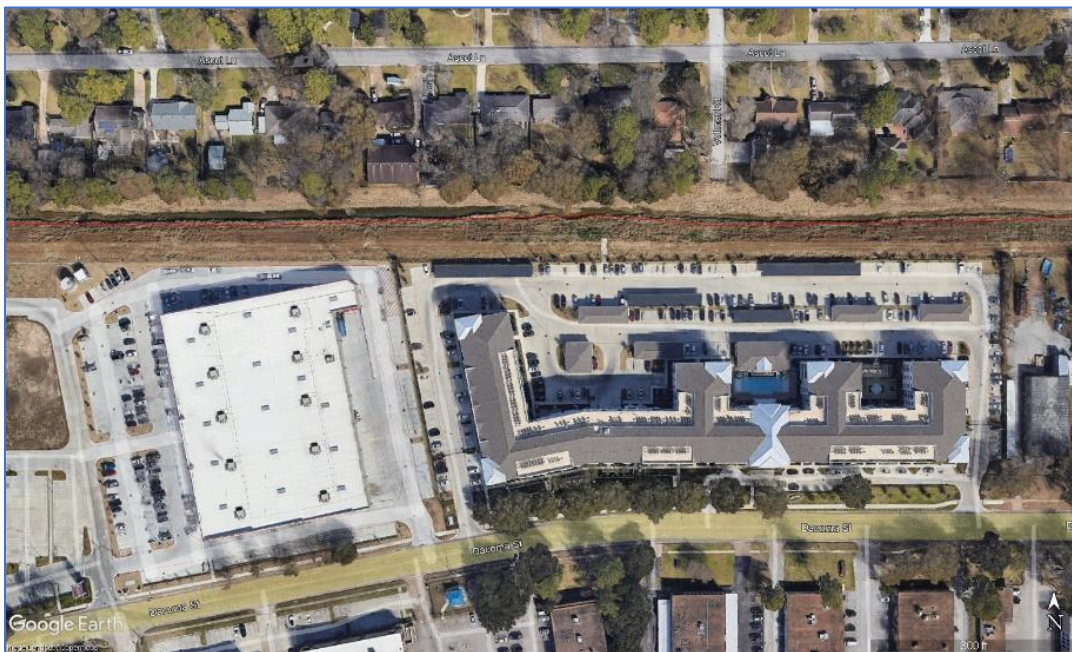
Figure 2. Possible source identified during desktop review.

- newly constructed apartments on Dacoma St. near US 290 that border the unnamed tributary (Figure 2)
- a small (0.45 acre) farm that may have runoff into the AU (Figure 3)

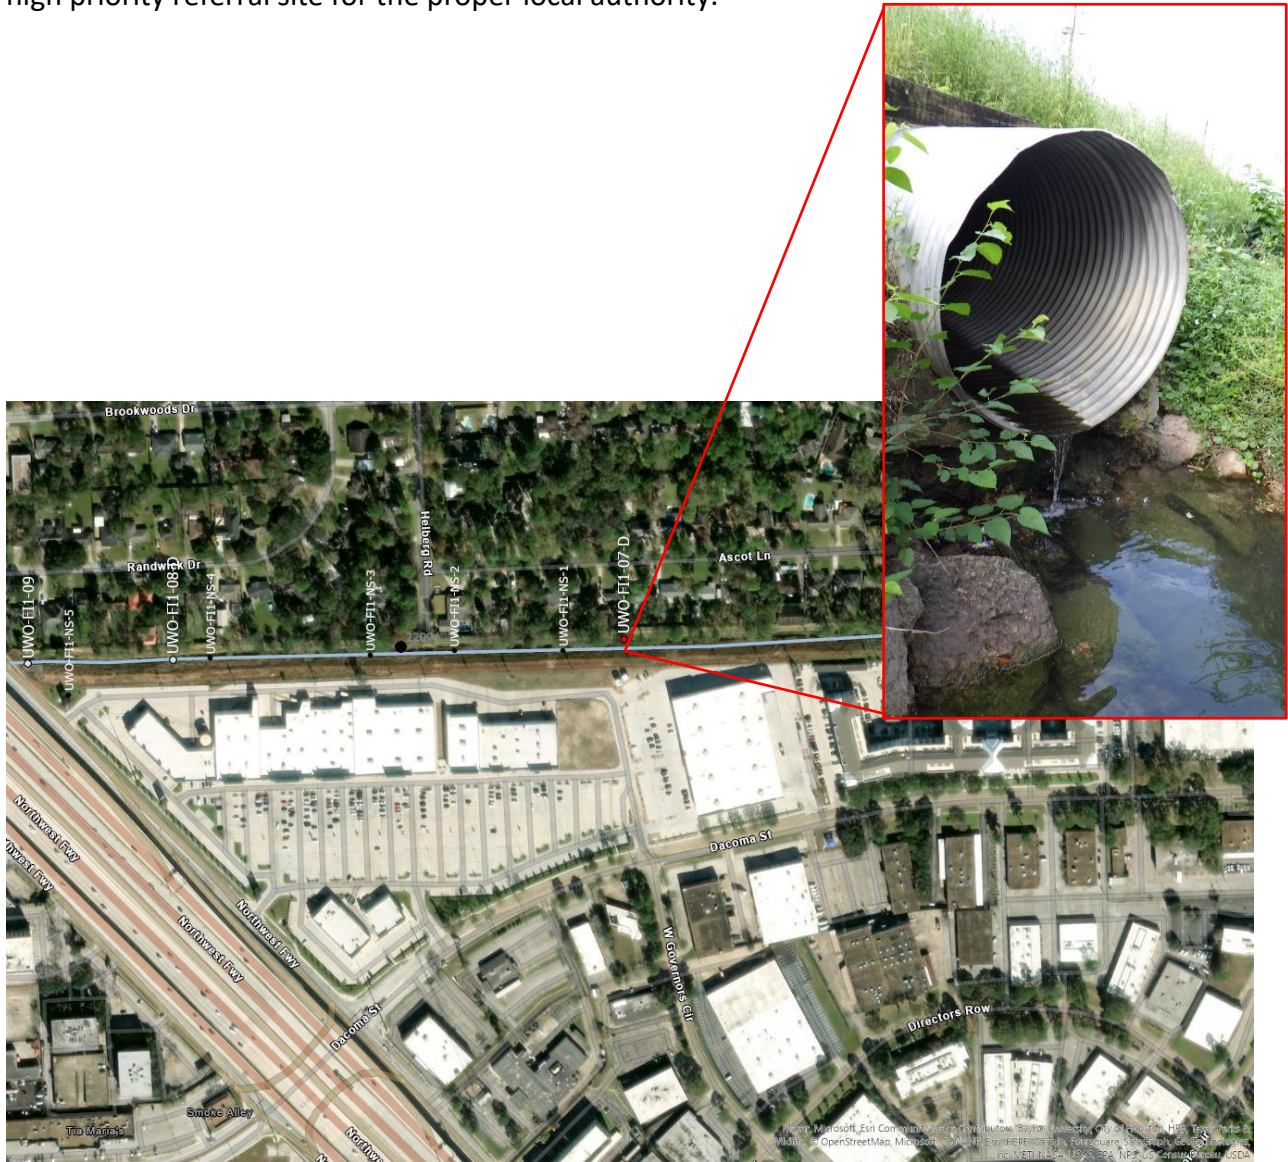
Referral site: UWO-FI1-07-D- High Priority

This is a 48 in. diameter metal pipe located on the right bank of the Unnamed Tributary to White Oak Bayou. Water within the pipe was 0.33 in. deep and flowing into a pooled area of the segment. There are commercial buildings located in the area on the right bank. A sample taken 0.3 m downstream of the pipe had a bacteria value of 3,990 MPN/100 mL. The ambient sample collected upstream of the pipe had a bacteria value of < 100 MPN/100 mL. This pipe is a high priority referral site for the proper local authority.

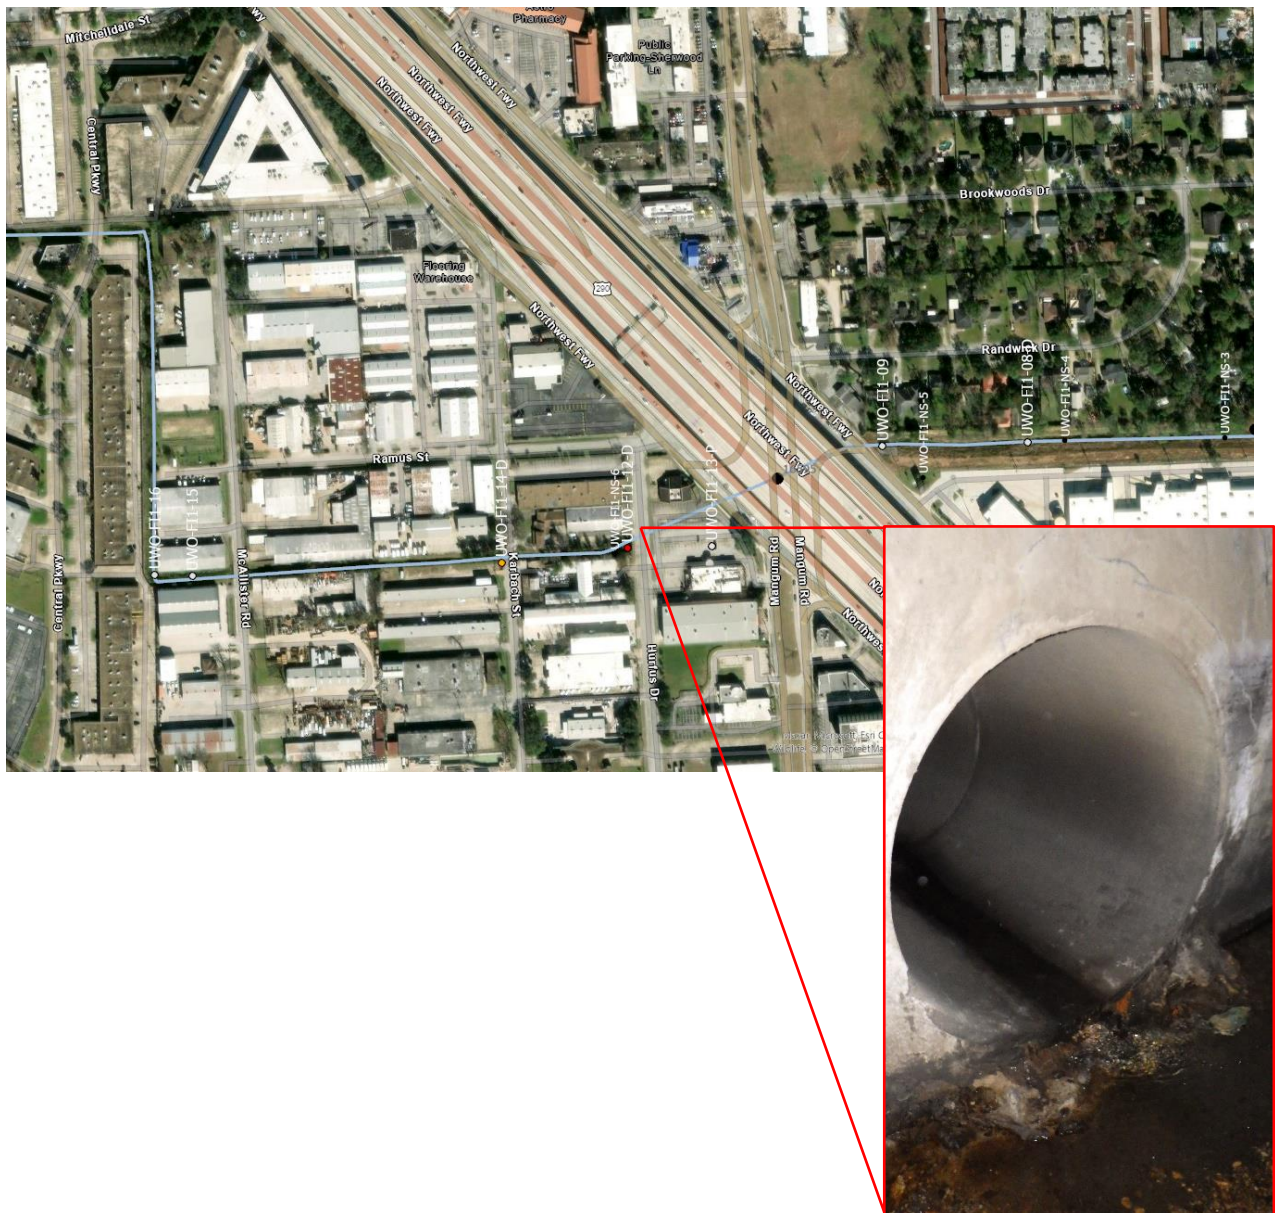
Referral site: UWO-FI1-12-D- High Priority

This is a 54 in. diameter cement pipe located on the left bank approximately 15 m downstream of the upstream side of the bridge on the Unnamed Tributary to White Oak Bayou. Water within the pipe was 0.6 in. deep and flowing into the segment. There was a pipe across from the sampled pipe that was barely trickling and not sampled. There are commercial buildings located in the area on the left bank. A sample taken 0.1 m downstream of the pipe had a bacteria value of 520 MPN/100 mL. The ambient sample collected upstream of the pipe had a bacteria value of < 100 MPN/100 mL. This pipe is a high priority referral site for the proper local authority.

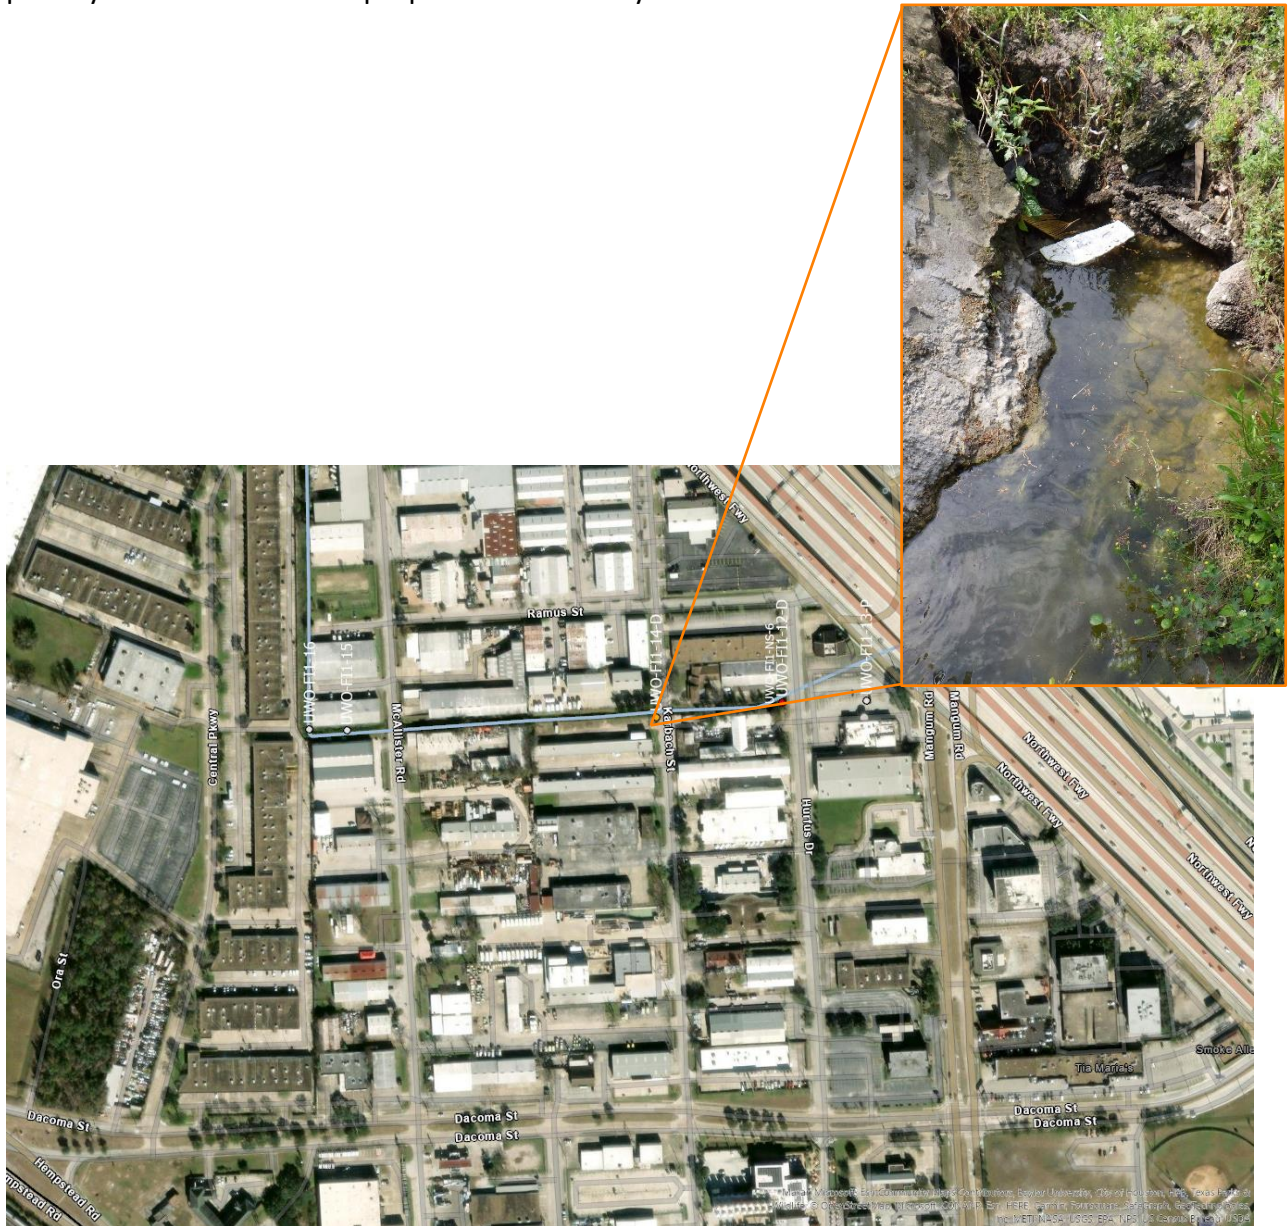
Referral site: UWO-FI1-14-D- Low Priority

UWO-FI1-14-D	29.80980	-95.46139	410	100	310	Y-L	Pipe is submerged and we are unable to tell if it is leaking but the concrete bank around it is collapsed and there is a deep pool under it.
UWO-FI1-15	29.80977	-95.46404	< 100	NA	NA	N	Ambient sample. White film on substrate. Small pool amidst very narrow and shallow section of tributary. Possible chemical (grease?) smell to sample. Flow is just a trickle.
UWO-FI1-16	29.80979	-95.46436	< 100	NA	NA	N	Top of wetted segment. Pipe seems to be main source of flow as it is completely dry upstream of here (after it turns 90 degrees to north) pipe comes from underground to west.

This is a 12 in. diameter cement pipe located on the right bank of the Unnamed Tributary to White Oak Bayou. The pipe is completely submerged and the field crew was unable to tell if it was flowing, but the cement bank around it was collapsed and there is a pool under it. There are commercial buildings located in the area on the right bank. A sample taken 1 m downstream of the pipe had a bacteria value of 410 MPN/100 mL. The ambient sample collected upstream of the pipe had a bacteria value of 100 MPN/100 mL. This pipe is a low priority referral site for the proper local authority.

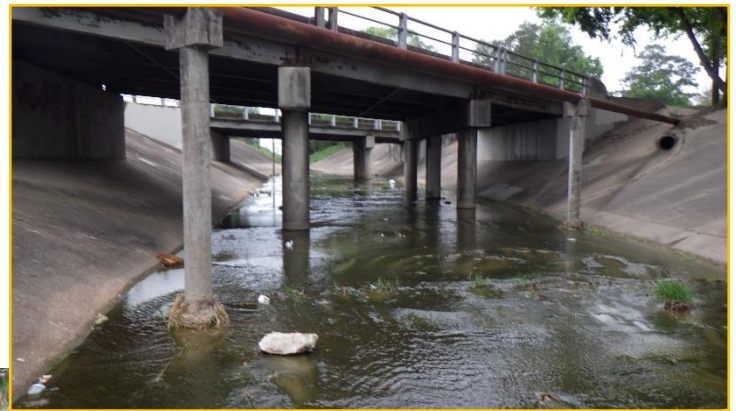
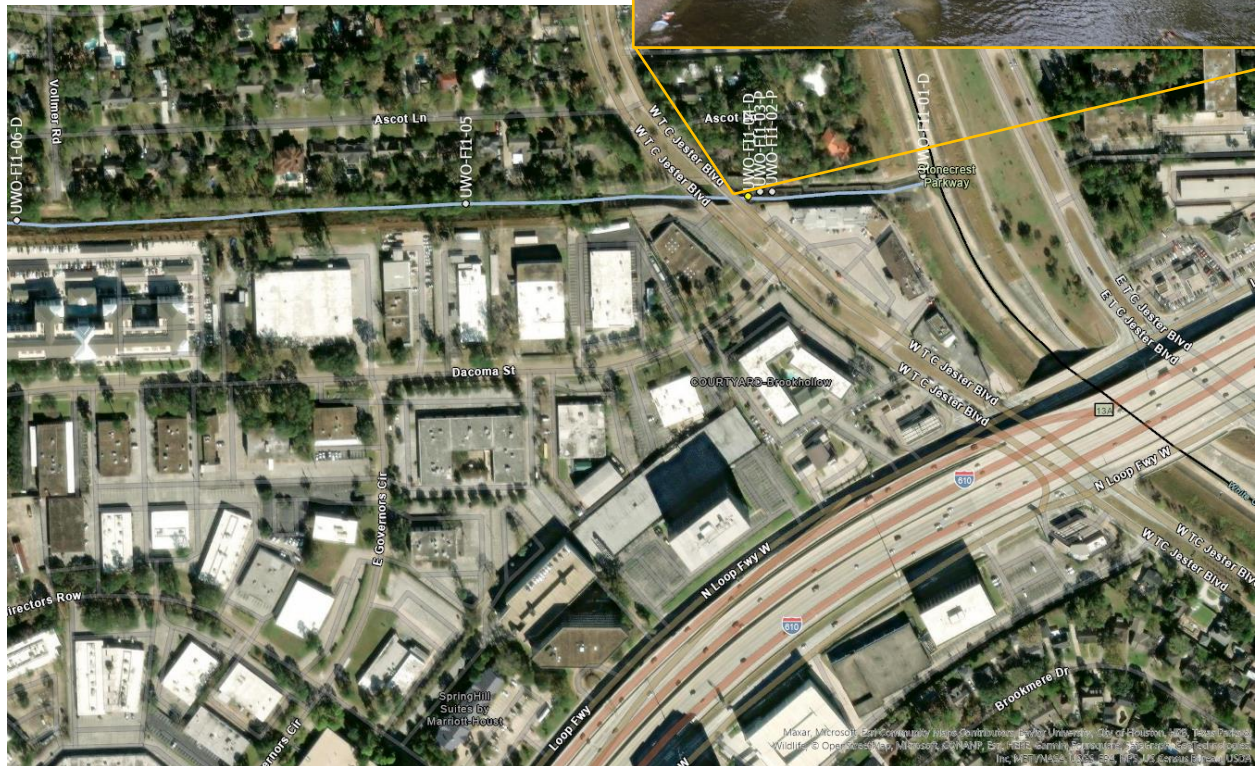
Referral site: UWO-FI1-04-U – Investigate Further

This was an ambient upstream sample taken on the Unnamed Tributary of White Oak Bayou for reference with the sample UWO FI1-04-D taken at a pipe on the right bank near the TC Jester bridge crossing. The ambient sample taken just downstream of the bridge crossing had a bacteria value of 3,320 MPN/100 mL. Another ambient sample was taken approximately 235 m further upstream and had a bacteria value of < 100 MPN/100 mL. No potential point sources were observed within this reach. Further investigation is recommended by the proper local authority to determine the source of elevated bacteria in this section of the segment. There are single-family homes located on the left bank and commercial building located on the right bank in this section of the segment.
