Targeted Bacteria Monitoring Project

Field Investigation Final Report

Assessment Unit 1017_03, White Oak Bayou Above Tidal

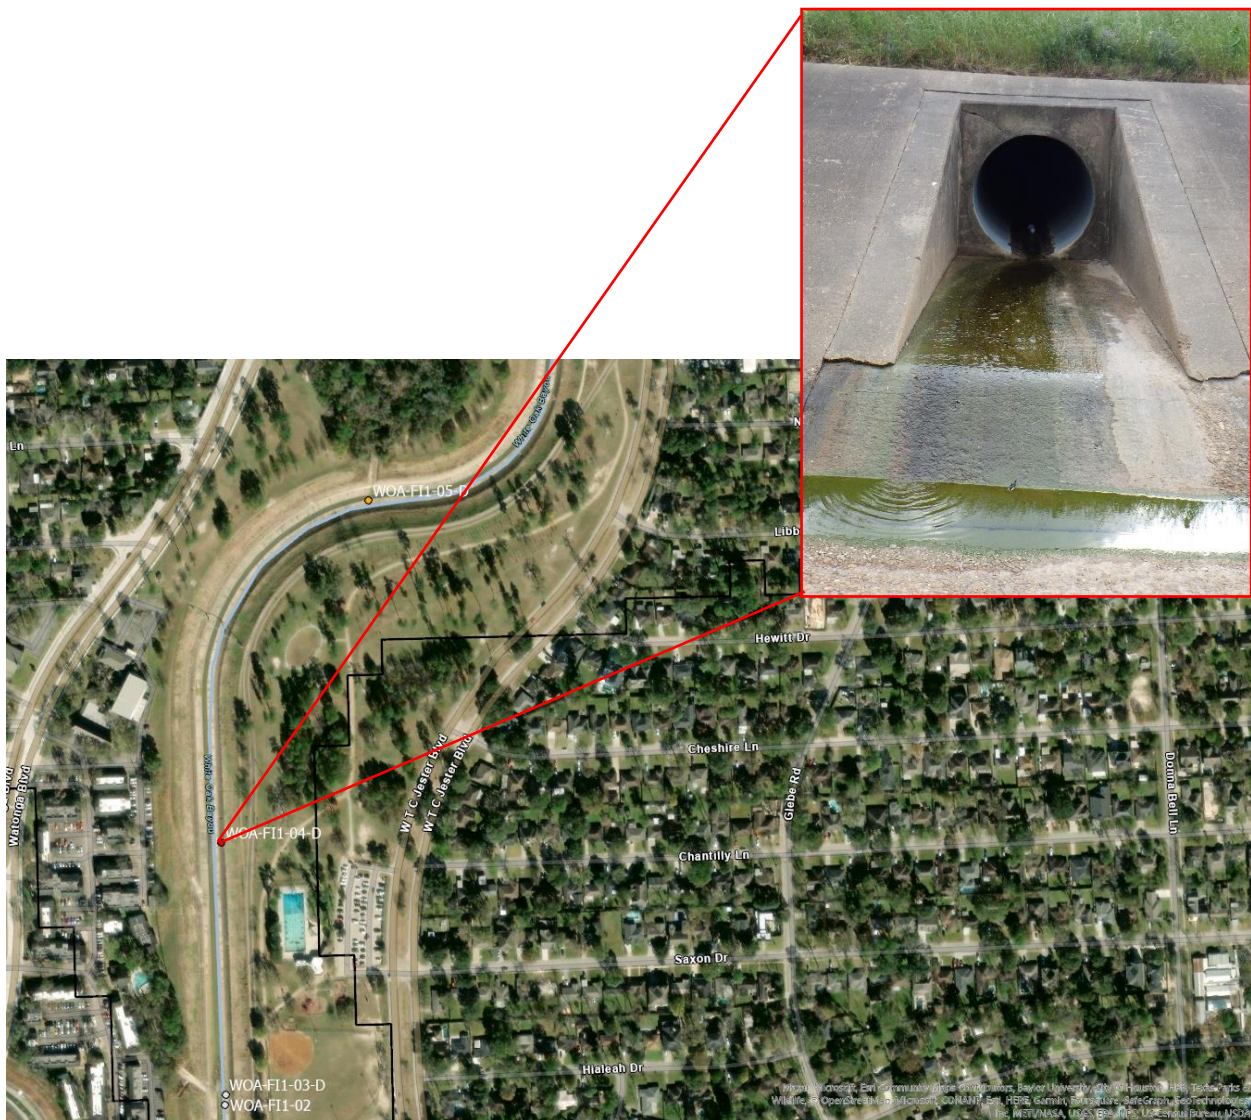
Referral site: WOA-FI1-04-D - High Priority

This is a 52 in. diameter metal pipe located on the left bank of White Oak Bayou Above Tidal. Water within the pipe was 0.25 in. deep and discharged onto a concrete lining before entering the AU. There is a walking trail that runs parallel with the bayou located on the left bank of this sampling location. Many joggers with dogs were observed utilizing this trail as the field crew was sampling. There is also a park with a public pool located on the left bank of this site, as well as many residential homes located in the adjacent area on the left bank. The area on the right bank is predominantly residential, with many apartment complexes and several schools. A sample taken 5.0 m downstream of the pipe had a bacteria value of 750 MPN/100 mL. The ambient sample collected upstream of the pipe had a bacteria value of 100 MPN/100 mL. This pipe is a high priority referral site for the proper local authority.

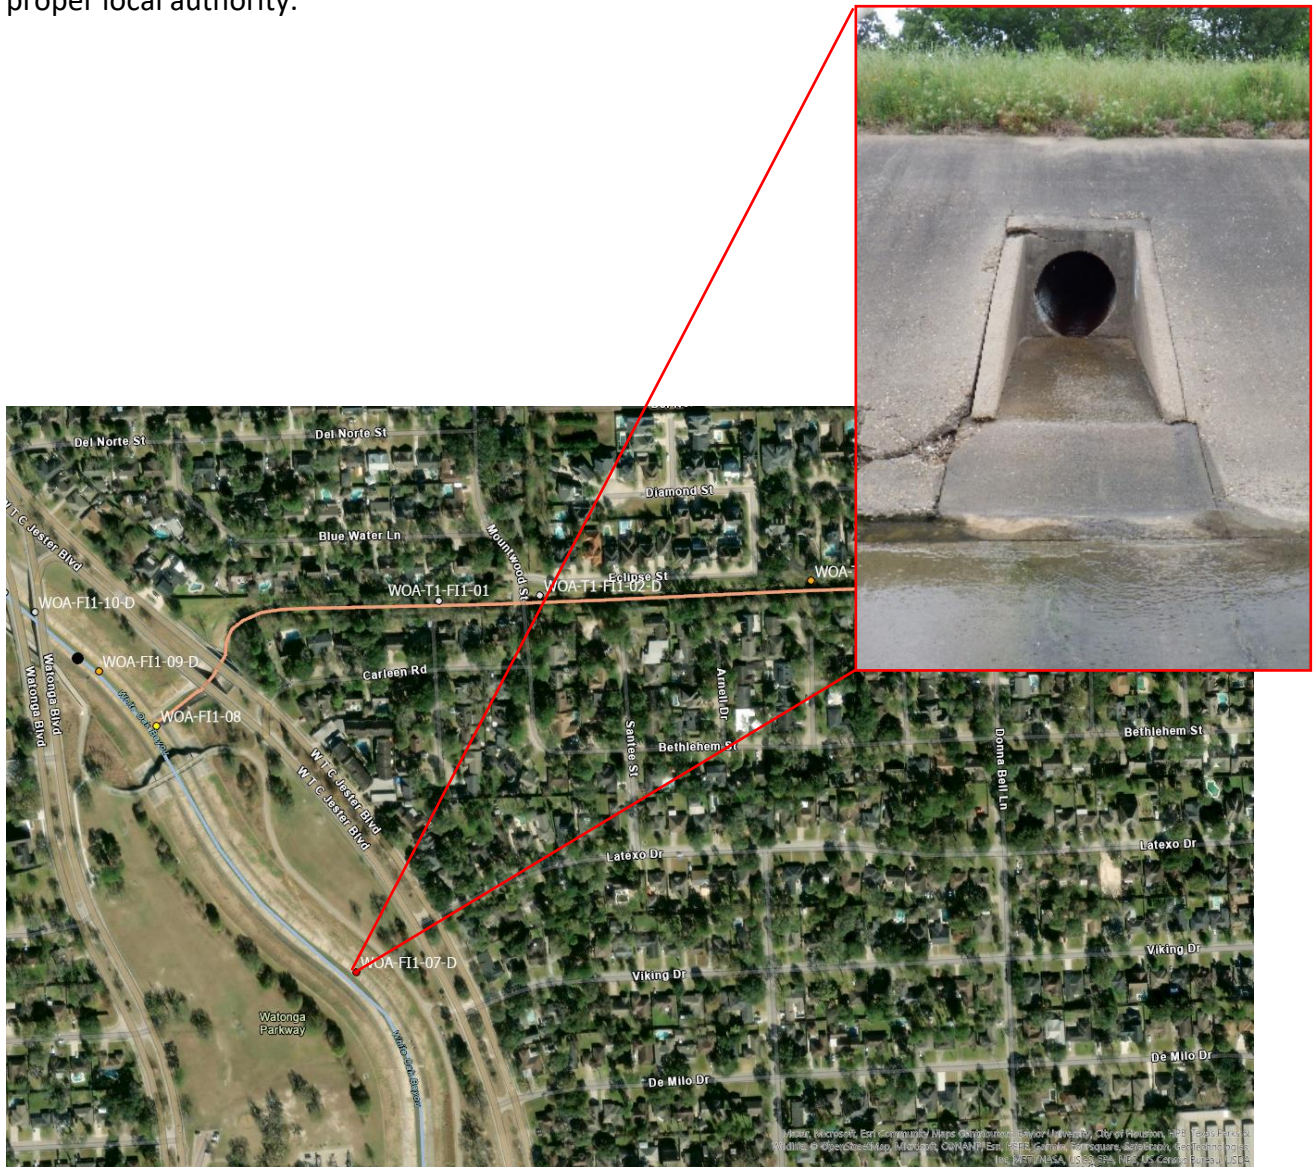
Referral site: WOA-FI1-07-D – High Priority

This is a 32 in. diameter metal pipe located on the left bank of White Oak Bayou Above Tidal. Water within the pipe was 0.6 in. deep and lightly flowing onto the concrete lining and bank before entering the segment. The water coming out of the pipe was noted to be brownish in color. There is a walking trail running parallel to the bayou on the left bank. The area on the left bank is predominately a single-family residential area. A sample taken 4.0 m downstream of the pipe had a bacteria value of 2,430 MPN/100 mL. The ambient sample collected upstream of the pipe had a bacteria value of 300 MPN/100 mL. This pipe is a high priority referral site for the proper local authority.

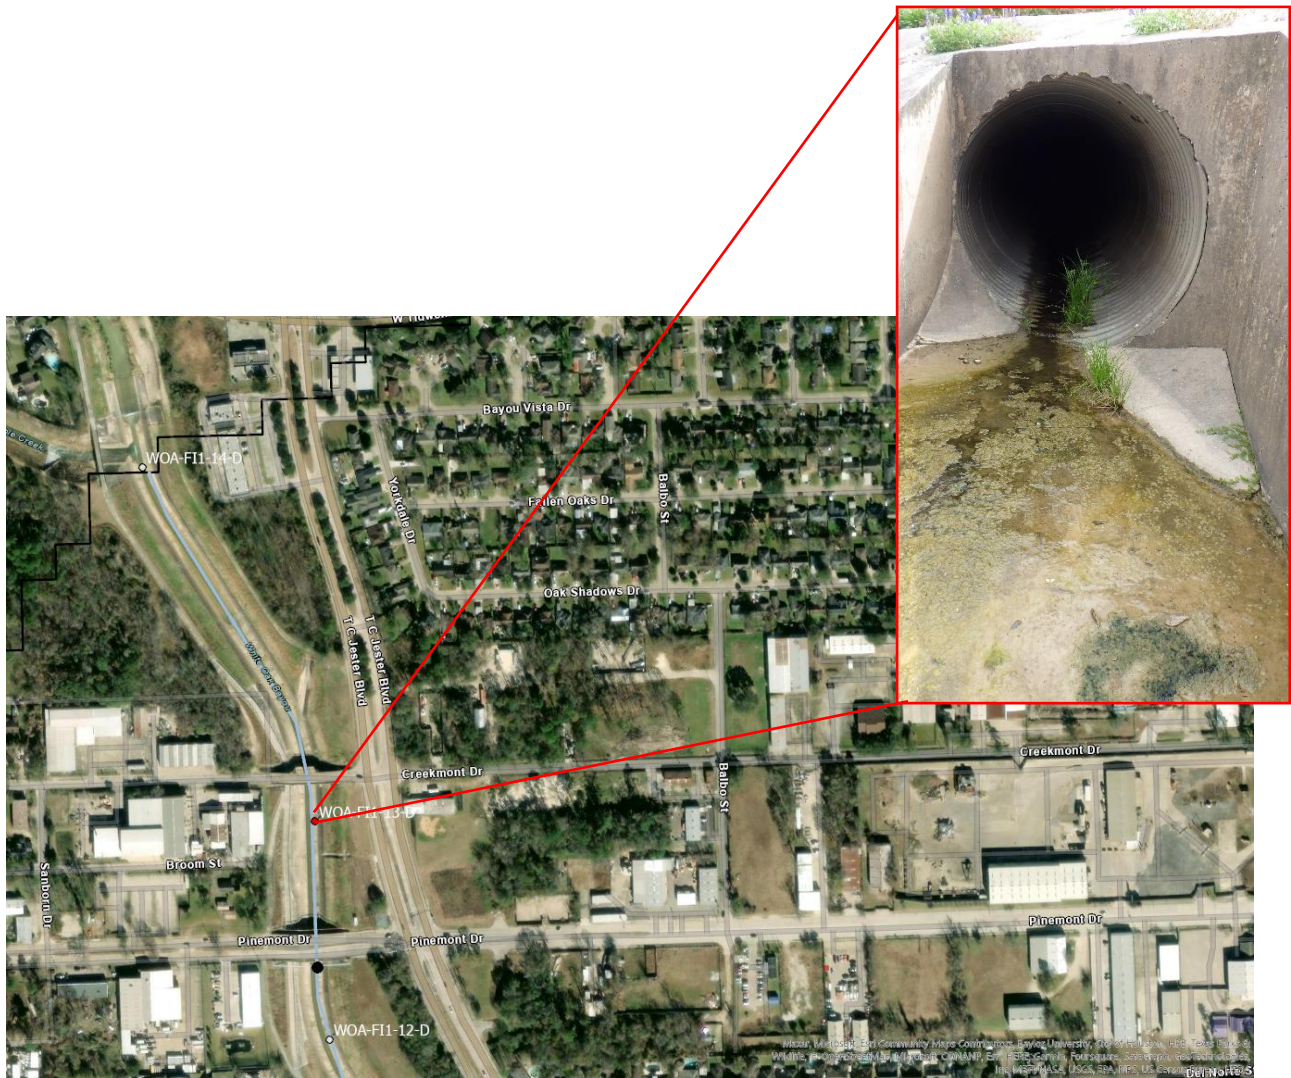
Referral site: WOA-FI1-13-D - High Priority

This is a 66 in. diameter metal pipe located on the left bank of White Oak Bayou Above Tidal. Water within the pipe was 1.0 in. deep and trickling through a large amount of algae before entering the AU. There is a walking trail that runs along the bayou. There are mostly small commercial and industrial properties located near this site. There is also a small lot with a port-o-potty where food trucks frequent on the left bank. A sample taken 15 m downstream of the pipe had a bacteria value of 520 MPN/100 mL. The ambient sample collected upstream of the pipe had a bacteria value of 200 MPN/100 mL. This pipe is a high priority referral site for the proper local authority.

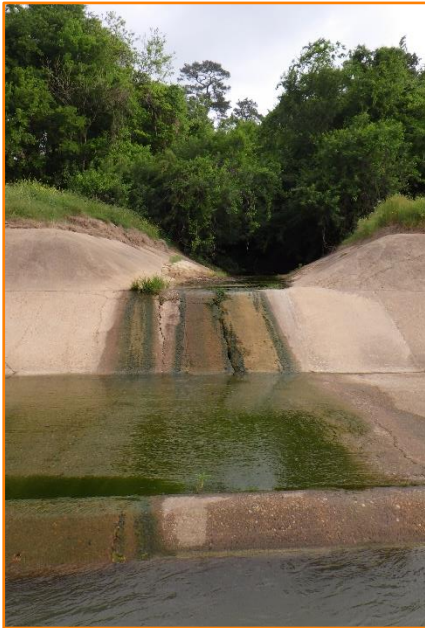
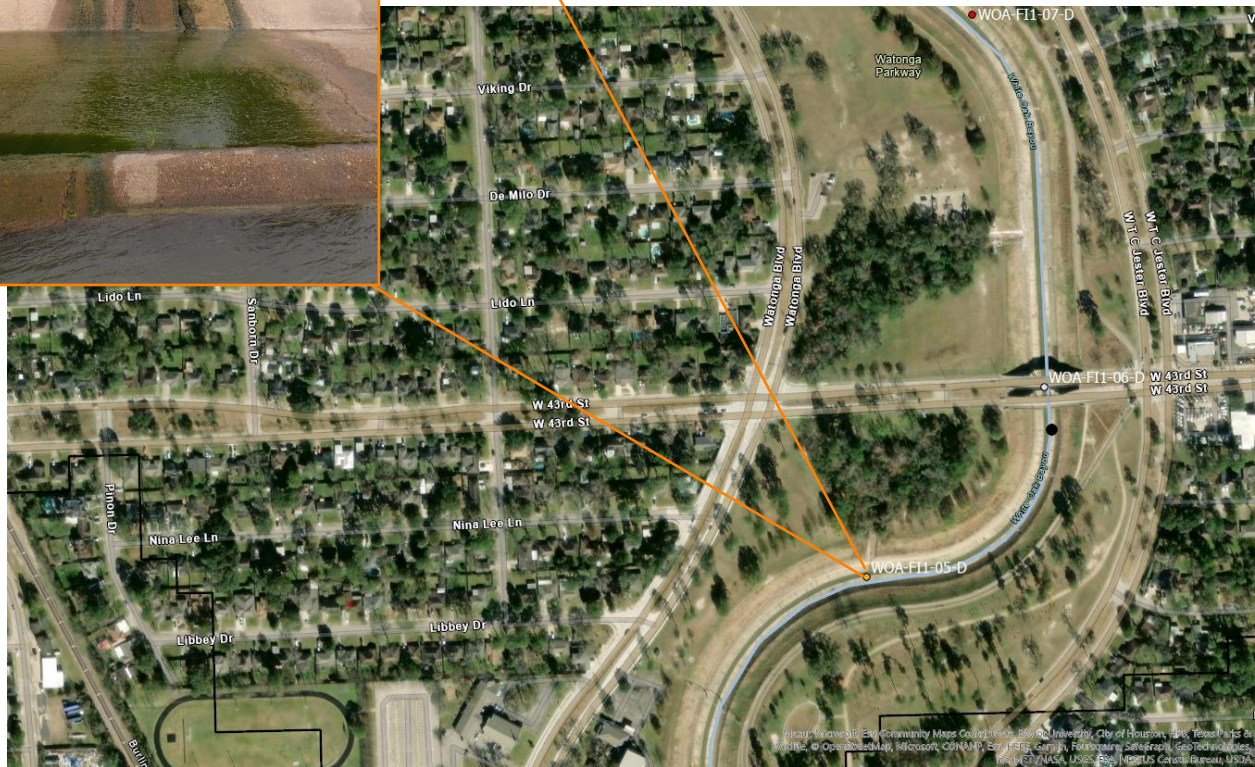
Referral site: WOA-FI1-05-D – Low Priority

This is a concrete-lined, open-air ditch that flows into White Oak Bayou Above Tidal from the right bank. Water within the ditch was flowing onto the concrete lined right bank before flowing into the AU. The ditch is located between a small dense wooded area and the main AU. A sample collected from the ditch had a bacteria value of 310 MPN/100 mL. The ambient sample collected upstream of the ditch had a bacteria value of 200 MPN/100 mL. This ditch is a low priority referral site for the proper local authority.

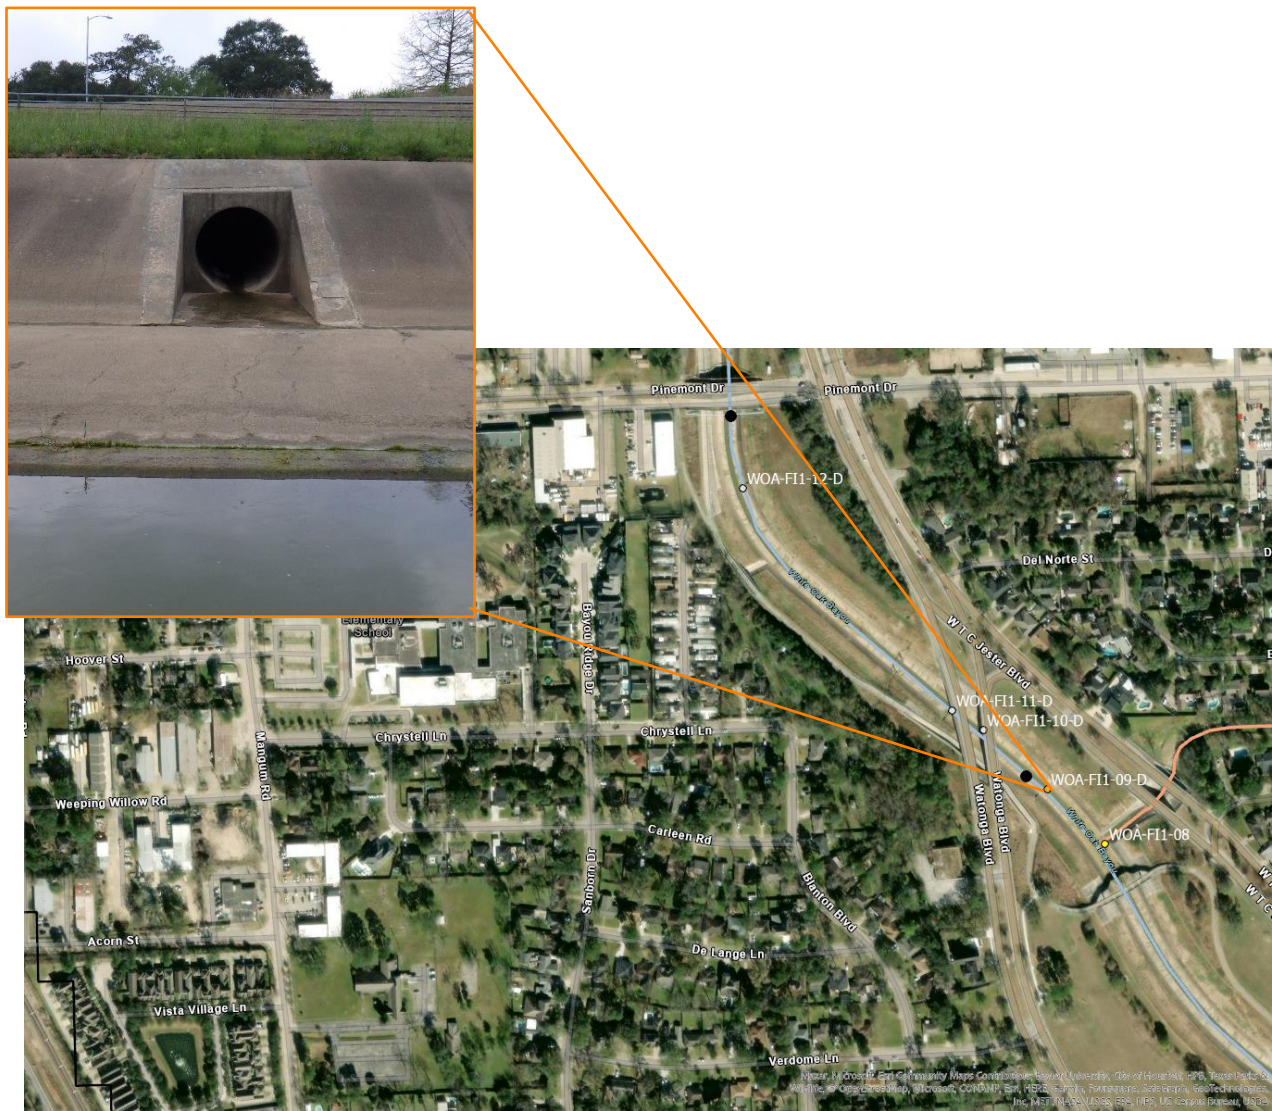
Referral site: WOA-FI1-09-D – Low Priority

This is a 60 in. diameter concrete pipe located on the right bank of White Oak Bayou Above Tidal. Water within the pipe was estimated to be 0.25 in. deep and was slowly flowing down cracks in the concrete-lined bank before entering the segment. There are a small number of commercial buildings located in the area on the right bank, but the area is mostly single-residence homes. There is a walking trail along the right bank at this site. The right bank was inaccessible to the field crew at this location so the sample was collected at the estimated mixing zone 20 m downstream of the pipe and had a bacteria value of 410 MPN/100 mL. The ambient sample collected upstream of the pipe had a bacteria value of 200 MPN/100 mL. This pipe is a low priority referral site for the proper local authority.

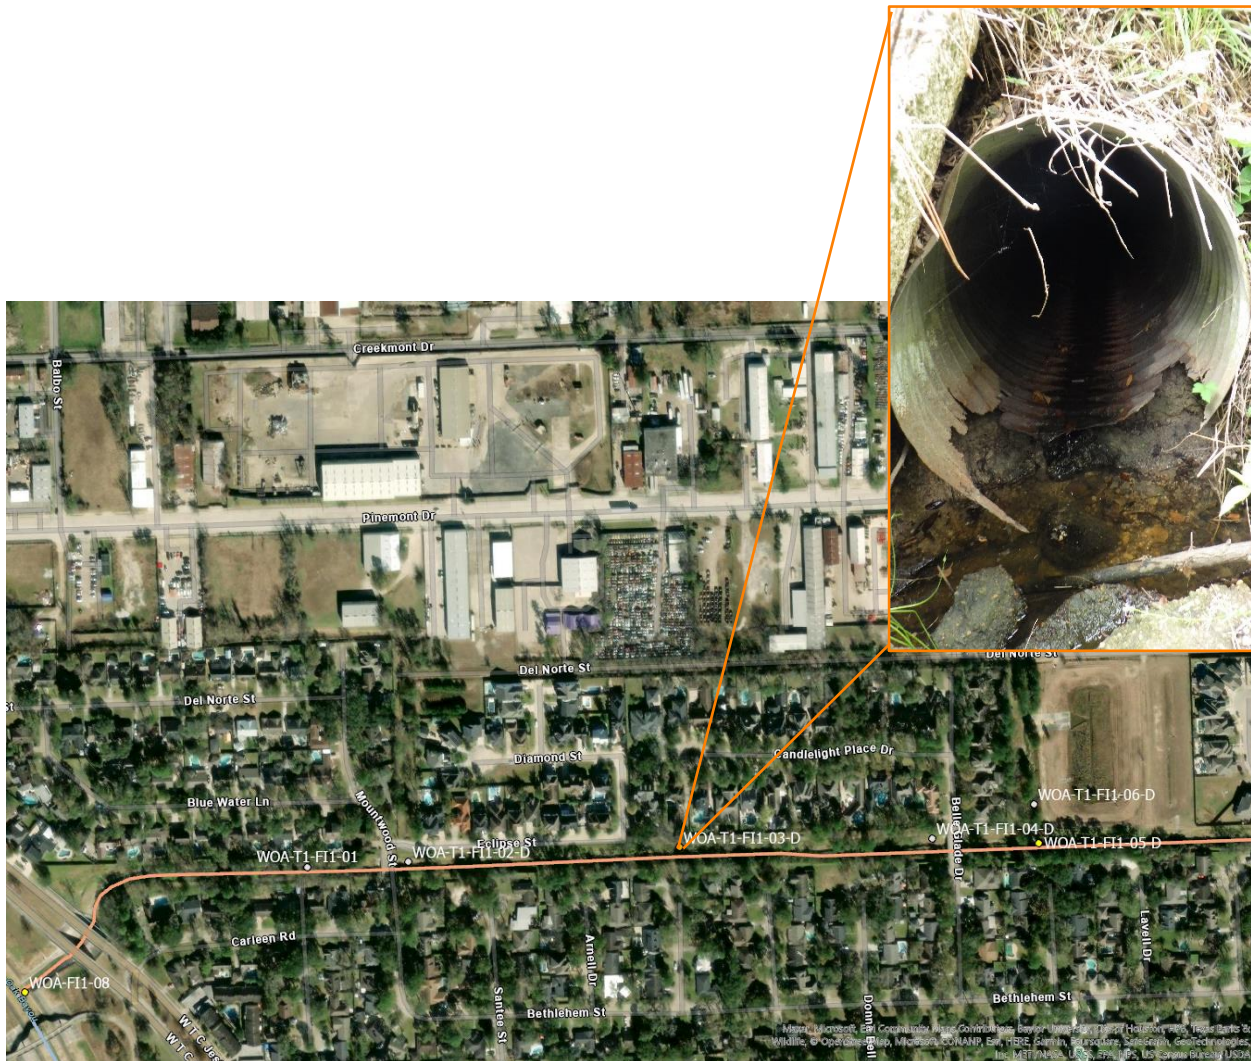
Referral site: WOA-T1-FI1-03-D – Low Priority

This is a 32 in. diameter metal pipe located on the right bank of tributary 1 of White Oak Bayou Above Tidal. Water within the pipe was 0.25 in. deep and trickling into the AU. The bottom of the pipe was rusted out and the water color was noted to be slightly brown. The area surrounding the site on both banks includes single-family residences with some small industrial properties located on the other side of the residential neighborhood on the right bank. A sample 0.3 m downstream of the pipe had a bacteria value of 410 MPN/100 mL. The ambient sample collected upstream of the pipe had a bacteria value of < 100 MPN/100 mL. This pipe is a low priority referral site for the proper local authority.

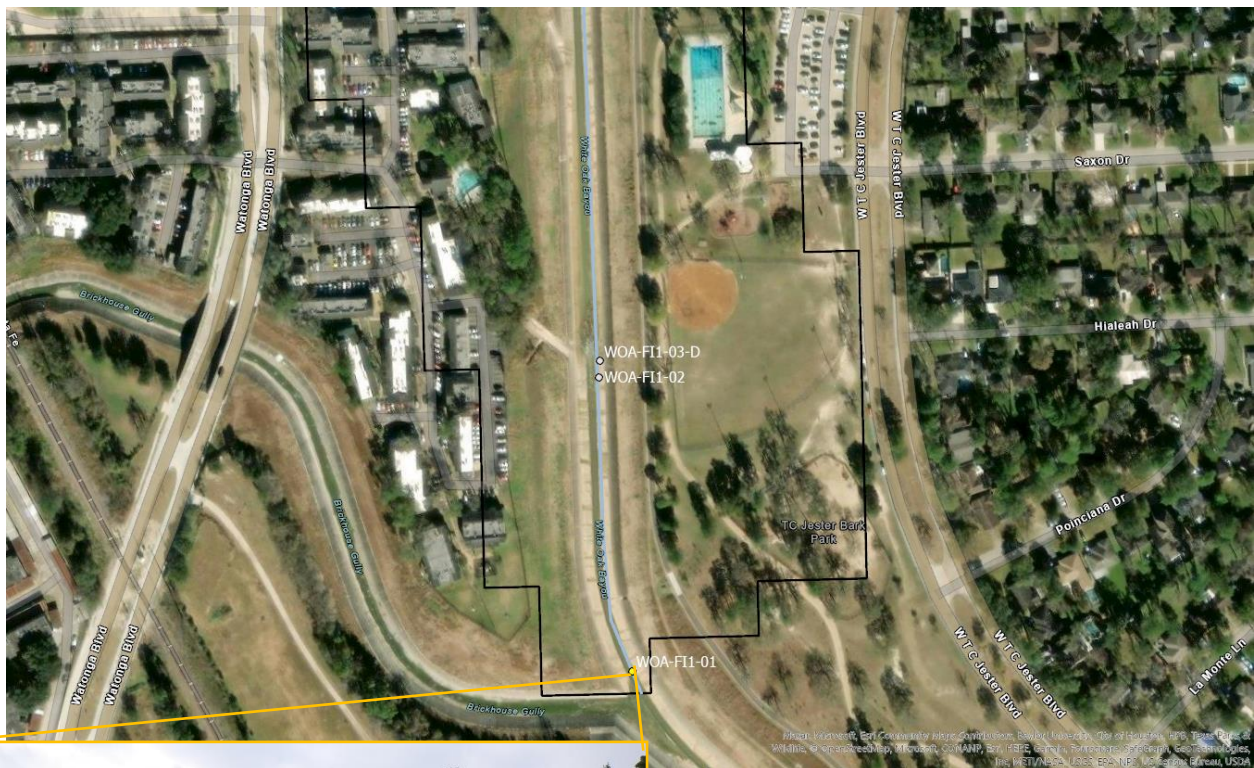
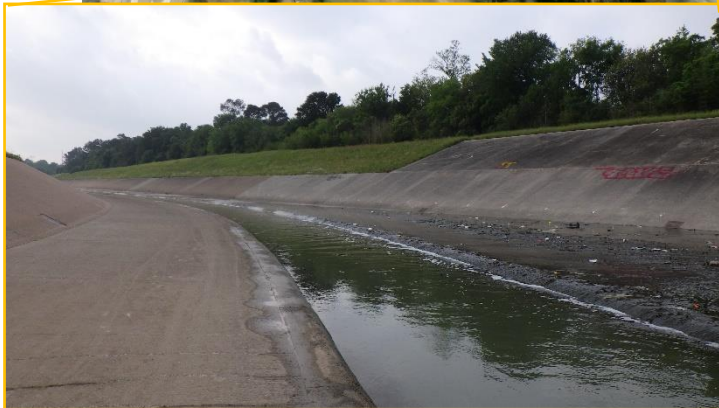
Referral site: WOA-FI1-01 – Investigate Further

This was an ambient sample taken at the most downstream portion of White Oak Bayou Above Tidal before the confluence with Brickhouse Gully. The ambient sample was taken just upstream of the mixing zone with Brickhouse Gully and had a bacteria value of 1,610 MPN/100 mL. The next sample taken upstream at WOA-FI1-02 had a bacteria value of 200 MPN/100 mL. There were no potential point sources observed between these two samples. Further investigation is recommended by the proper local authority to determine the source of elevated bacteria upstream of the segment. There are apartments and single-family homes located upstream of the site, as well as a small dog park on the left bank.

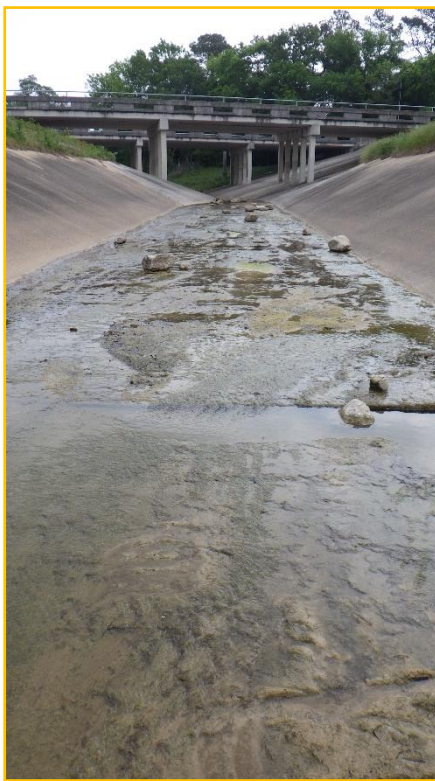
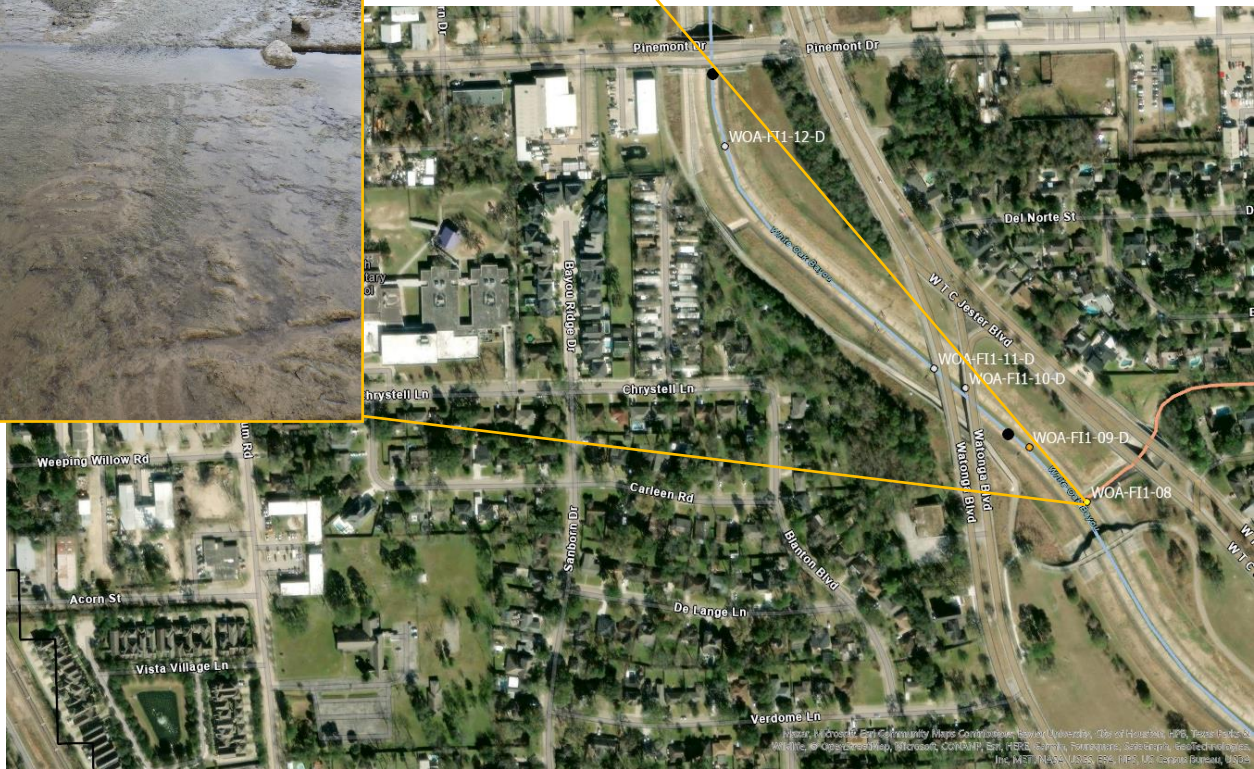
Referral site: WOA-FI1-08 – Investigate Further

This was an ambient sample taken at the most downstream portion of tributary 1 of White Oak Bayou Above Tidal before it flows into the main AU. The ambient sample was taken just downstream of the bridge of TC Jester Blvd. that runs over the tributary and had a bacteria value of 2,430 MPN/100 mL. There was a sample collected approximately 286 m upstream of this sample which was 100 MPN/100 mL, but there were no pipes that were observed to be flowing into the tributary in between these samples at the time of sampling. The TC Jester Blvd. bridge did have a colony of bats living under it and there was a large amount of bat droppings on both banks. Further investigation is recommended by the proper local authority to determine the source of elevated bacteria underground and upstream of the segment.

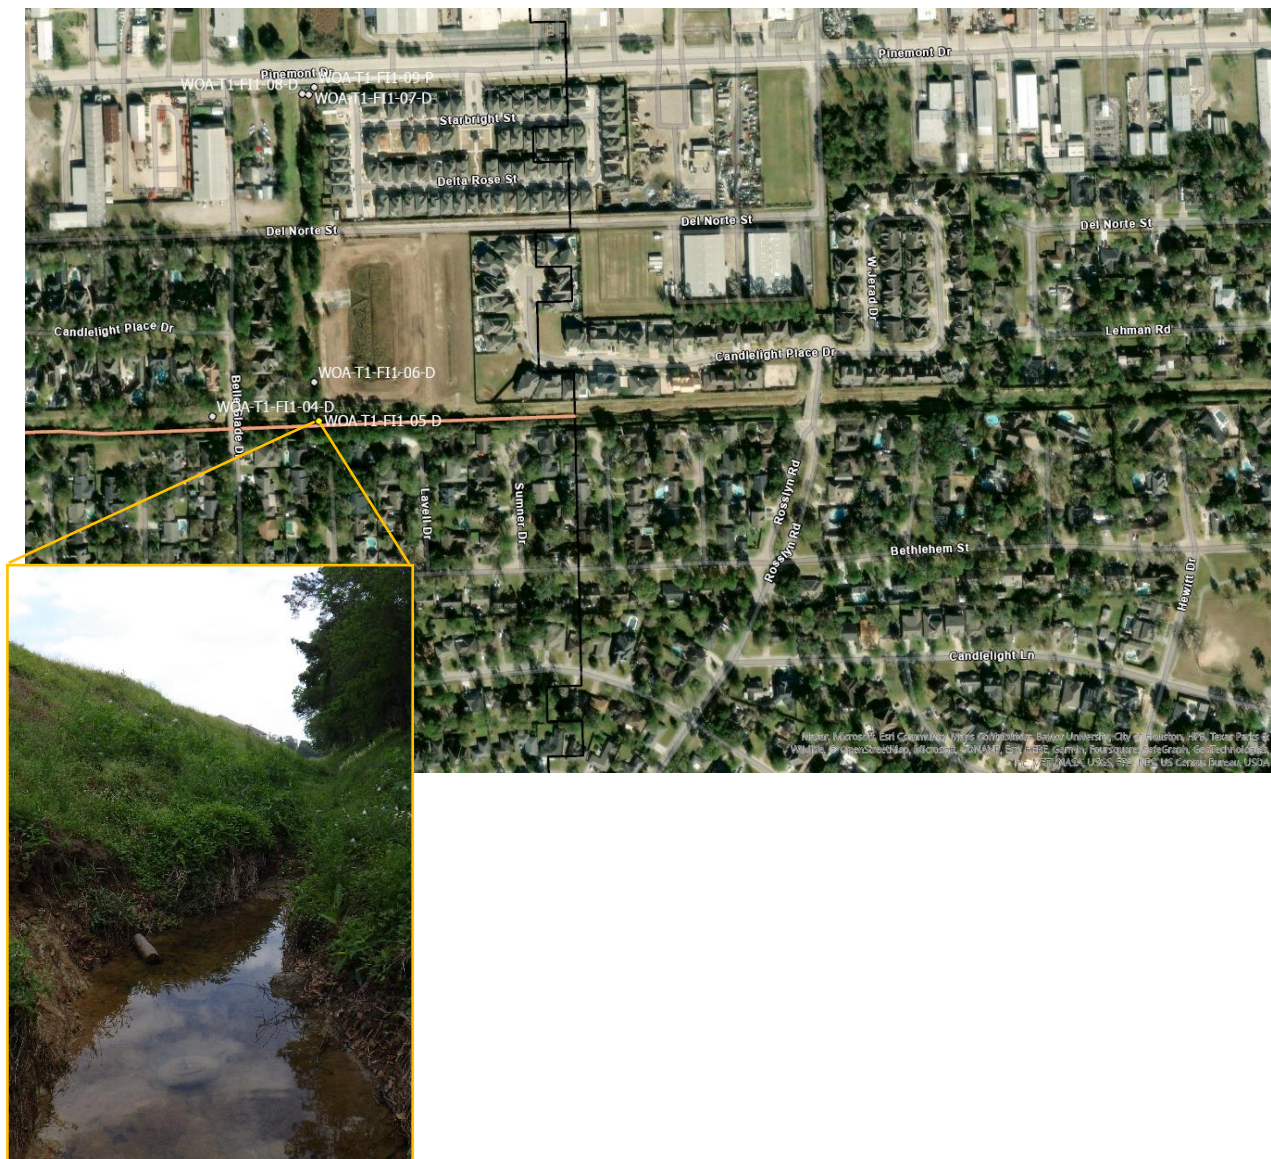
Referral site: WOA-T1-FI1-05-D – Investigate Further

This was an ambient sample taken at the most downstream portion of a small stem of tributary 1 of White Oak Bayou Above Tidal. The ambient sample collected from the smaller branch of the tributary had a bacteria value of 520 MPN/100 mL and an ambient sample collected on the main stem of tributary 1 upstream of this confluence was < 100 MPN/100 mL. Further investigation is recommended by the proper local authority to determine the source of elevated bacteria in this section of the tributary. There are single-family homes located upstream of the site on both banks.
