Targeted Bacteria Monitoring Report

Field Investigation Final Report

Assessment Unit 1017E_01, Unnamed Tributary of White Oak Bayou

May 15, 2023

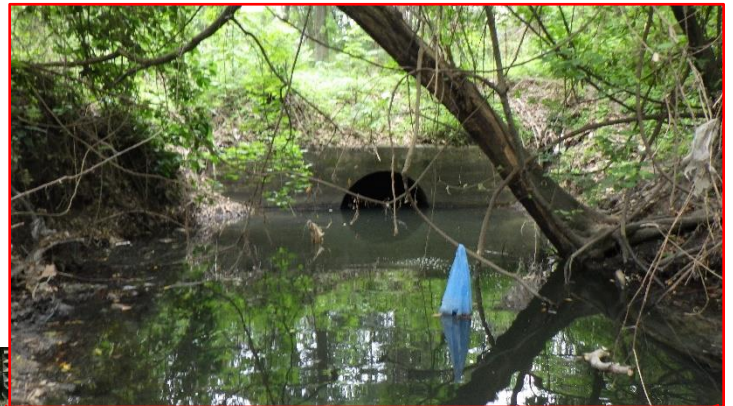
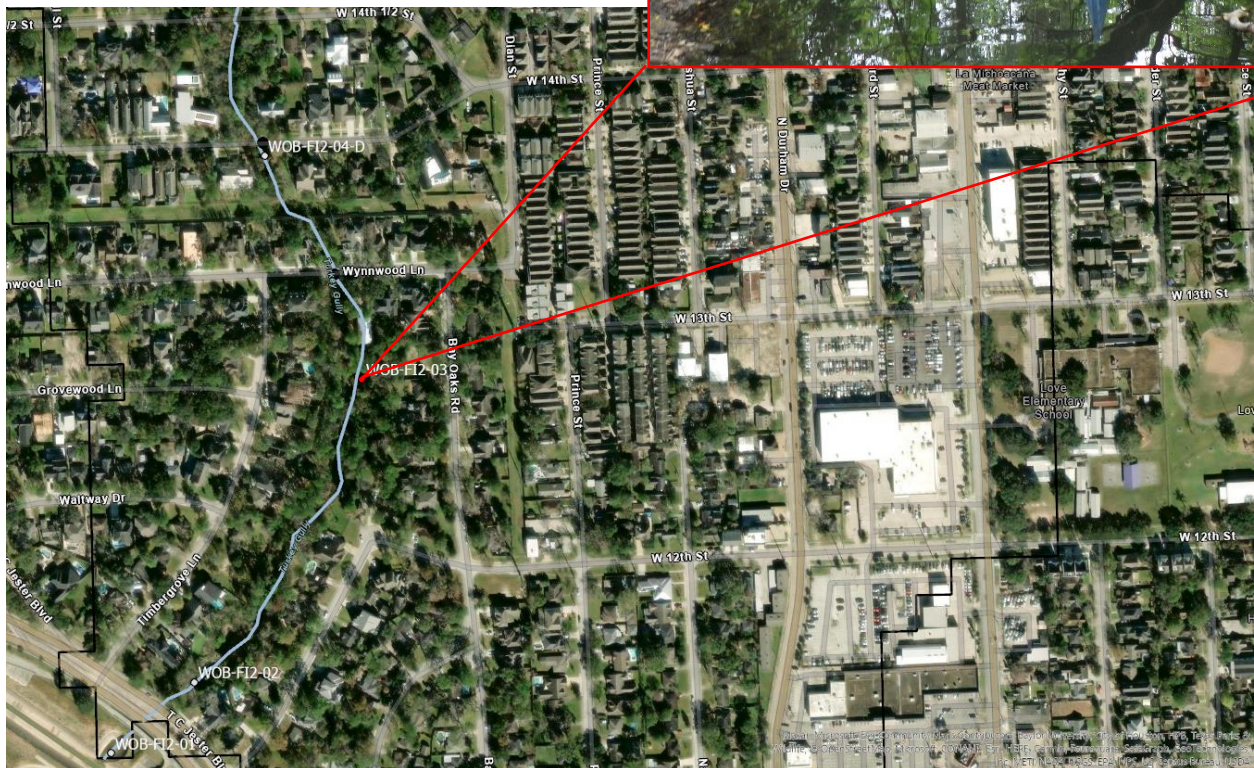
Referral site: WOB-FI2-03 – High Priority

This is a 51 in. diameter concrete pipe that was submerged on the left bank of the Unnamed Tributary of White Oak Bayou. Water within the pipe was 36 in. deep and the field crew was unable to tell if it was flowing into the segment due to it being submerged. The area in front of the pipe was a stagnant pool and the substrate appeared to be black in color with a white film on top. When disturbed, the substrate gave off an anoxic odor. A sample was taken from the mouth of the submerged pipe and had a bacteria value of 5,200 MPN/100 mL. An ambient sample was not collected directly upstream of this pool, but the next ambient sample collected approximately 200m upstream of the pipe had a bacteria value of 850 MPN/100 mL. This pipe is a high priority referral site for the proper local authority.

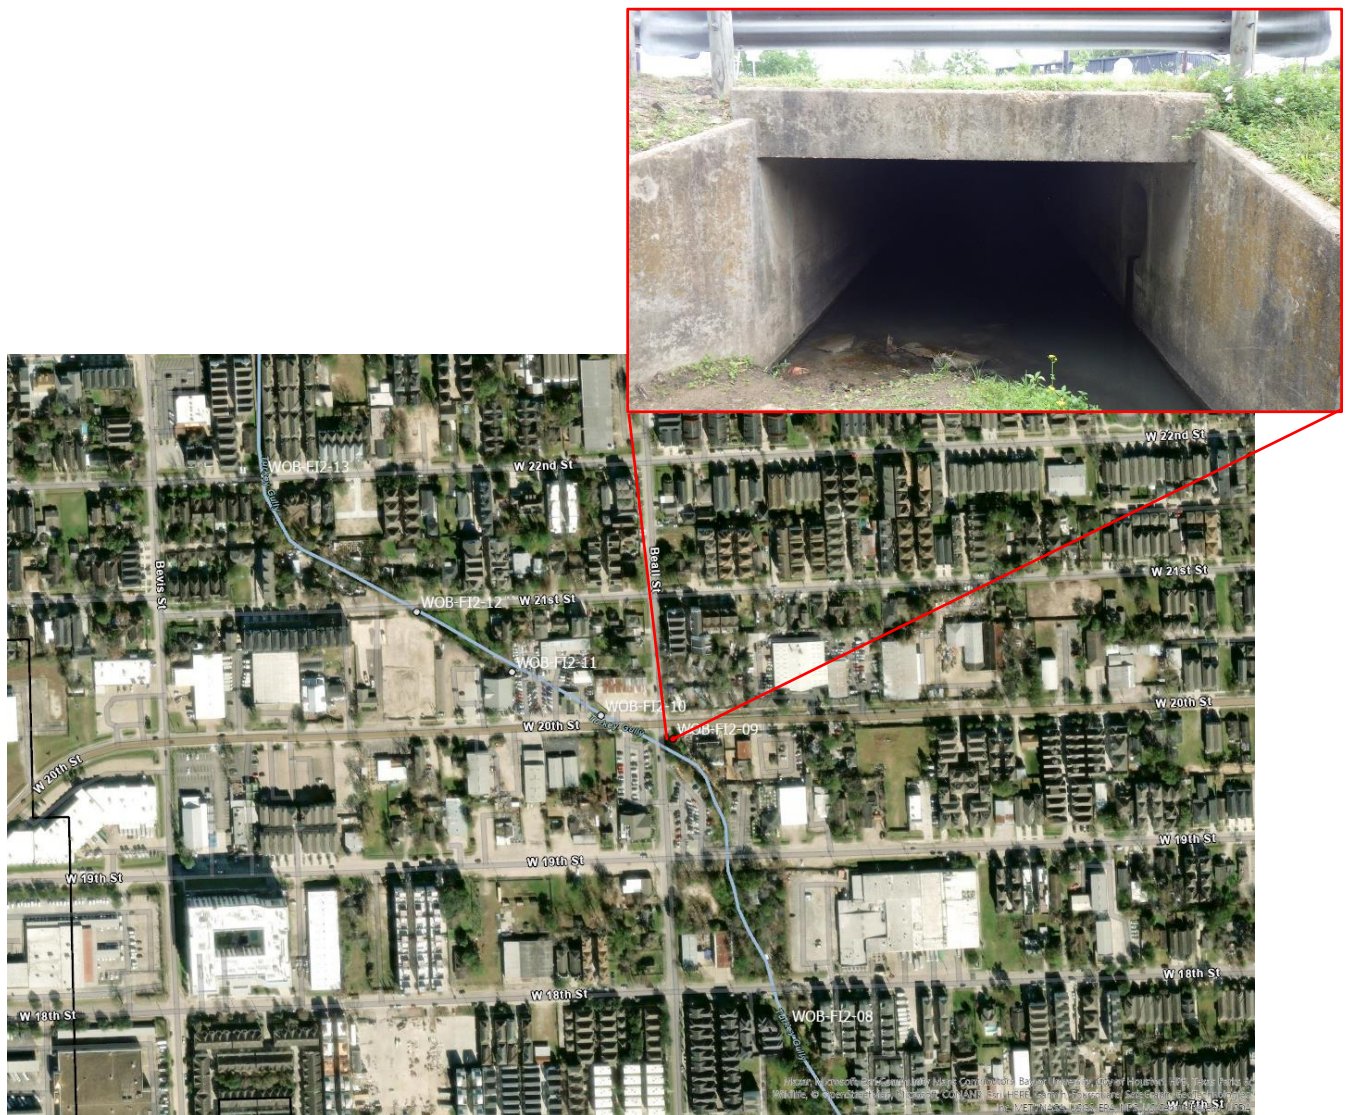
Referral site: WOB-FI2-09 – High Priority

This is where the Unnamed Tributary of White Oak Bayou goes underground. An ambient sample was collected just downstream of this bridge and had a bacteria value of 173,000 MPN/100 mL. The next ambient sample collected ~460 m upstream had a bacteria value of 100 MPN/100 mL. There were no pipes between these two ambient samples that were observed to be flowing into the AU at the time of sampling. This portion of the AU runs through a mix of restaurants, clubs, and residences. This section of the AU is a high priority referral site for the proper local authority.

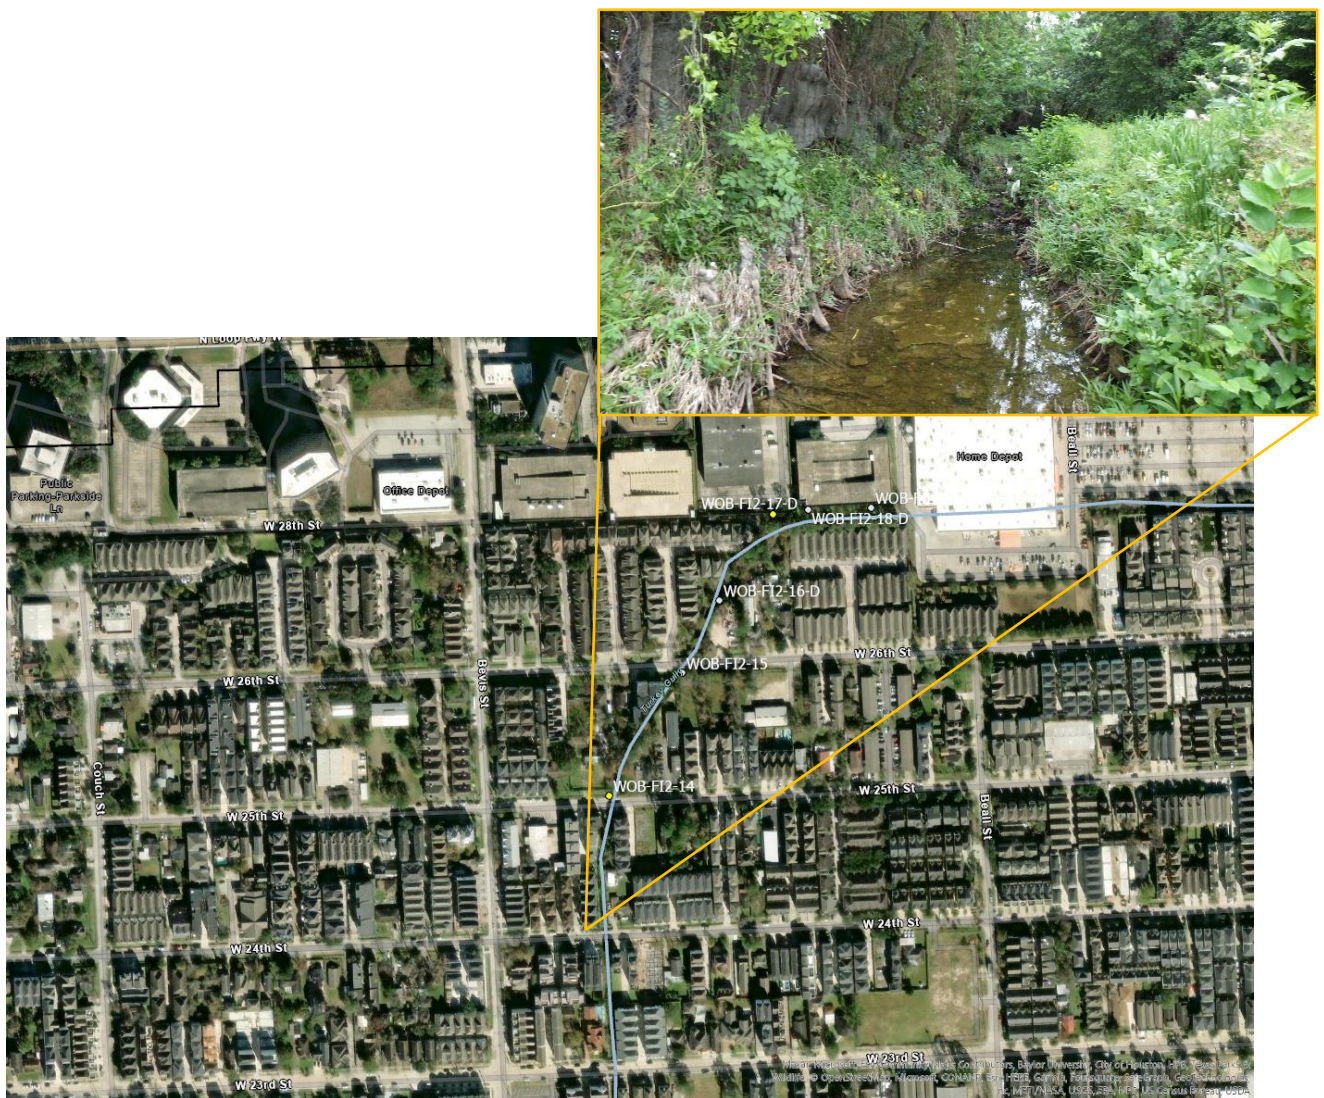
Referral site: WOB-FI2-14 – Investigate Further

This was an ambient sample taken just upstream of the bridge of W 25th St. on the Unnamed Tributary of White Oak Bayou. This ambient sample had a bacteria value of 6,130 MPN/100 mL. The next ambient sample was collected 115 m upstream and had a bacteria value of 310 MPN/100 mL. No pipes were observed to be flowing between these two sampling locations during the time of sampling. Further investigation is recommended by the proper local authority to determine the source of elevated bacteria in this section of the AU. There are apartment and single-family homes located upstream of the site.

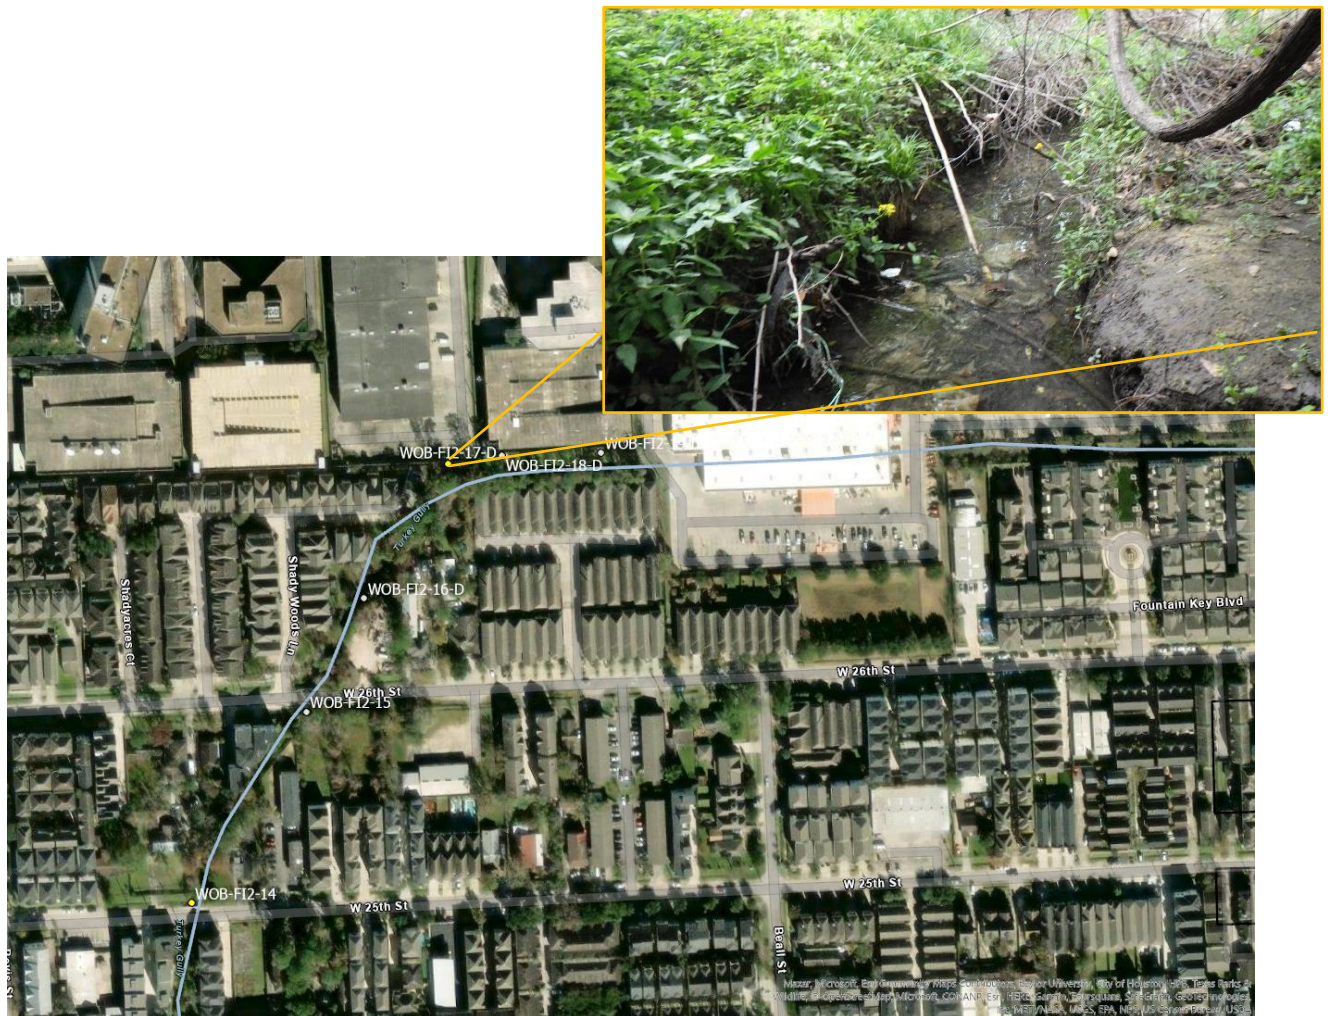
Referral site: WOB-FI2-17-U – Investigate Further

This portion between two pipes had suspect levels of bacteria. The ambient sample taken just upstream of this pipe had a bacteria value of 11,800 MPN/100 mL yet the sample collected downstream of the next pipe (18-D), which was only 30 m upstream, had a bacteria value of 630 MPN/100 mL. There were no pipes that were observed to be flowing into the AU between pipes 17-D and 18-D at the time of sampling. Further investigation is recommended by the proper local authority to determine the source of elevated bacteria in this section of the AU. There are apartments and single-family homes located upstream of the site, as well as commercial properties.
