Targeted Bacteria Monitoring Project

Field Investigation Final Report

Assessment Unit 10140_01

Spring Branch (Tributary of Buffalo Bayou)

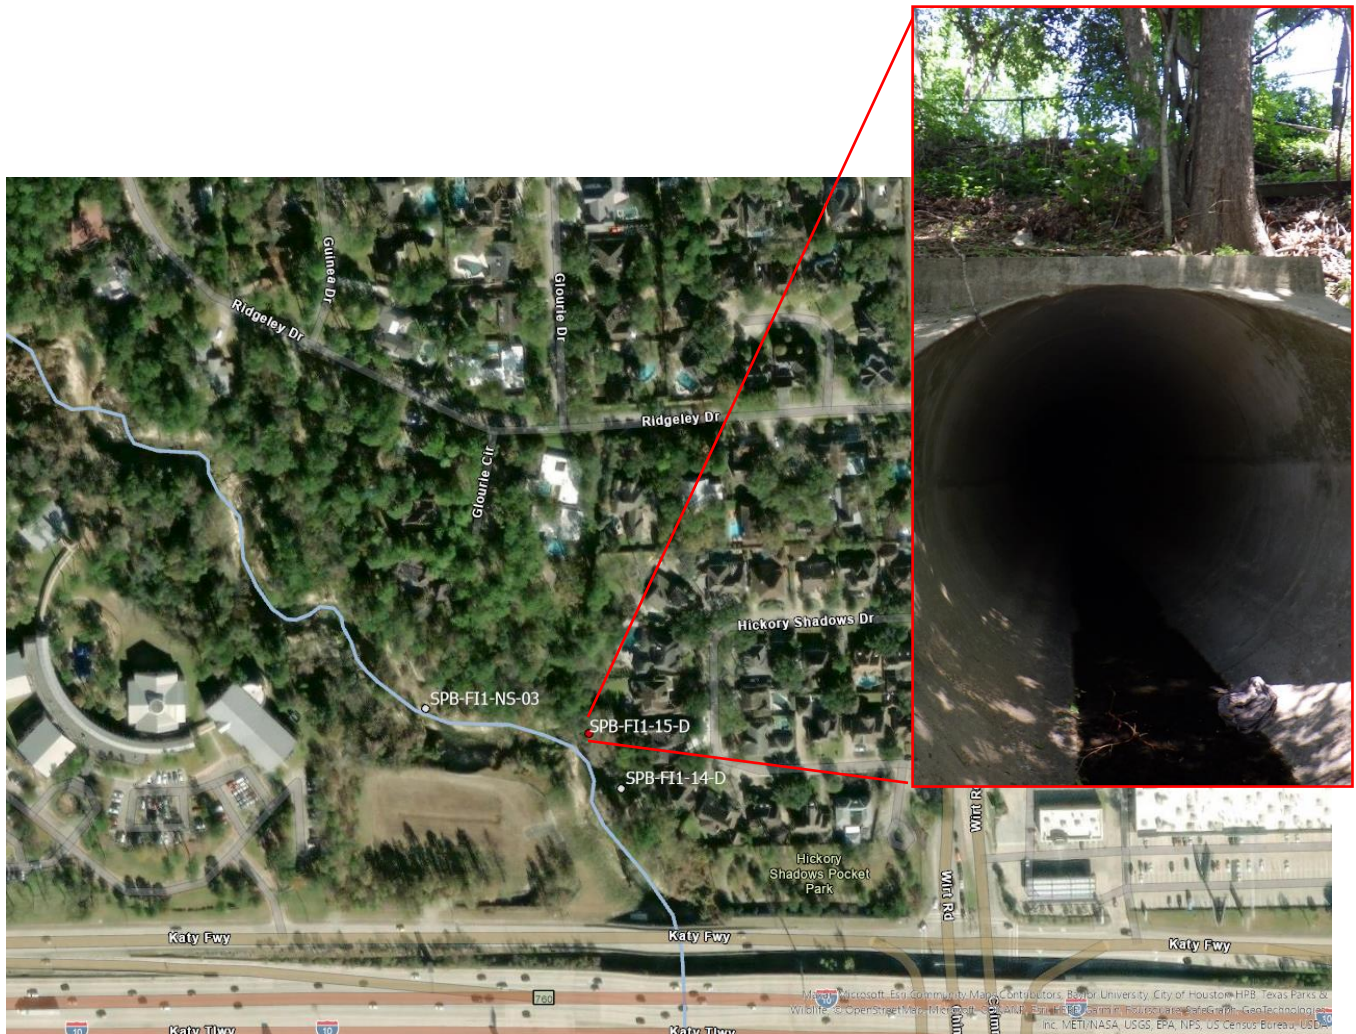
Referral site: SPB-FI1-15-D- High Priority

This is a 124 in. diameter concrete pipe located on the left bank of Spring Branch. Water within the pipe was 2 in. deep with a substantial flow into the segment. There are single family homes in the area. A sample taken 0.25 m downstream of the pipe had a bacteria value of 1,210 MPN/100 mL. The ambient sample collected upstream of the pipe had a bacteria value of 100 MPN/100 mL. This pipe is a high priority referral site for the proper local authority.

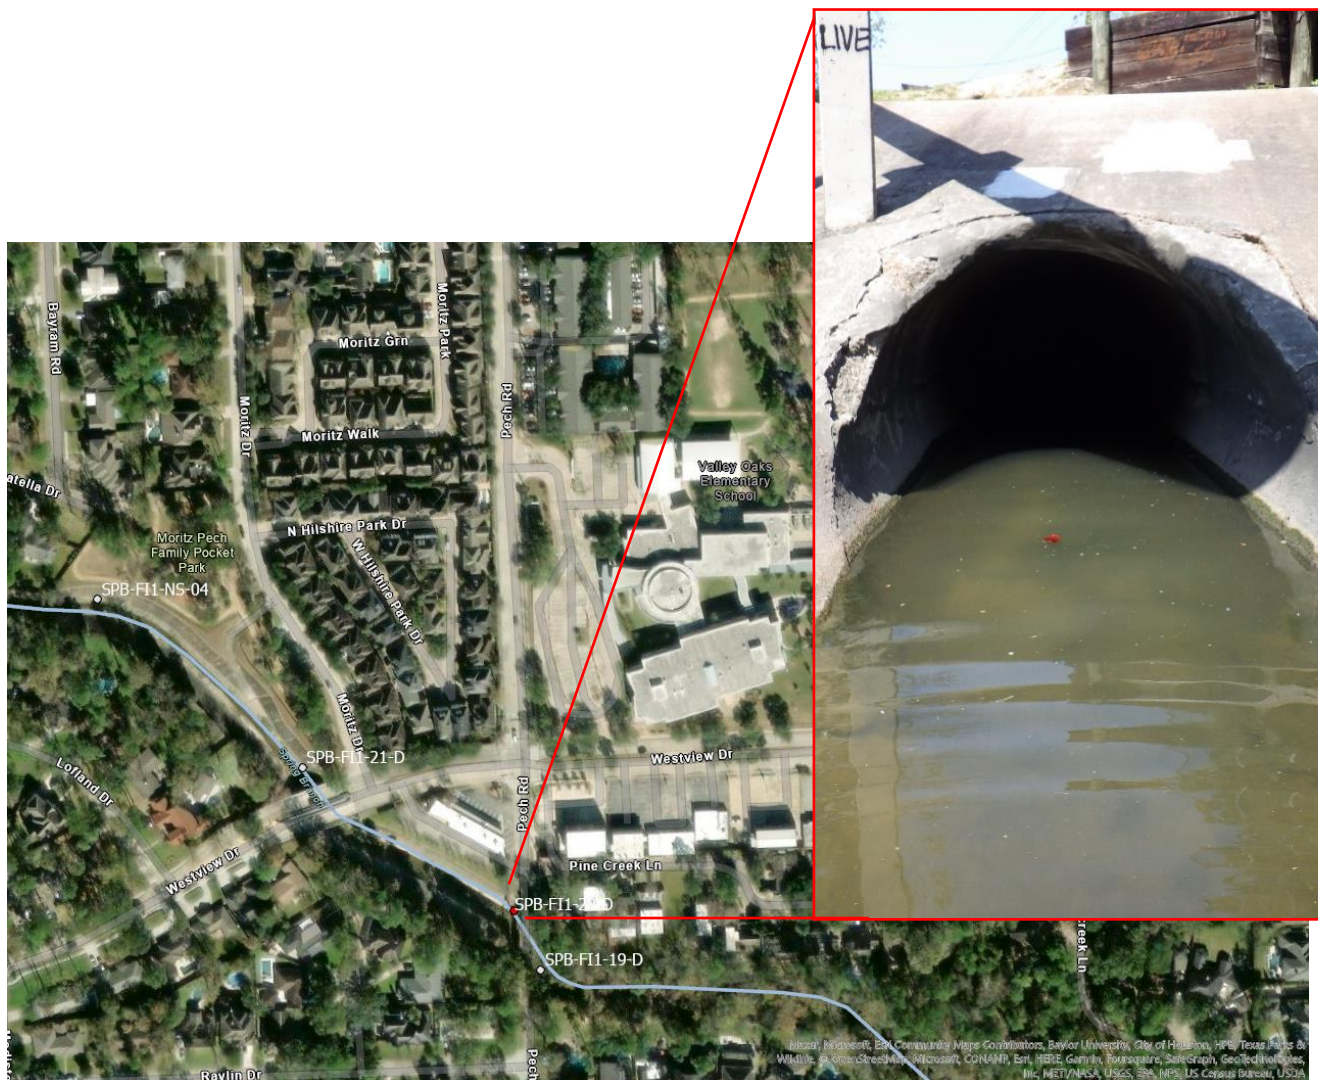
Referral site: SPB-FI1-20-D- High Priority

This is a 104 in. diameter concrete pipe located on the left bank of Spring Branch. Water within the submerged pipe was 22 in. deep. Bats are present under the bridge upstream of where these samples were taken. There are single family homes, commercial businesses, schools, and parks in the area. A sample taken at the mouth of the submerged pipe had a bacteria value of > 242,000 MPN/100 mL. The ambient sample collected upstream of the pipe had a bacteria value of 17,800 MPN/100 mL. This pipe is a high priority referral site for the proper local authority.

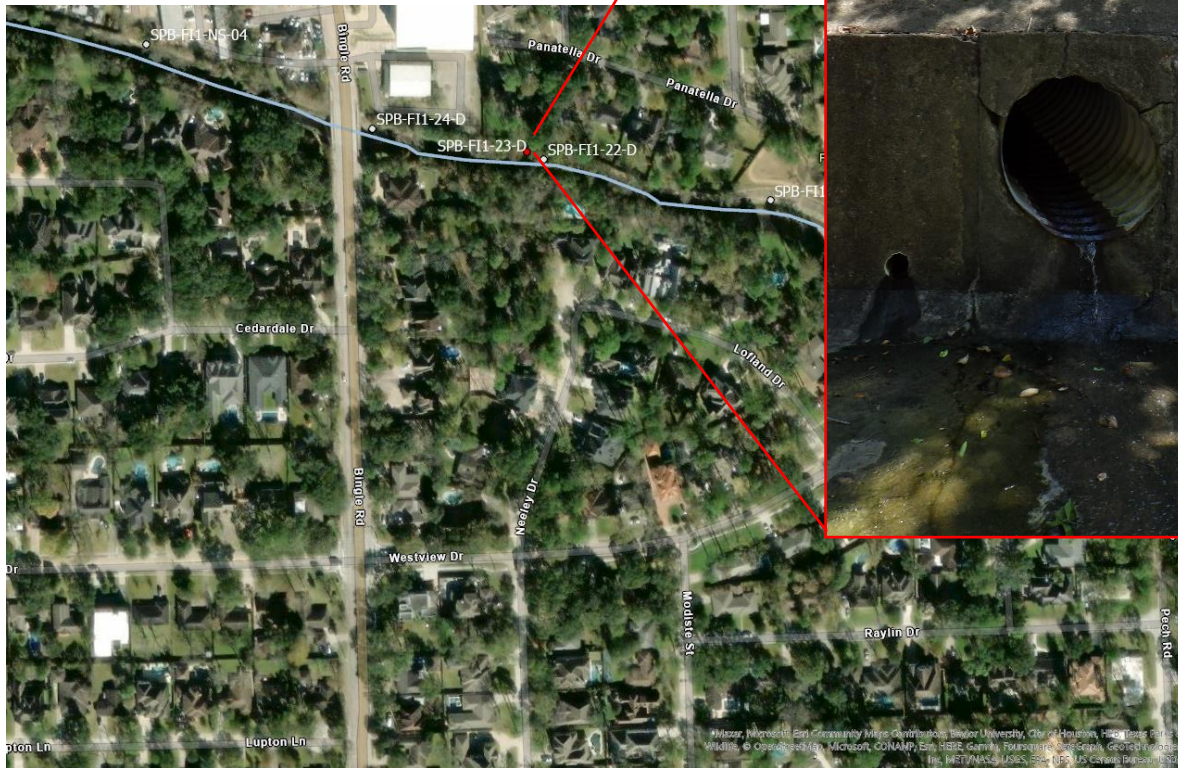
Referral site: SPB-FI1-23-D- High Priority

This is a 32 in. diameter metal pipe located on the right bank of Spring Branch. Water within the pipe was 0.5 in. deep. While the pipe was not flowing initially, water started flowing out of the pipe while the team was present and it smelled of effluent. There are single-family homes in the area and commercial businesses on the left bank. A sample was taken 1.8 m downstream of the pipe and it had a bacteria value of 1,340 MPN/100 mL. The ambient sample collected upstream of the pipe had a bacteria value of 100 MPN/100 mL. This pipe is a high priority referral site for the proper local authority.

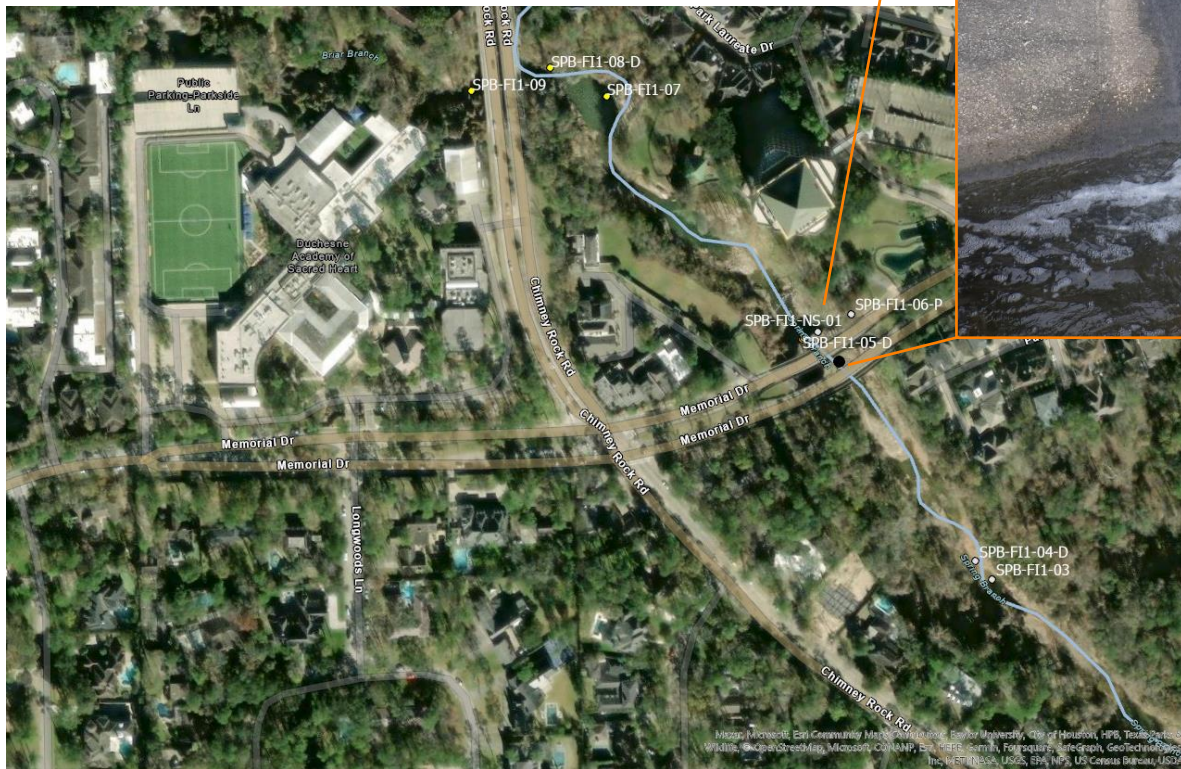
Referral site: SPB-FI1-05-D- Low Priority

This is a 48 in. diameter metal pipe located on the right bank of Spring Branch where a small waterfall mixes with the outflow of the pipe. Water within the pipe was 0.5 in. deep. There are single family homes in the area and a high school on the right bank. A sample 1.5 m downstream of the pipe had a bacteria value of 740 MPN/100 mL. The ambient sample collected upstream of the pipe had a bacteria value of 410 MPN/100 mL. This pipe is a low priority referral site for the proper local authority.

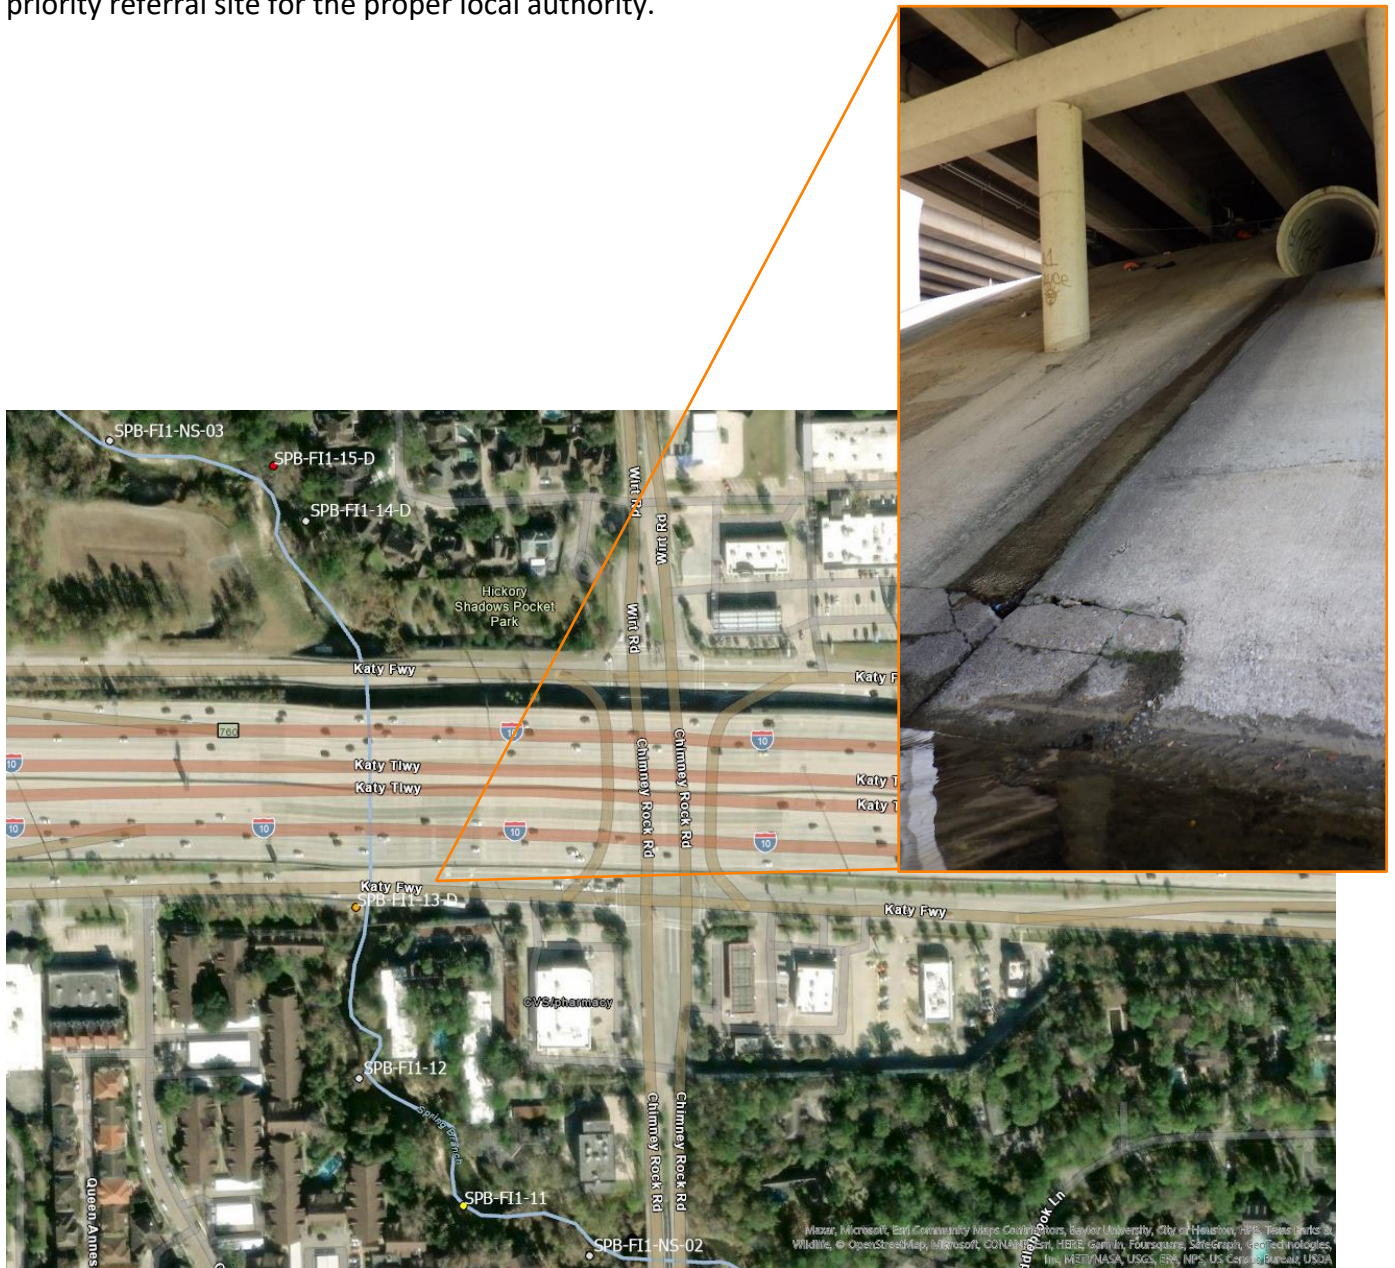
Referral site: SPB-FI1-13-D- Low Priority

This is a ~72 in. diameter concrete pipe located on the left bank of Spring Branch. Water within the pipe was estimated to be 0.125 in. The pipe is parallel with Interstate 10 and there are commercial businesses, condos, and single-family homes in the area. Outflow from the pipe runs down ~15 m of concrete into cracks before entering the stream. A sample taken downstream of the pipe had a bacteria value of 1,340 MPN/100 mL. The ambient sample collected upstream of the pipe had a bacteria value of 740 MPN/100 mL. This pipe is a low priority referral site for the proper local authority.

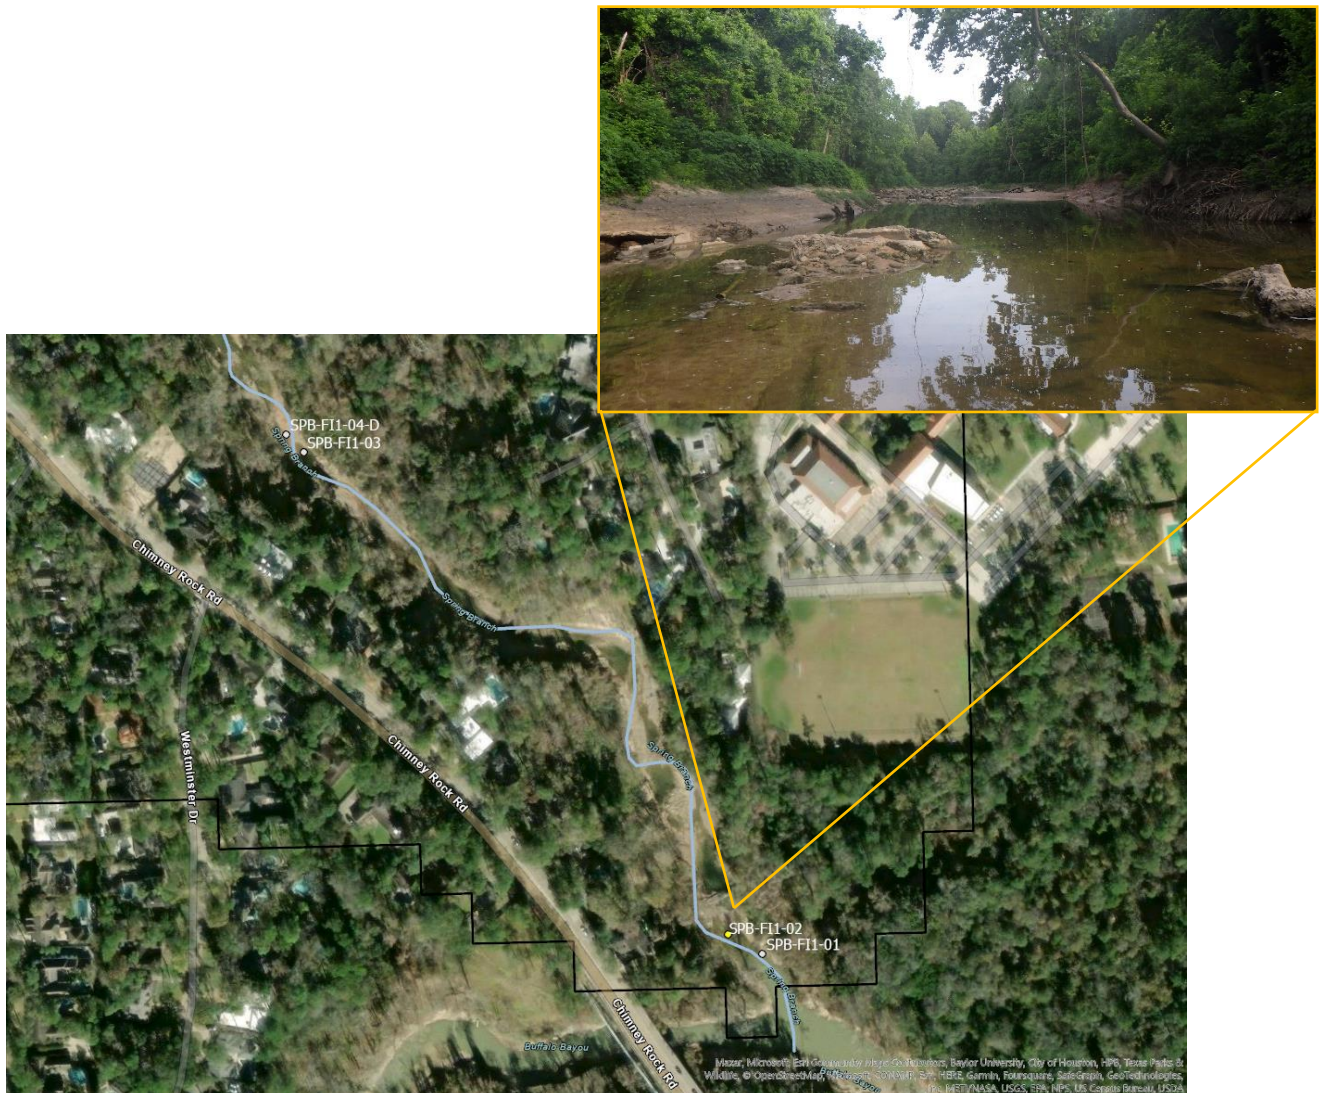
Referral site: SPB-FI1-02– Investigate Further

This was an ambient sample taken upstream of the estimated mixing zone of the confluence of Spring Branch and Buffalo Bayou. The ambient sample had a bacteria value of 980 MPN/100 mL while another ambient sample taken ~400 m further upstream had a bacteria value of 410 MPN/100 mL. Further investigation is recommended by the proper local authority to determine the source of elevated bacteria in this section of the segment. There are single-family homes and a seminary in the area.

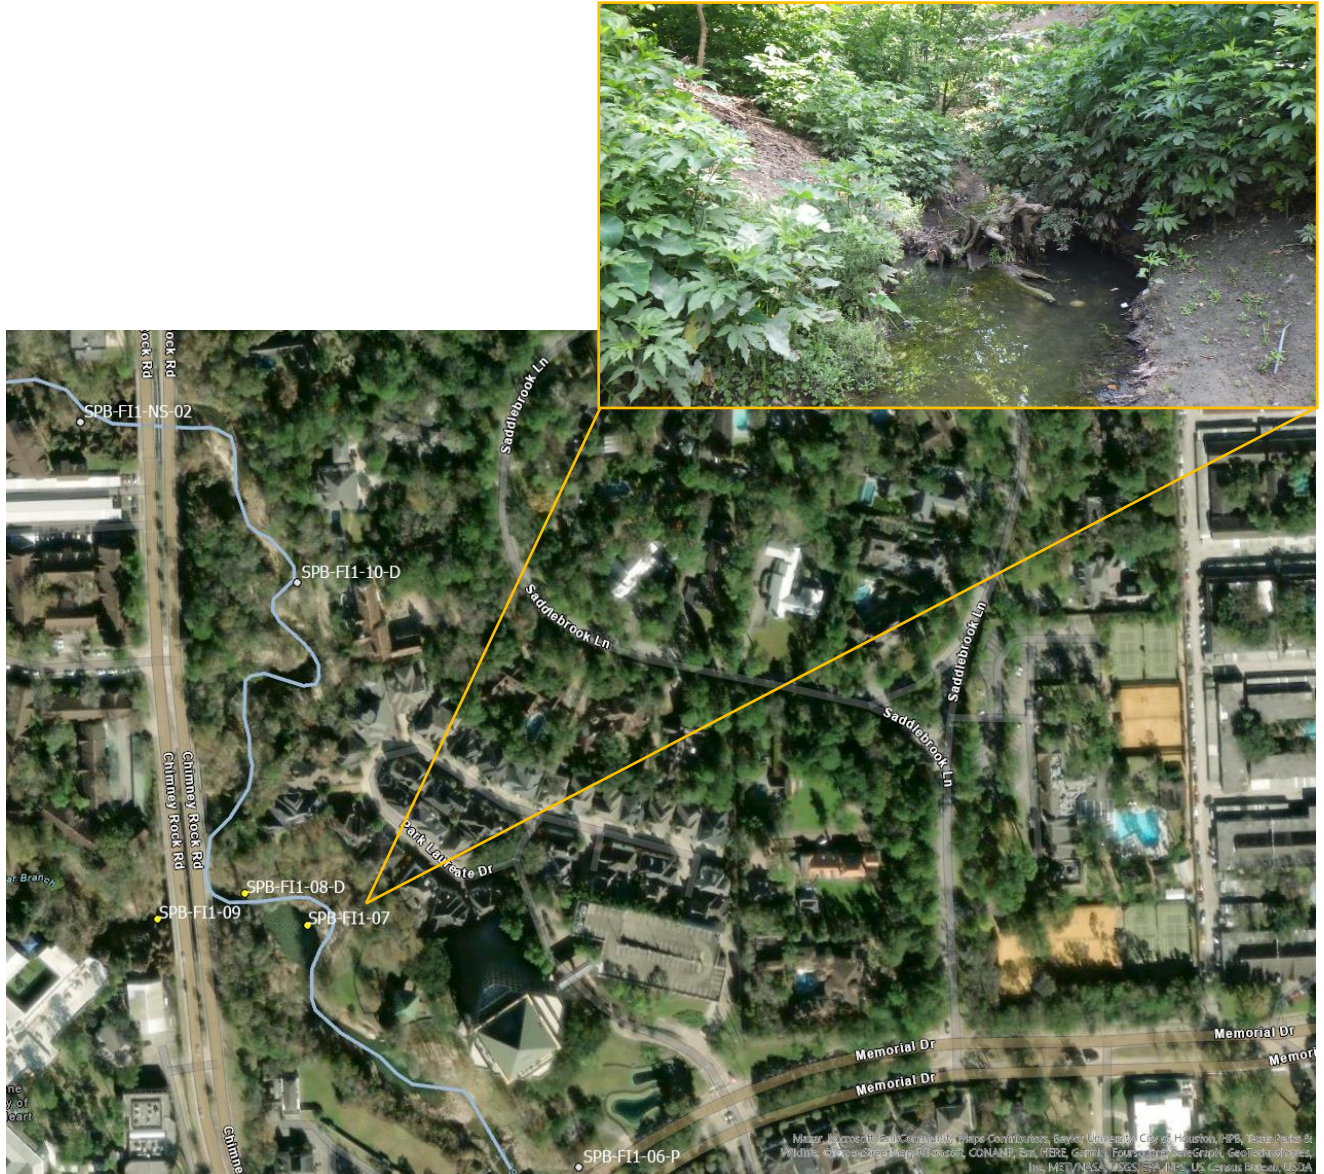
Referral site: SPB-FI1-07- Investigate Further

This was an ambient sample taken from a tributary to Spring Branch on the left bank. The ambient sample had a bacteria value of 1,460 MPN/100 mL. Further investigation is recommended by the proper local authority to determine the source of elevated bacteria in this tributary. There are single-family homes and commercial buildings in the area.

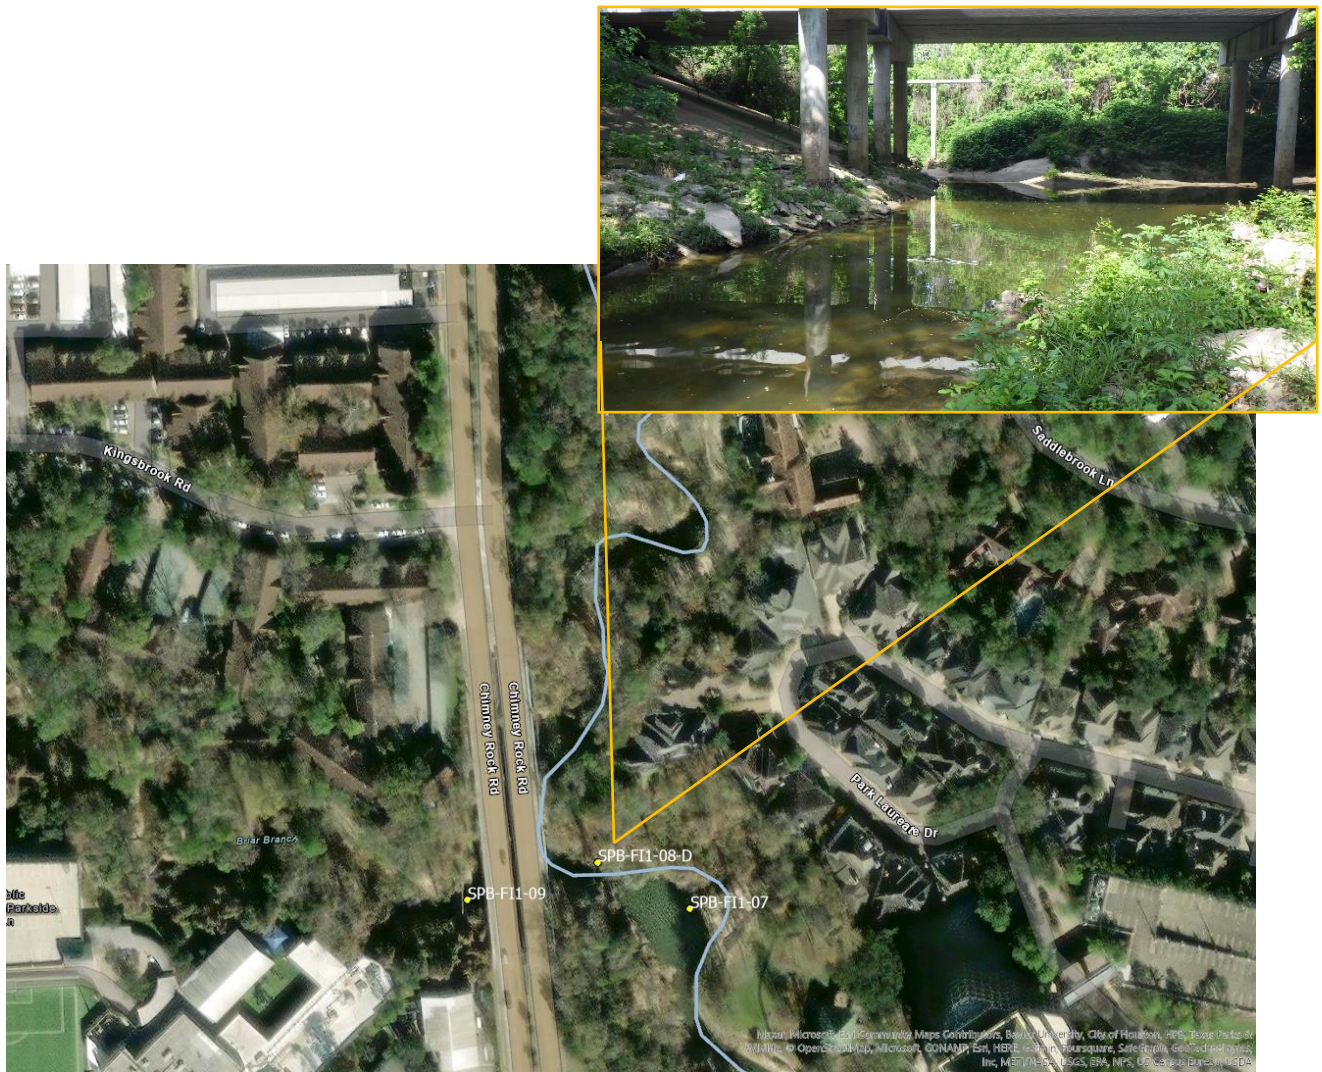
Referral site: SPB-FI1-08-D- Investigate Further

This is a 24 in. metal pipe that was dripping on the left bank of Spring Branch. This sample had a bacteria value of <100 MPN/100 mL but the upstream sample had a bacteria value of 8,390 MPN/100 mL. Bats are present under the bridge upstream of where samples were taken, and a beaver was observed in the water at the site. The next sample taken upstream of this site was SPB-IF1-10D where the upstream sample was 860 MPN/100 mL. There are single-family homes in the area and a high school on the right bank. Further investigation is recommended by the proper local authority to determine the source of elevated bacteria in this section of the segment.

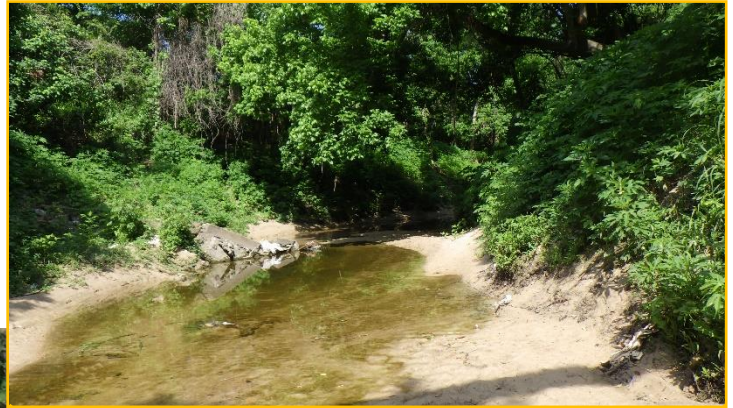
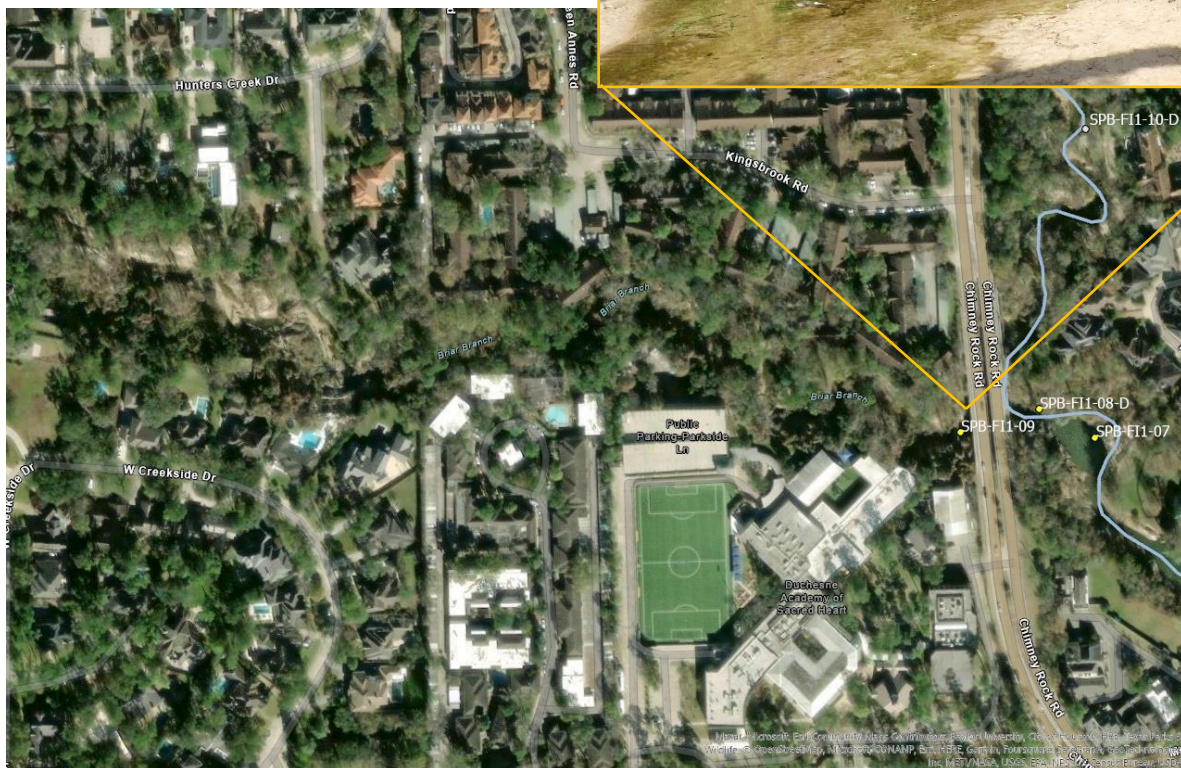
Referral site: SPB-FI1-09– Investigate Further

This was an ambient sample taken from a tributary (Briar Branch) on the right bank of Spring Branch upstream of the Chimney Rock Bridge. This sample had a bacteria value of 630 MPN/100 mL. A FI or further investigation of this tributary is recommended. There are single-family homes in the area and a high school on the right bank of this tributary.

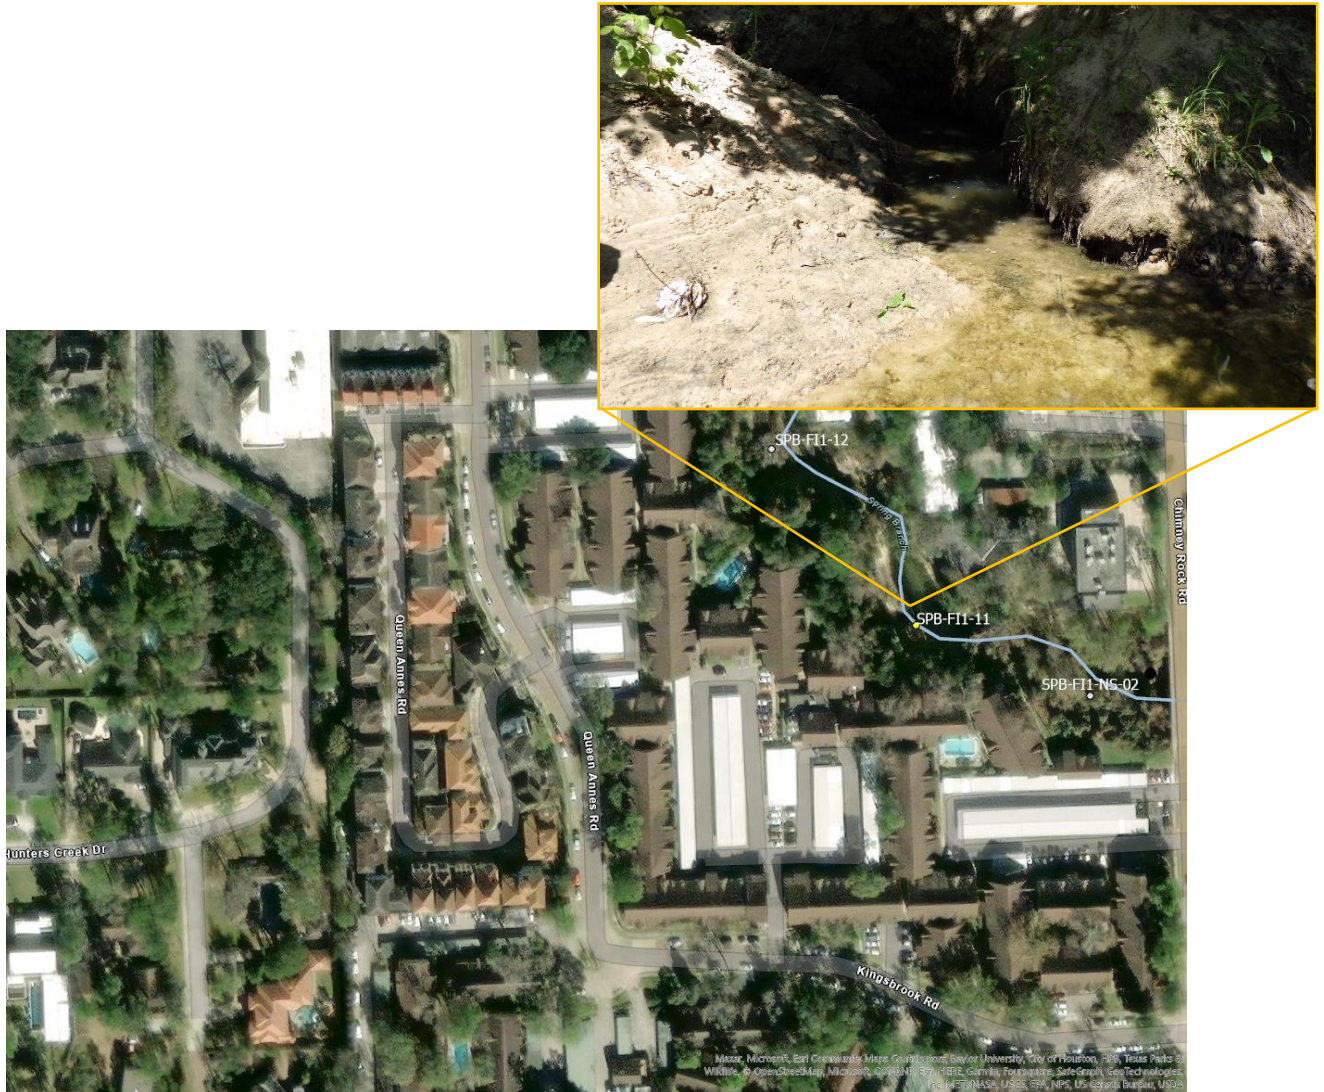
Referral site: SPB-FI1-11- Investigate Further

This was an ambient sample taken from a small tributary that is located the right bank of Spring Branch. This sample had a bacteria value of 410 MPN/100 mL. Further investigation is recommended by the proper local authority to determine the source of elevated bacteria in this tributary. There are apartments on the right bank where it looks like this tributary originates.

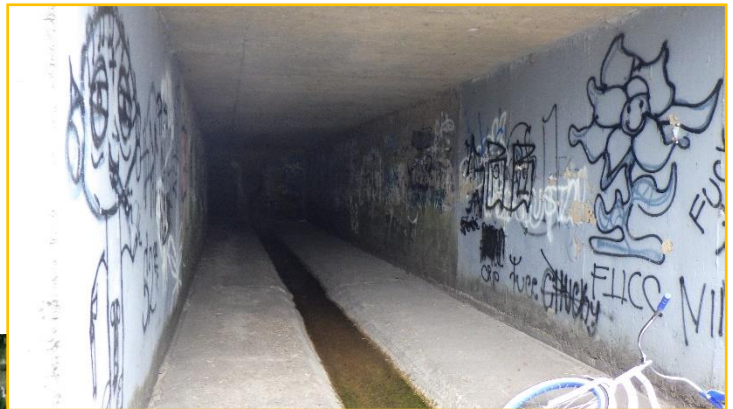
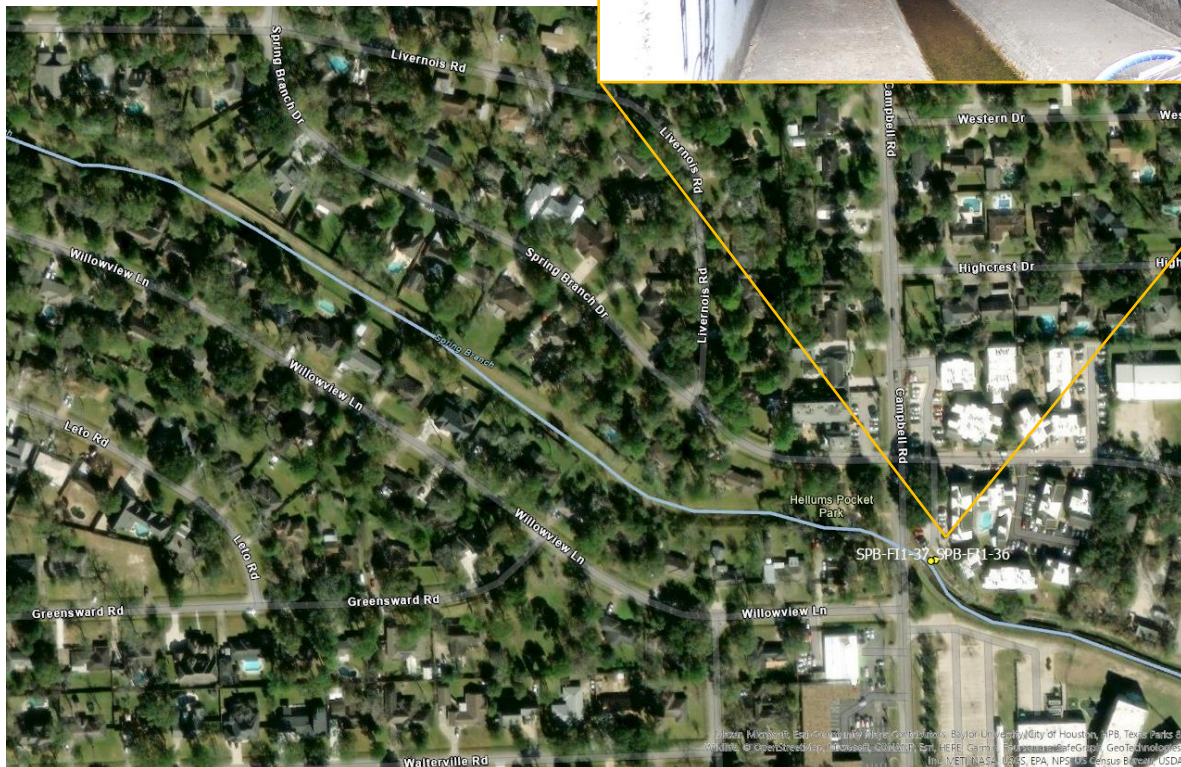
Referral site: SPB-FI1-36- Investigate Further

This was an ambient sample taken from the opening of the left bank pipe at the top of the segment that had a bacteria value of 410 MPN/100 mL. The segment goes underground after this point and flow could be heard entering the somewhere further upstream. Further investigation is recommended by the proper local authority to determine the source of elevated bacteria underground and upstream of the segment. There are apartments in the area and a park is located upstream on the right bank.

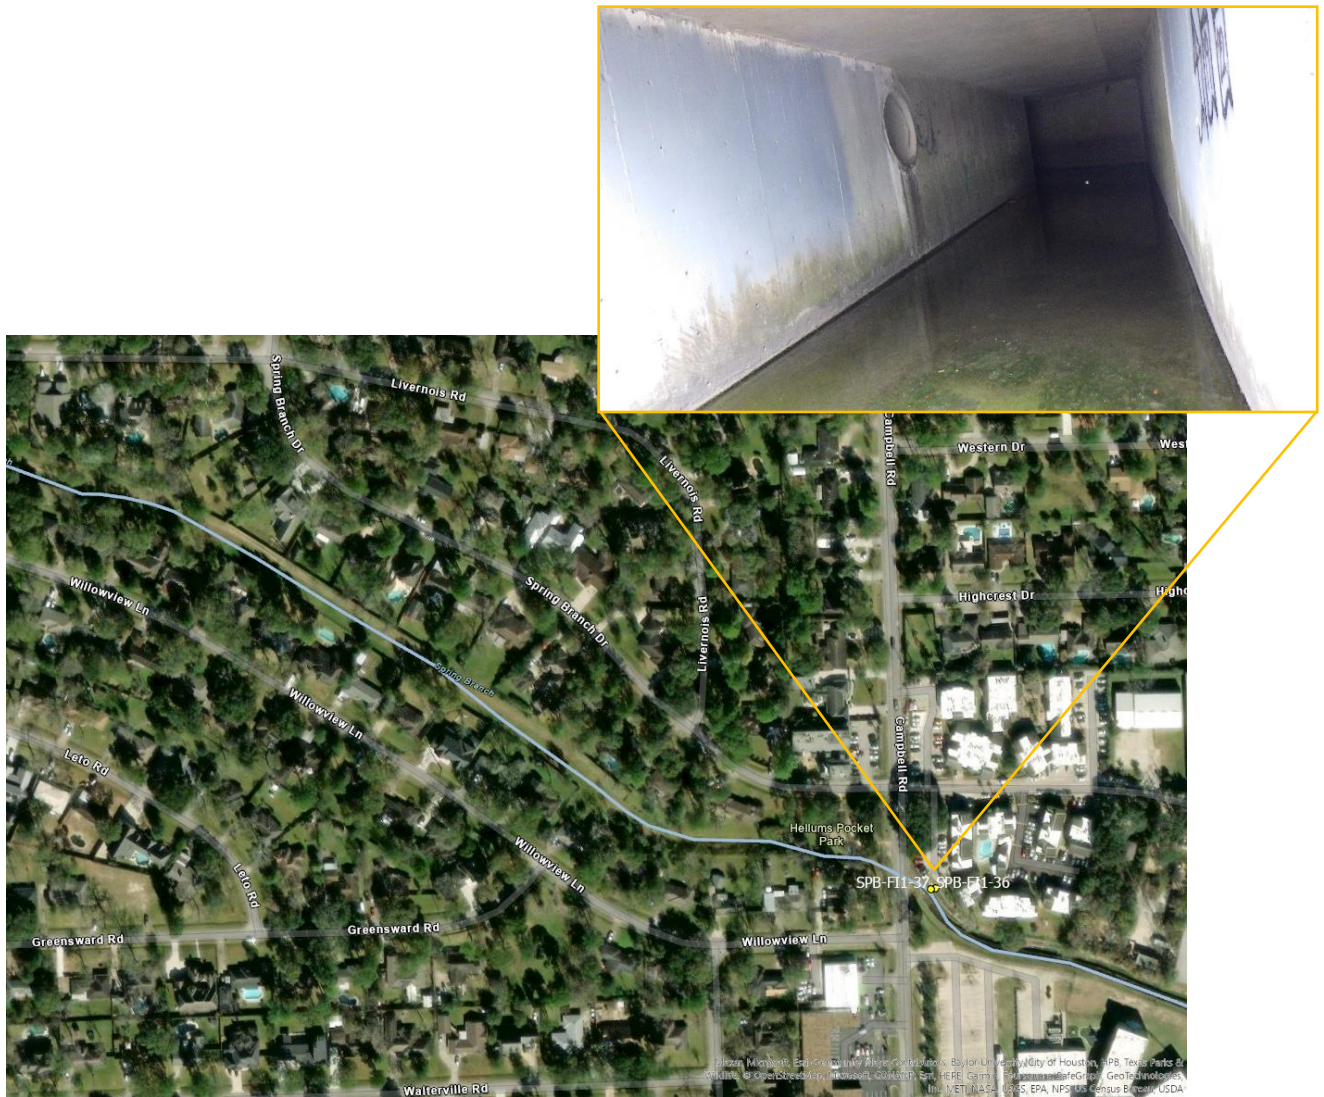
Referral site: SPB-FI1-37- Investigate Further

This was an ambient sample taken from the opening of the right bank pipe at the top of the segment that had a bacteria value of 750 MPN/100 mL. The segment goes underground after this point. Further investigation is recommended by the proper local authority to determine the source of elevated bacteria underground and upstream of the segment. There are apartments in the area and a park is located upstream on the right bank.

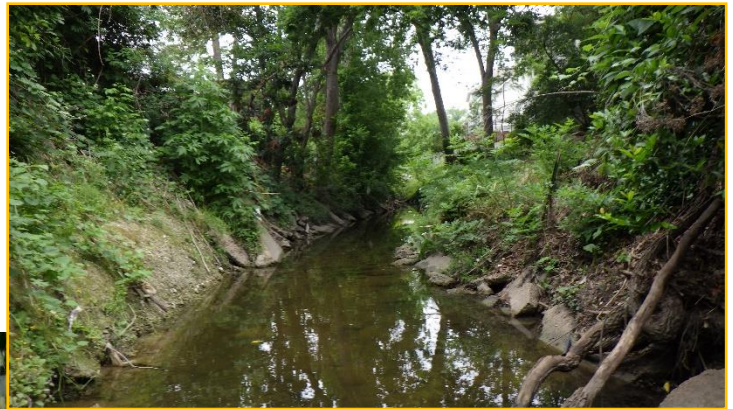
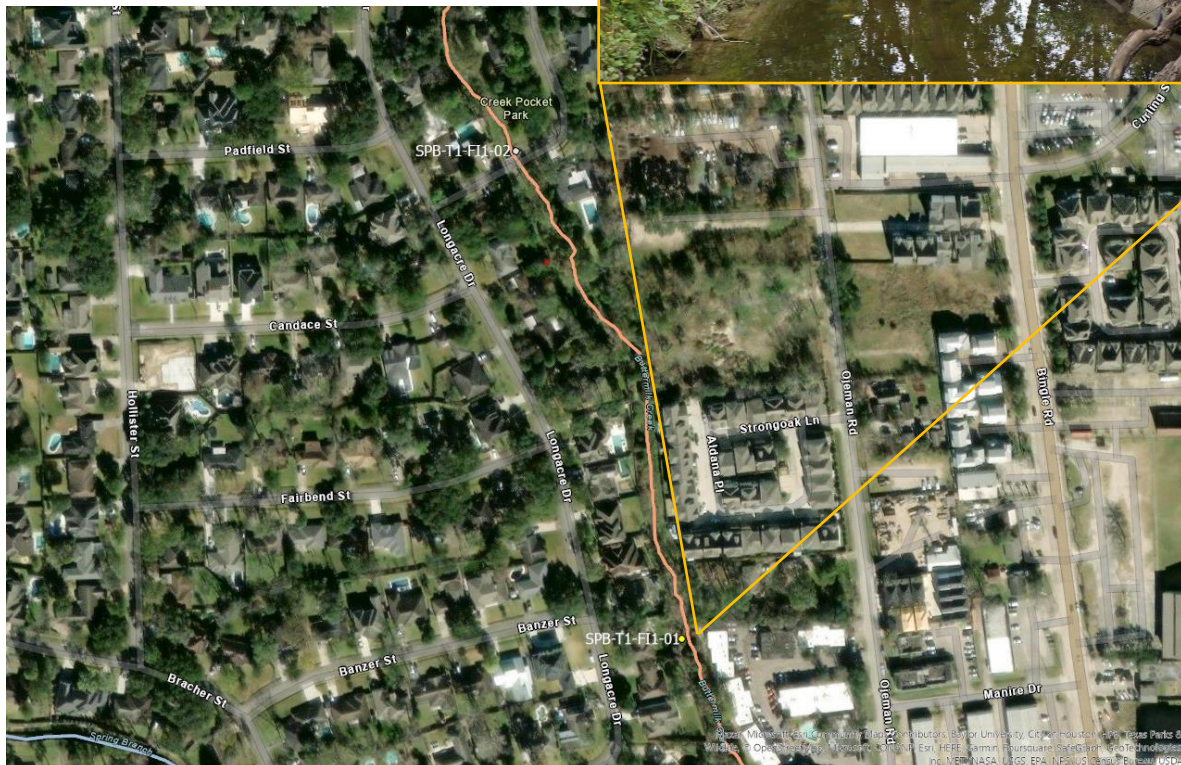
Referral site: SPB-T1-FI1-01- Investigate Further

This was an ambient sample taken from a tributary of Spring Branch that had a bacteria value of 34,500 MPN/100 mL. Another ambient sample taken ~300 m further upstream in the tributary and had a bacteria value of 310 MPN/100 mL. No evidence of flow entering the stream was observed between the two samples. Further investigation is recommended by the proper local authority to determine the source of elevated bacteria in this section of the tributary. There are apartments and single-family homes located in the area.

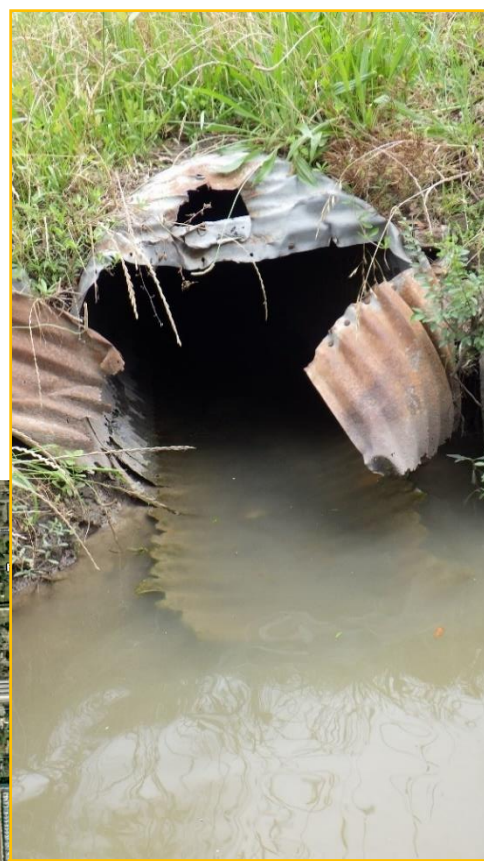
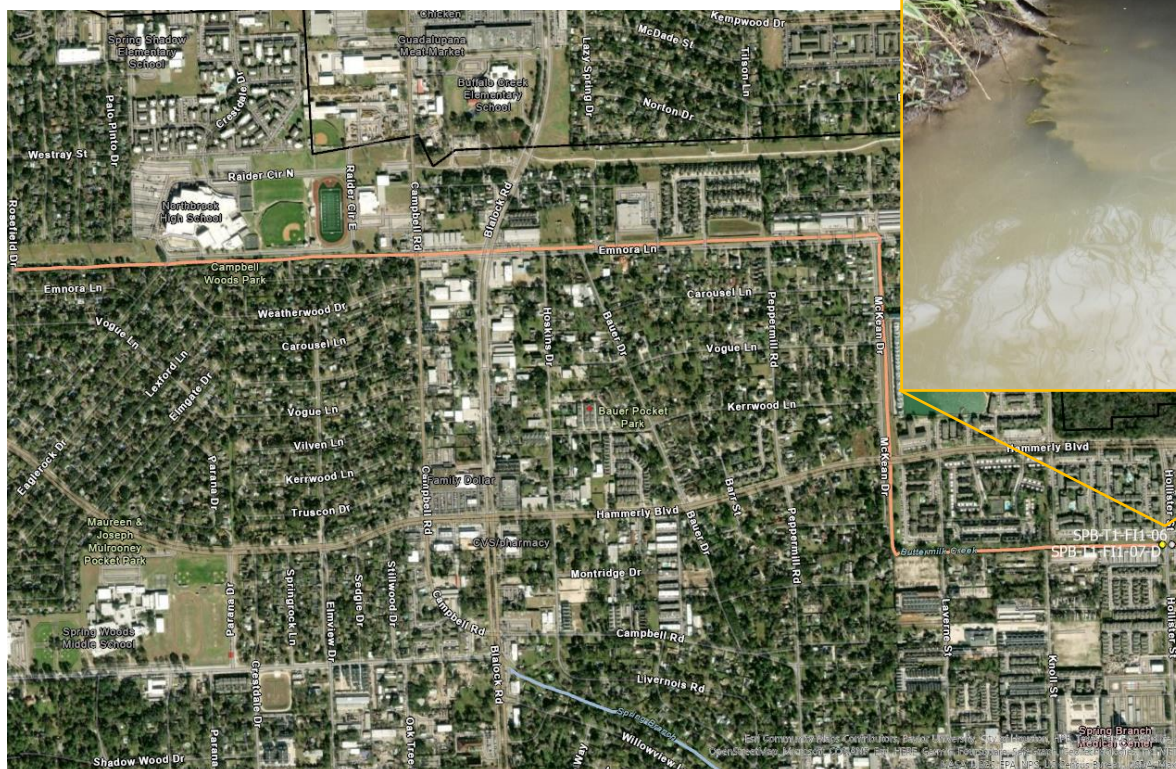
Referral site: SPB-T1-FI1-07- Investigate Further

This is a 36 in. diameter rusted out metal pipe located on the left bank of the tributary of Spring Branch. Water within the submerged pipe was 5 in. deep and the team was unable to determine if it was flowing into the tributary. There are apartments and commercial buildings located in the area. A sample taken at the mouth of the submerged pipe had a bacteria value of 520 MPN/100 mL. The sample collected upstream of the pipe had a bacteria value of 860 MPN/100 mL. A sample from this location during the WS resulted in a bacteria value of < 100 MPN/100 mL and therefore the FI ended at this site. Due to the higher bacteria levels during the FI, further investigation is recommended by the proper local authority to determine the source of elevated bacteria upstream in the tributary.
