**Central and Southeast Texas Recreational Use-Attainability Analyses Project
Bullhead Bayou (Segment 1245C) and Unnamed Tributary of Bullhead Bayou (Segment 1245D)
Basic RUAA**

Results Report

Contract No. 582-9-90440
EIH Technical Report # 10-004

Prepared by:
George Guillen & Jenny Wrast
University of Houston-Clear Lake

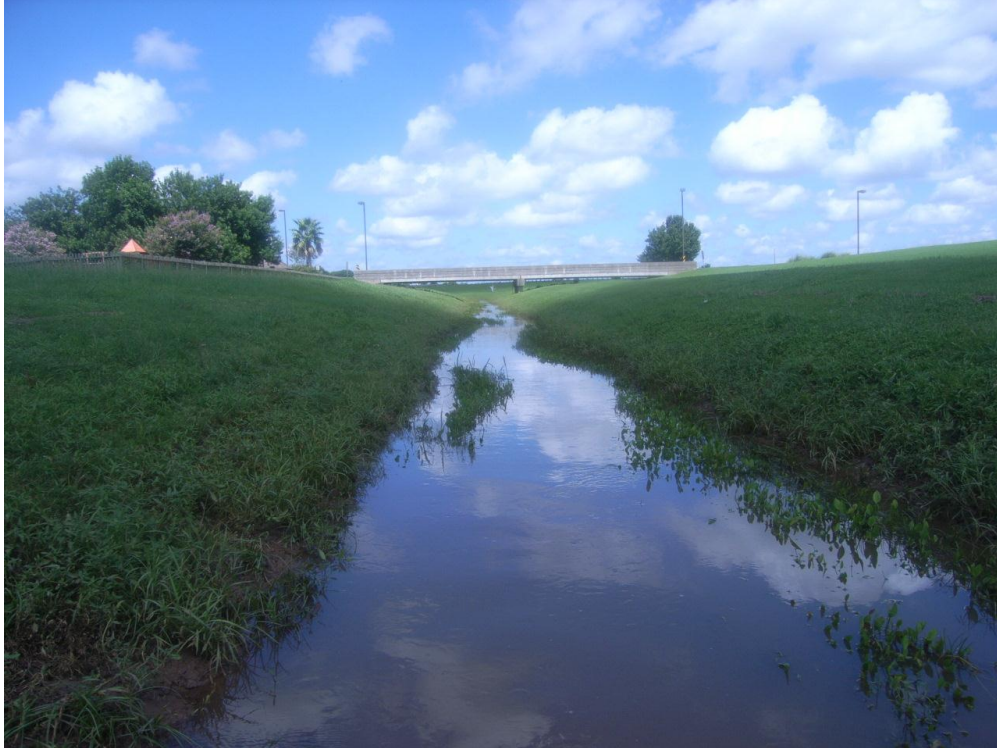
Figure 3. Picture of field survey site 3, showing the general representation of the physical conditions seen on Bullhead Bayou, Segment 1245C.

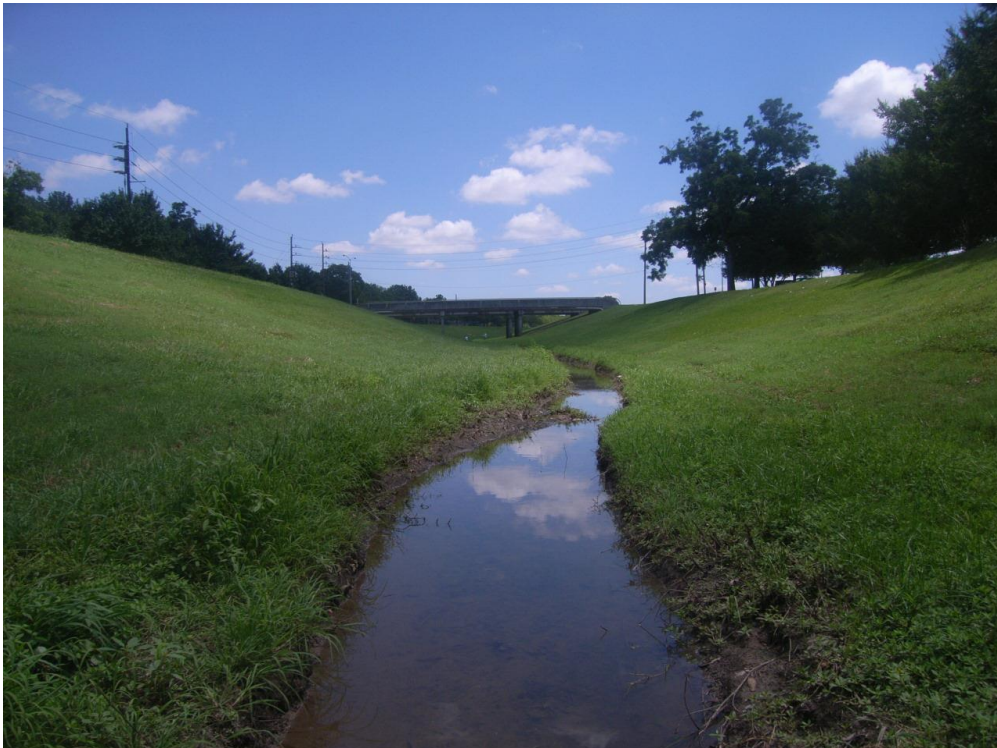
Figure 4. Picture of field survey site 3, showing the general representation of the physical conditions seen on the Unnamed Tributary of Bullhead Bayou, Segment 1245D.
