**Central and Southeast Texas Recreational Use-Attainability Analyses Project  
Cedar Creek (Segment 1209G) Basic RUAA**

**Results Report**

Contract No. 582-9-90440  
EIH Technical Report # 10-007

Prepared by:  
George Guillen & Jenny Wrast  
University of Houston-Clear Lake

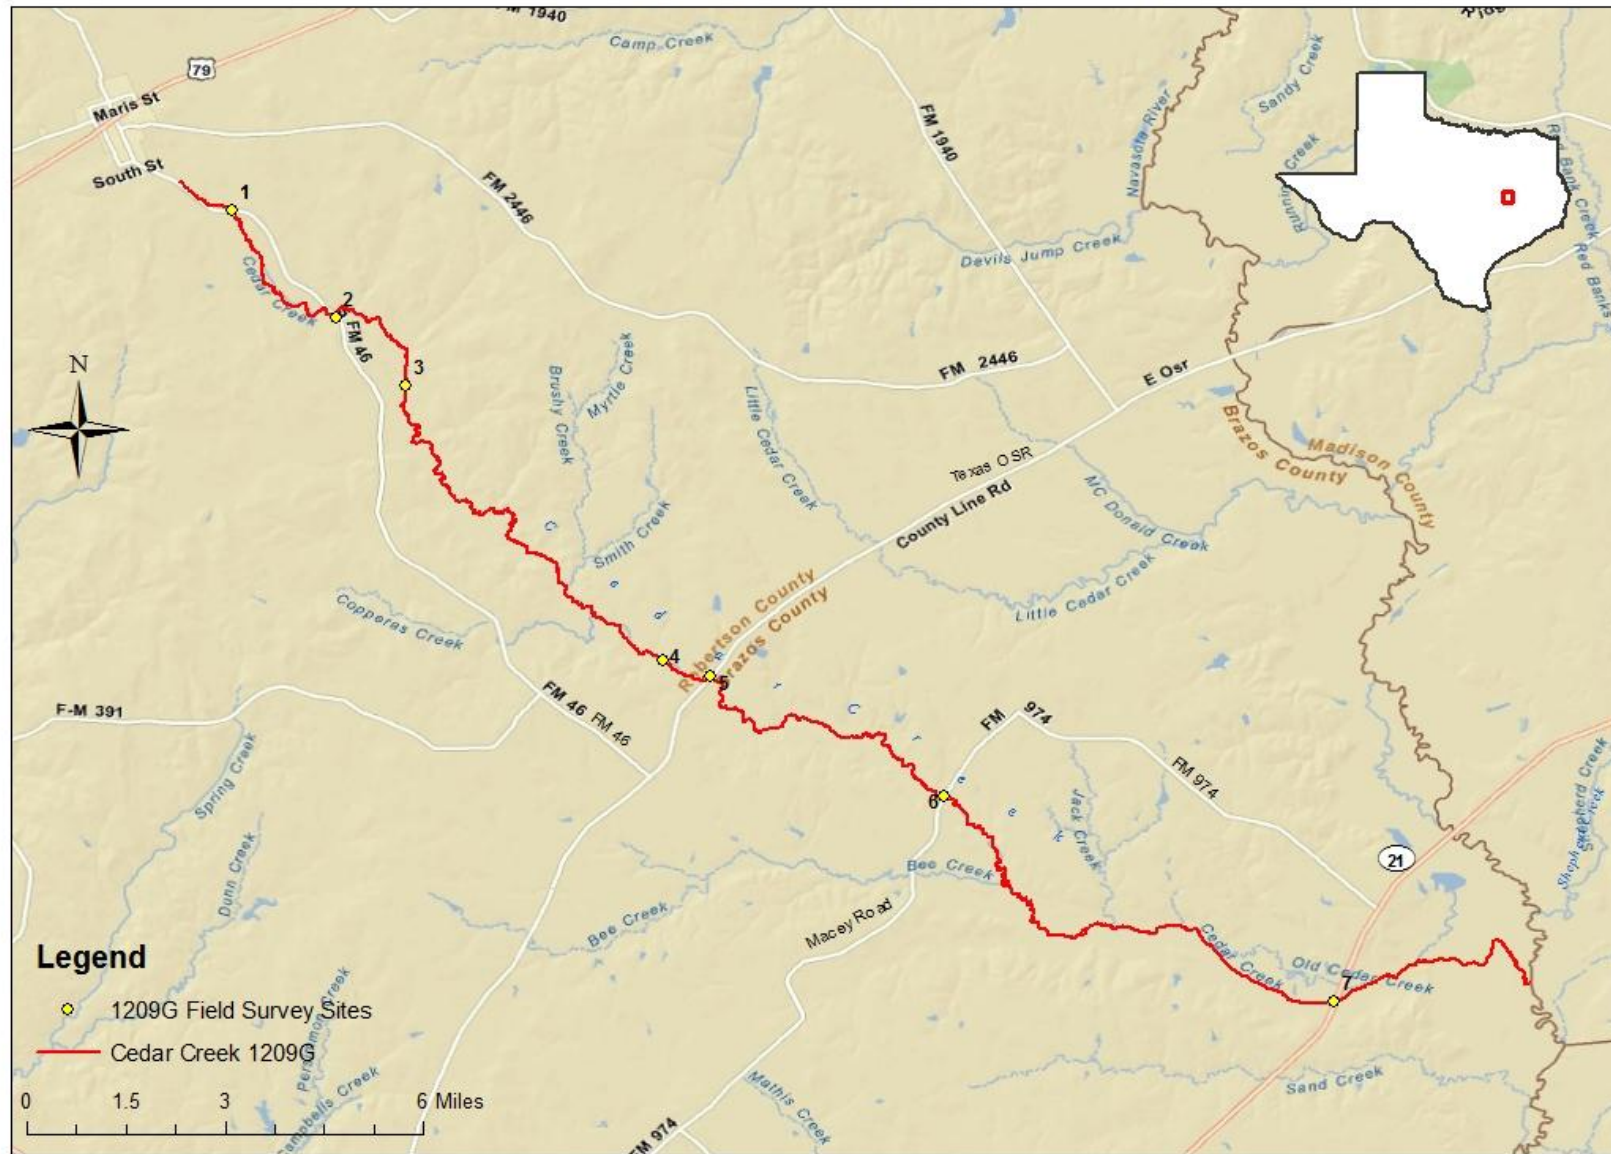
**Figure 1.** Basic RUAA survey sites on Cedar Creek, Segment 1209G, selections based on river mile/assessment units, accessibility, and recreational features.

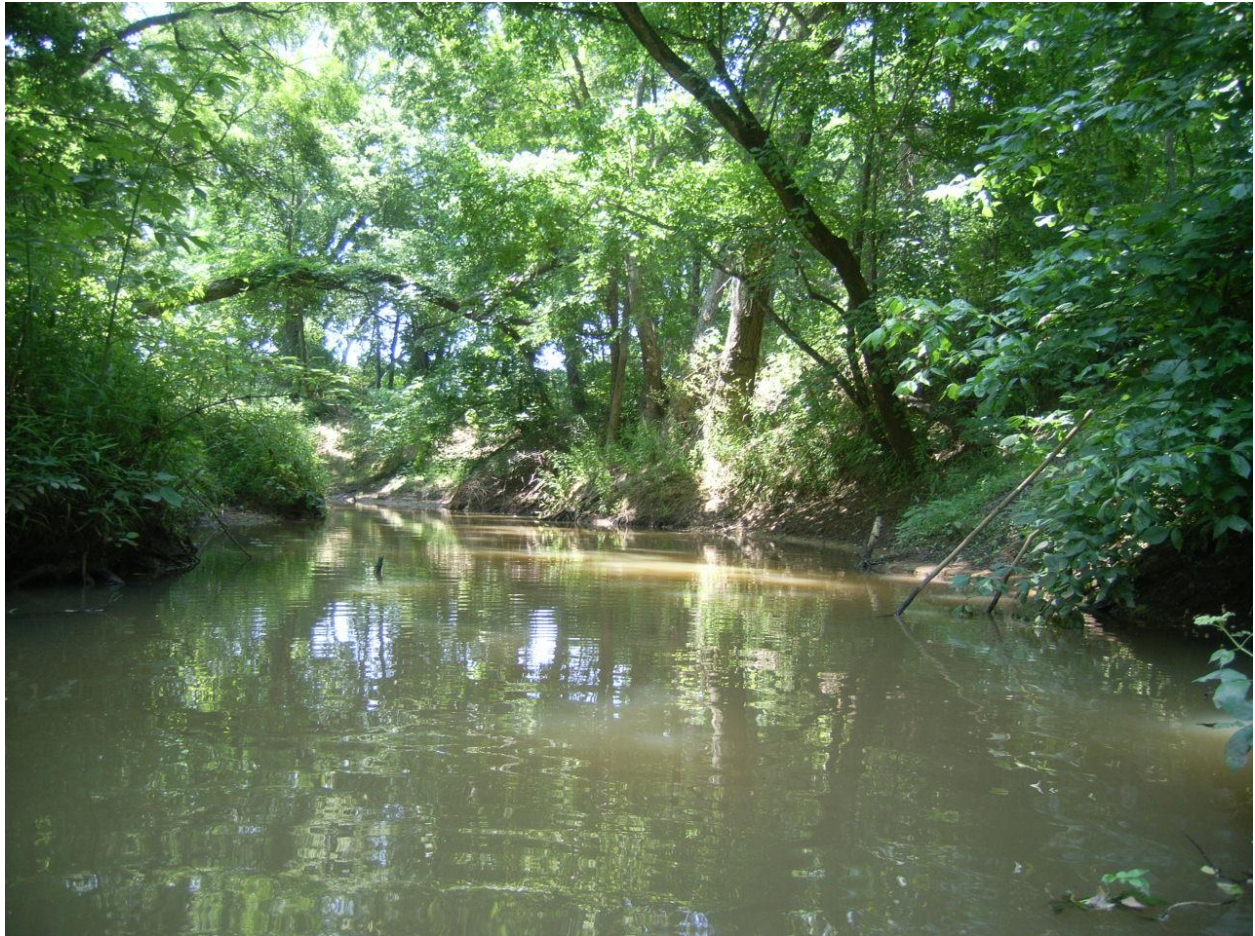
Every effort was made to obtain supplementary recreational use information about the entire length of the segment, including areas other than the selected sites in this Basic RUAA. Topographic maps and aerial imagery were used to provide the needed geographic information about potential recreational opportunities, potential access points, and access obstacles along the Cedar Creek. Review of these resources resulted in reconnaissance site selection. The subsequent reconnaissance site visits confirmed the limited public access along the Cedar Creek. Fences, gates, and no trespassing signage are common public access limitations on the segment and resulted in less than three (3) sites for every five (5) miles of stream. Figure 2 photograph was taken at field survey site 5 and is a good representation of the general site conditions found along Cedar Creek.

**Figure 2.** Picture of field survey site 5, showing the general representation of the physical conditions seen on Cedar Creek, Segment 1209G

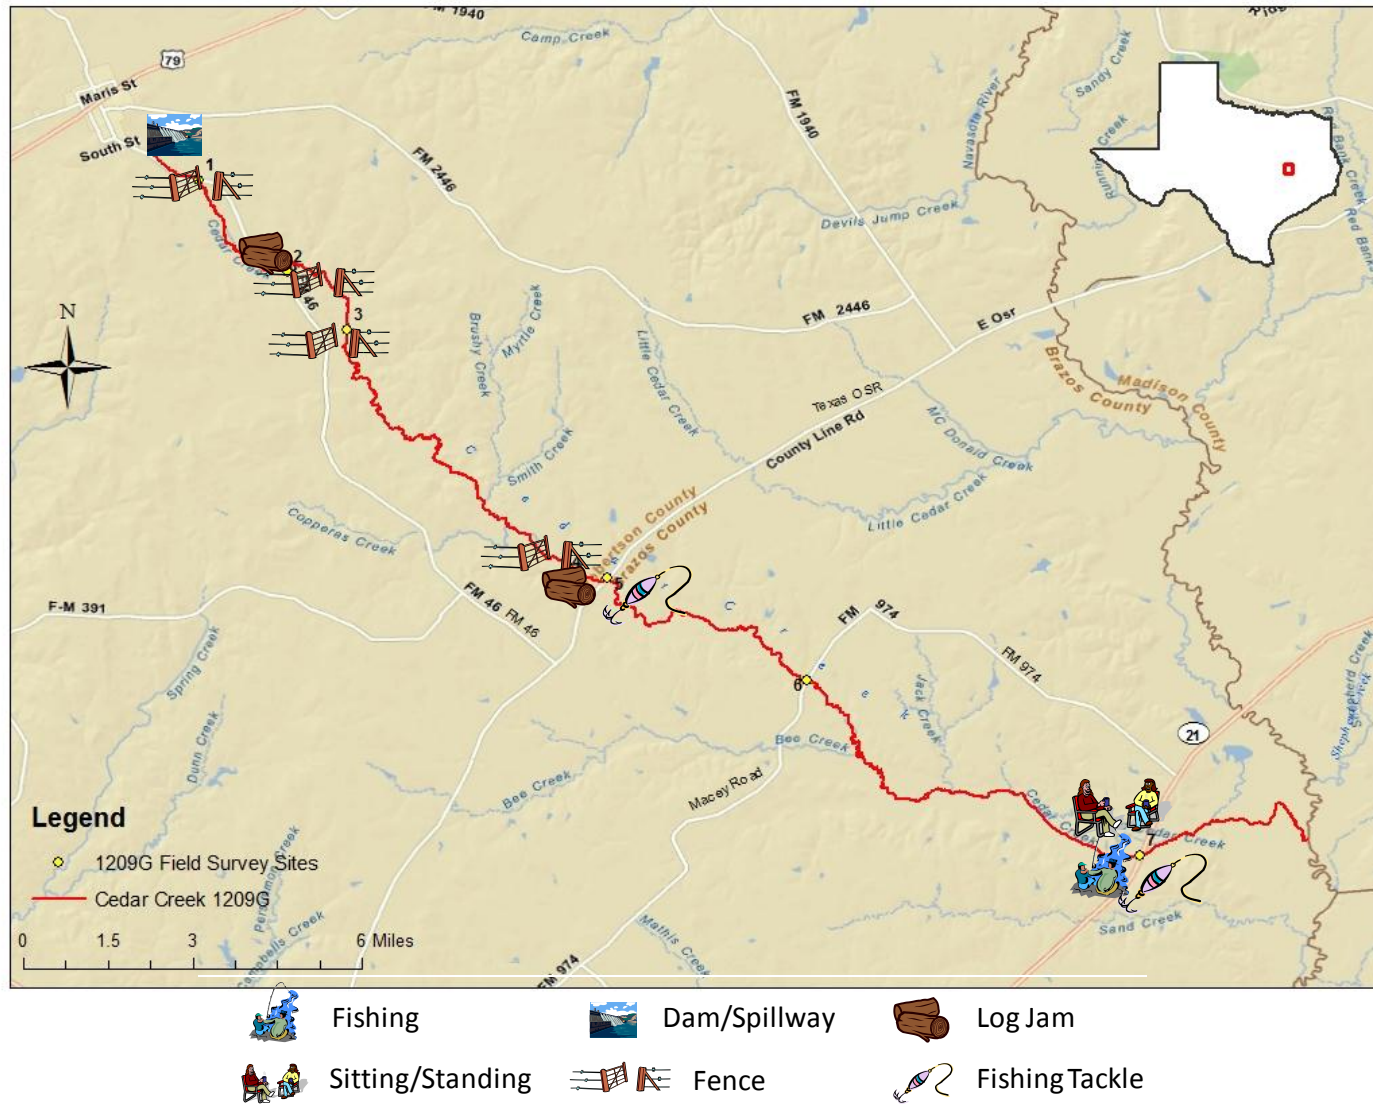
Uses observed during field survey site visits include: fishing, standing, and sitting (Table 5, Figure 3, & Appendix 5). These observed uses occurred at site number 7. Evidence of recreational use in the form of fishing tackle was documented twice at field survey sites 5 and 7. Field survey site 7 was the only site at which no impediments to recreation were observed. Channel obstructions, most commonly fences, log jams, and steep slopes, were documented impediments at the other six sites (Table 5, Figure 3, & Appendix 5).

**Figure 3.** Basic RUAA survey sites on Cedar Creek, Segment 1209G with depictions of observed recreational uses, evidence of recreational uses, and impediments. Locations are approximate. See Appendix 5: Google Earth Interactive Map for exact locations of uses, evidence, and impediments.
