**Central and Southeast Texas Recreational Use-Attainability Analyses Project
Steele Creek (Segment 1209K) Basic RUAA**

Results Report

Contract No. 582-9-90440
EIH Technical Report # 10-012

Prepared by:
George Guillen & Jenny Wrast
University of Houston-Clear Lake

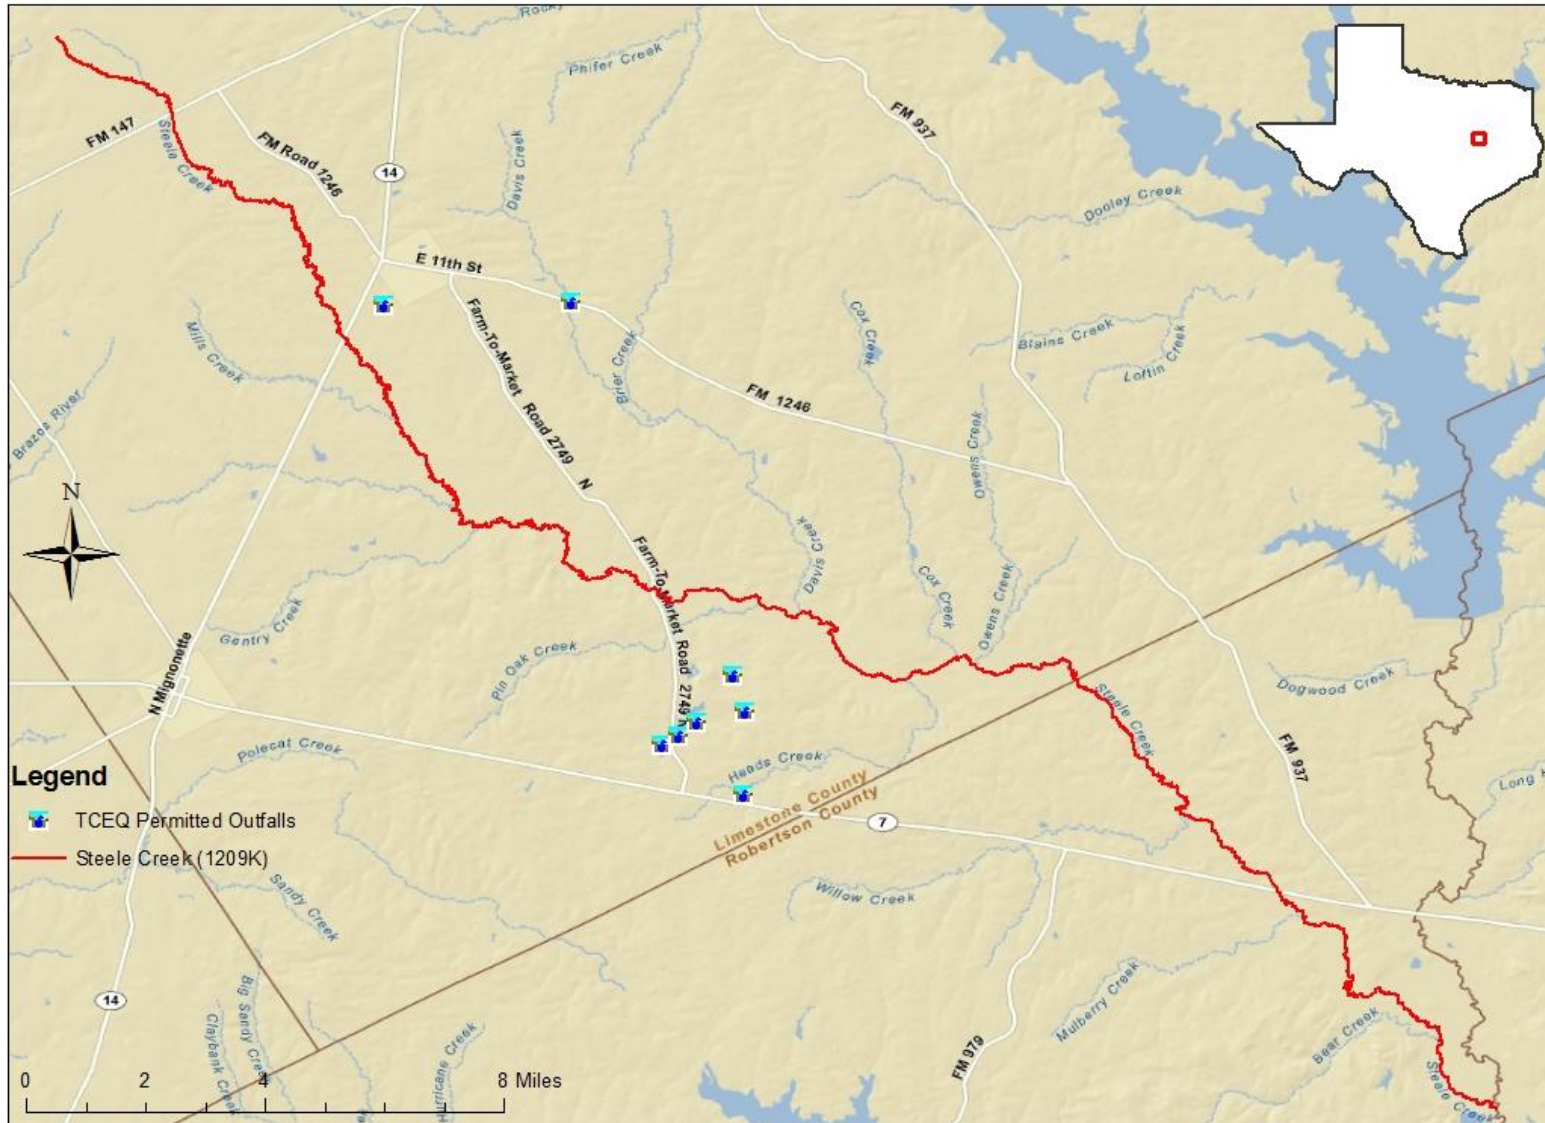
Figure 1. TCEQ permitted outfalls adjacent to Steele Creek, Segment 1209K.

Steele Creek is affected by storm water runoff from agricultural, industrial, and urban areas. Under TPDES, the TCEQ has issued eight permits to discharge treated wastewater to the Segment 1209K watershed (Figure 1). The permits are held by Oak Grove Mining Co., LLC (2), U.S. Silica Co. (5), and the City of Thornton (1).

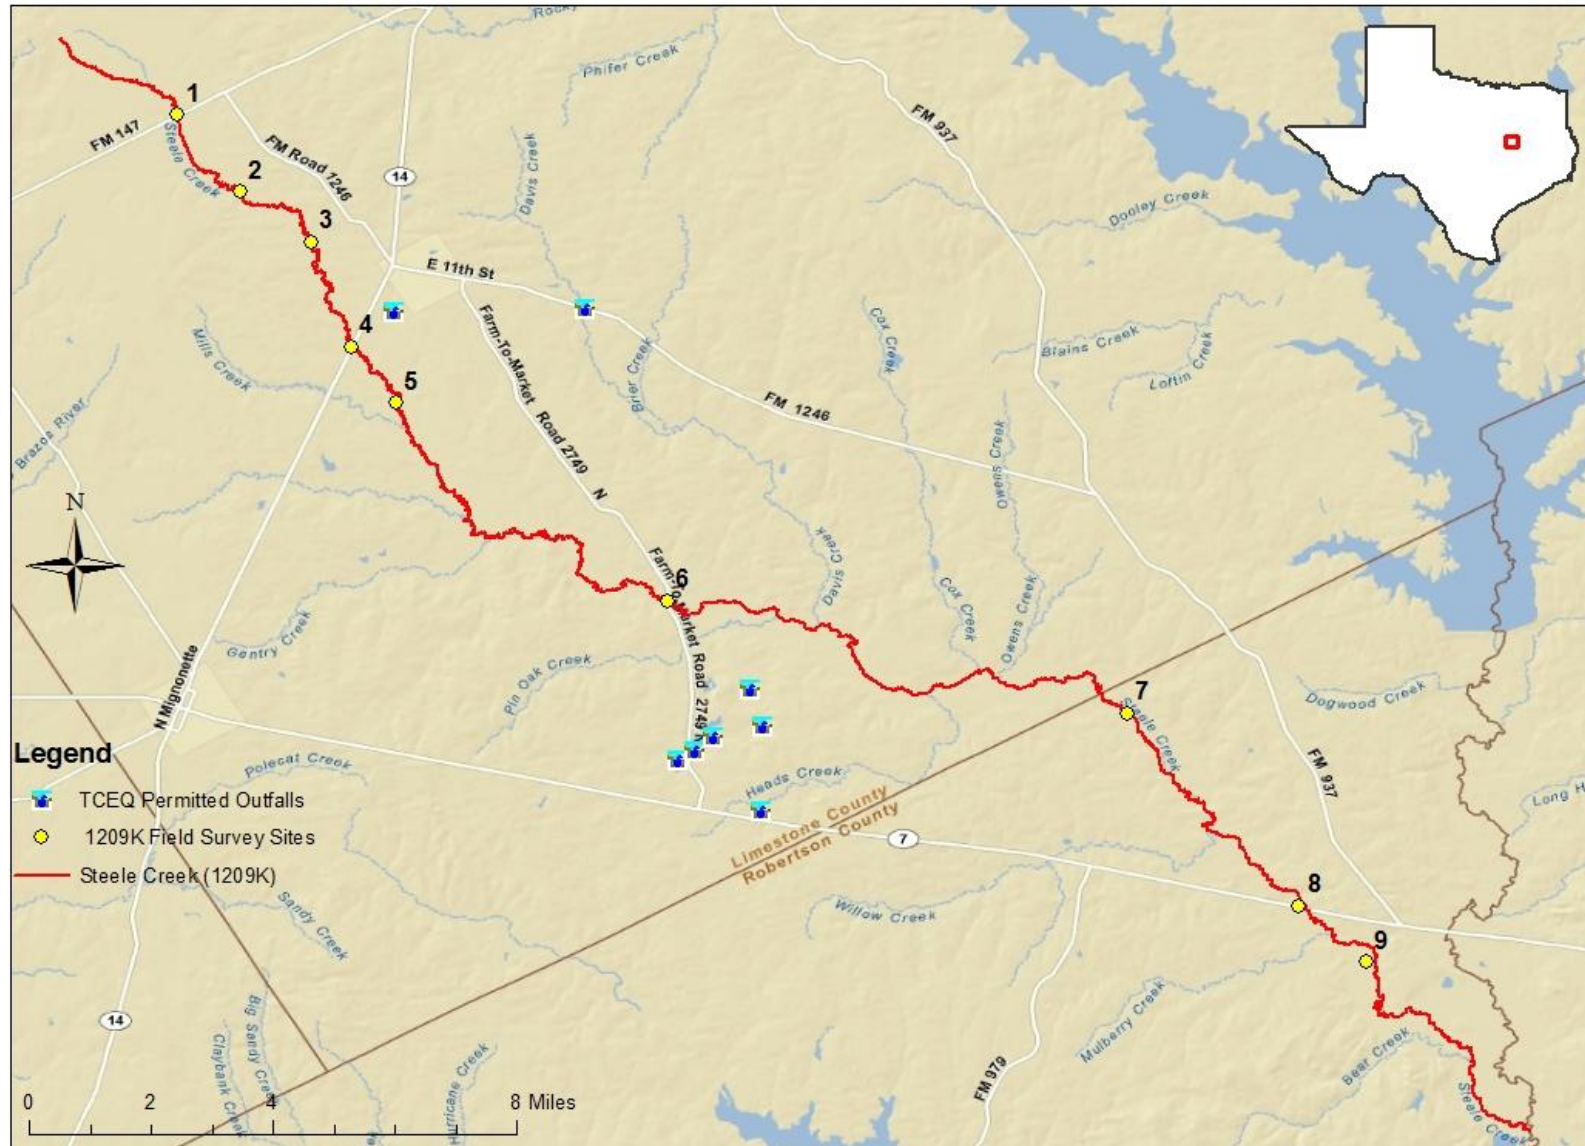
Figure 2. Basic RUAA survey sites on Steele Creek, Segment 1209K, selections based on river mile/assessment units, accessibility, and recreational features.

Table 2. Field survey sites for the Basic RUAA on Steele Creek, Segment 1209K (corresponding to Figure 2 and Table 1).

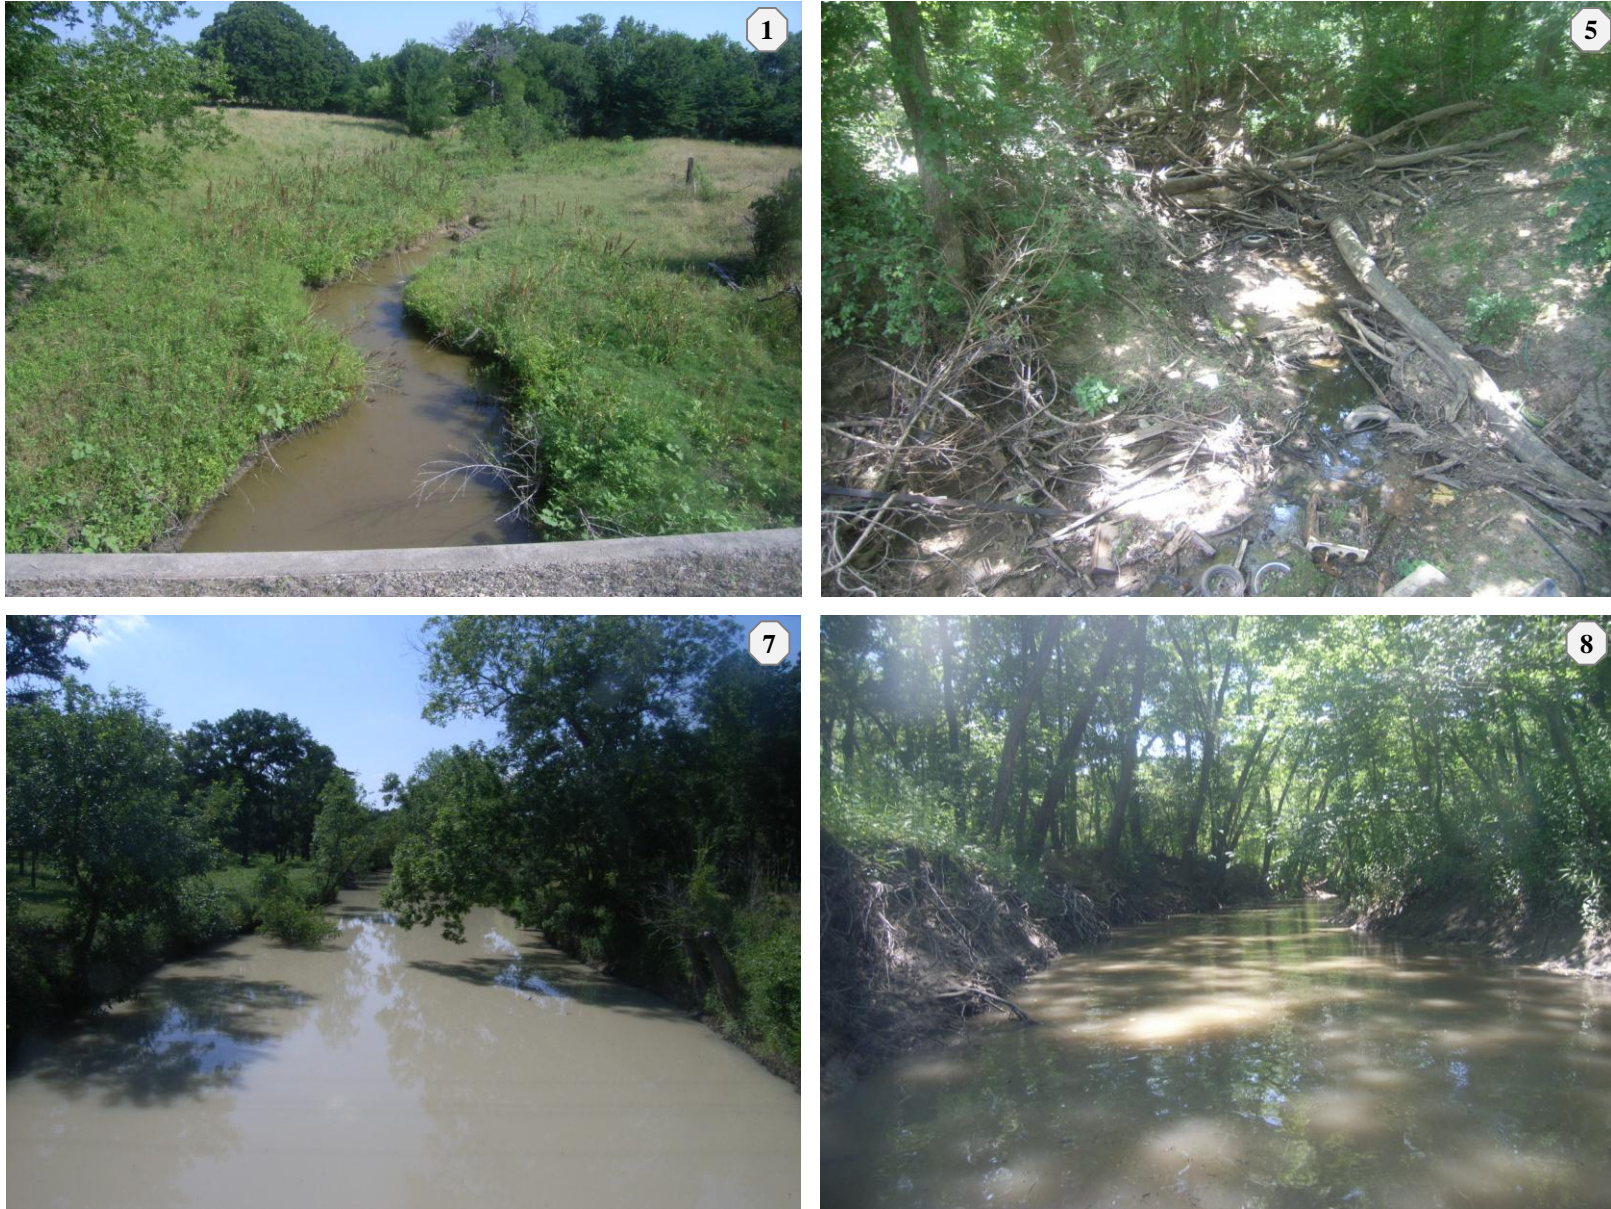
Figure 3. Pictures taken at field survey sites 1, 5, 7, and 8 that depict the various physical characteristics observed along Steele Creek, Segment 1209K.

Topographic maps and aerial imagery were used to provide the needed geographic information about potential recreational opportunities, potential access points, and potential access obstacles along the Steele Creek. Review of these resources resulted in reconnaissance site selection. The subsequent reconnaissance site visits confirmed the limited public access along the Steele Creek. Fences, gates, and no trespassing signage are common public access limitations on the segment and resulted in less than three (3) sites for every five (5) miles of stream. Figure 3 photographs were taken during the field survey depicting the various physical conditions observed along Steele Creek.

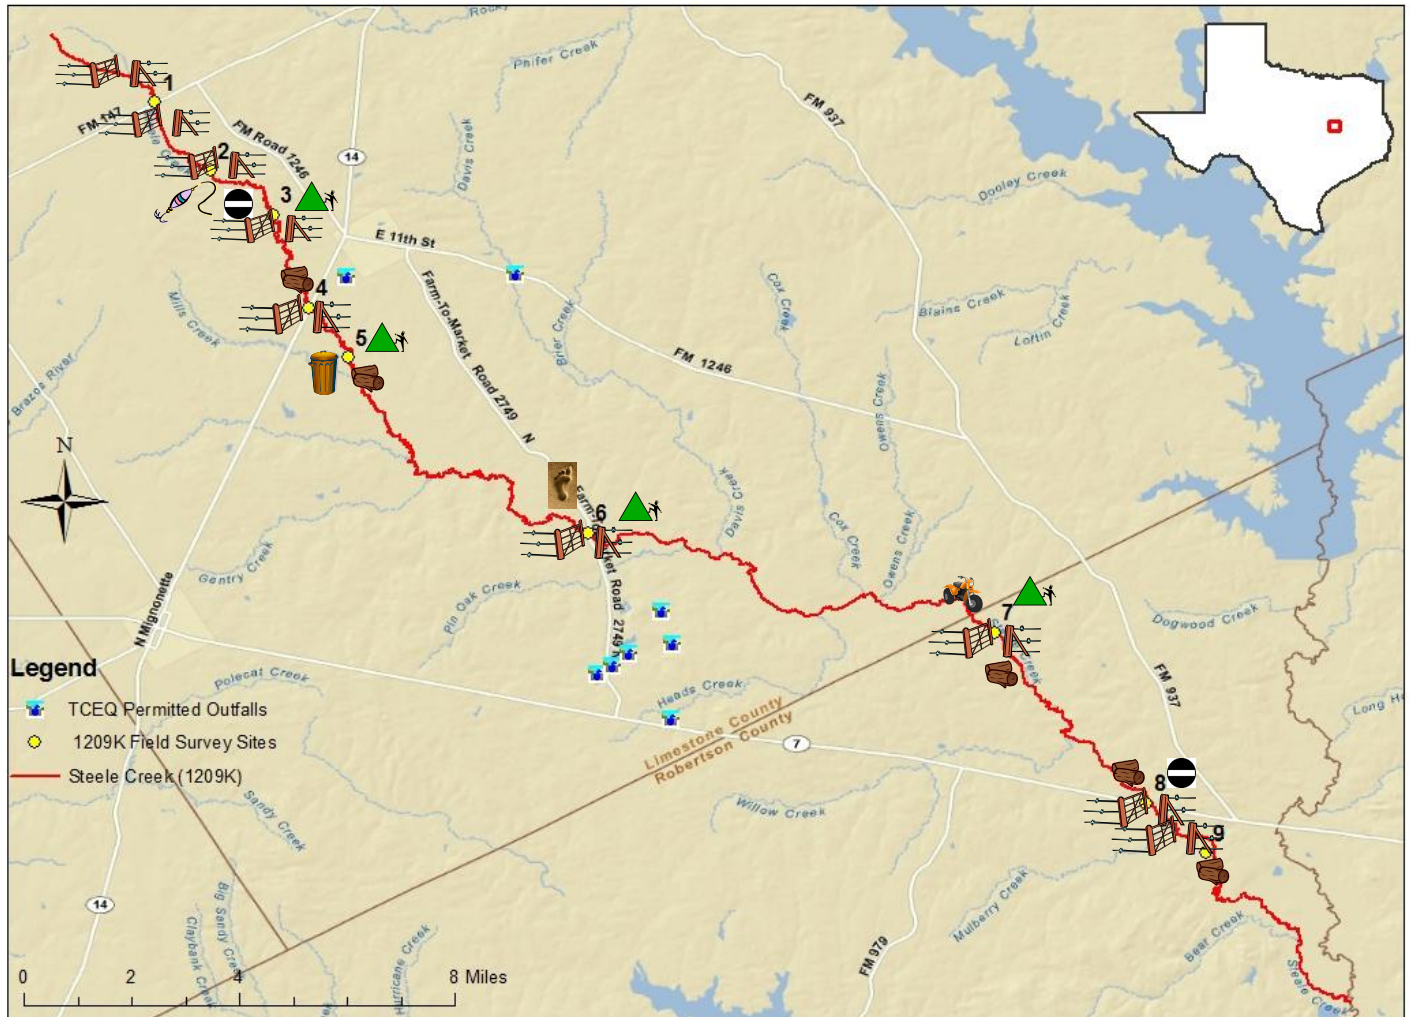
Based on our field surveys, we did not personally observed recreation on Steele Creek (Segment 1209K). We observed evidence of both water related activities (fishing tackle) at field survey site 2 and non-water related activities; foot path/prints at site 6, and RV/ATV tracks at site 7 (Table 5, Figure 4, & Appendix 5). There were many noted impediments along Steele Creek that could limit the recreation including: private property, steep slopes, fences, debris in the water, and log jams (Table 5, Figure 4, & Appendix 5).

Table 5. Observed evidence of recreational use and impediments to recreational use documented on Steele Creek, Segment 1209K, for the Basic Recreational Use Attainability Analysis. No recreation was observed during the Basic RUAA field surveys. Corresponds to Figure 4

Field Survey Site	Site Description	Impediments	Evidence
1	FM 147 @ Steele Creek	Fence	
2	LCR 648 @ Steele Creek	Fence, Private Property, Log Jams	Fishing Tackle
3	LCR 656 @ Steele Creek	Fence, Private Property, Steep Slopes, No Public Access	
4	SH 14 @ Steele Creek	Fence, Log Jams	
5	LCR 722 @ Steele Creek	Steep Slopes, Log Jams, Large Trash Piles	
6	FM 2749 @ Steele Creek	Fence, Steep Slopes	Foot Prints
7	CR 477 @ Steele Creek	Fence, Private Property, Steep Slopes, Fallen Trees	RV/ATV Tracks
8	SH 7 @ Steele Creek	Fence, Private Property, Debris, Steep Slopes	
9	CR 472 @ Steele Creek	Fence, Log Jams, Barbed Wire
