**Central and Southeast Texas Recreational Use-Attainability Analyses Project
Wickson Creek (Segment 1209E) Basic RUAA**

Results Report

Contract No. 582-9-90440
EIH Technical Report # 10-013

Prepared by:
George Guillen & Jenny Wrast
University of Houston-Clear Lake

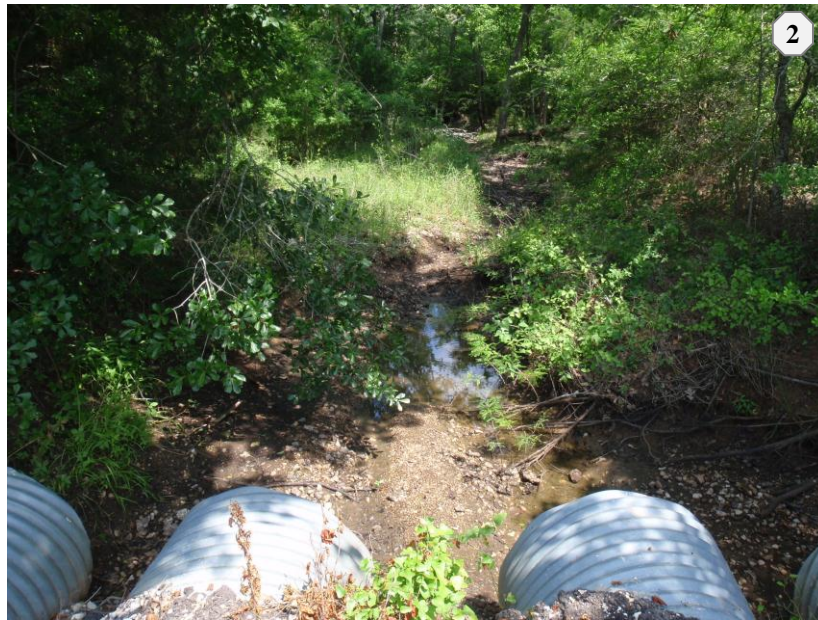
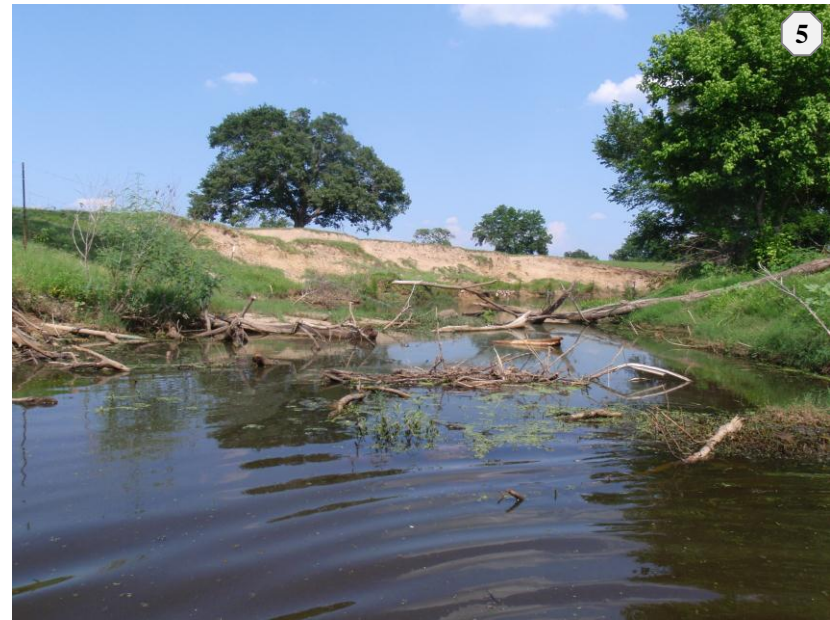
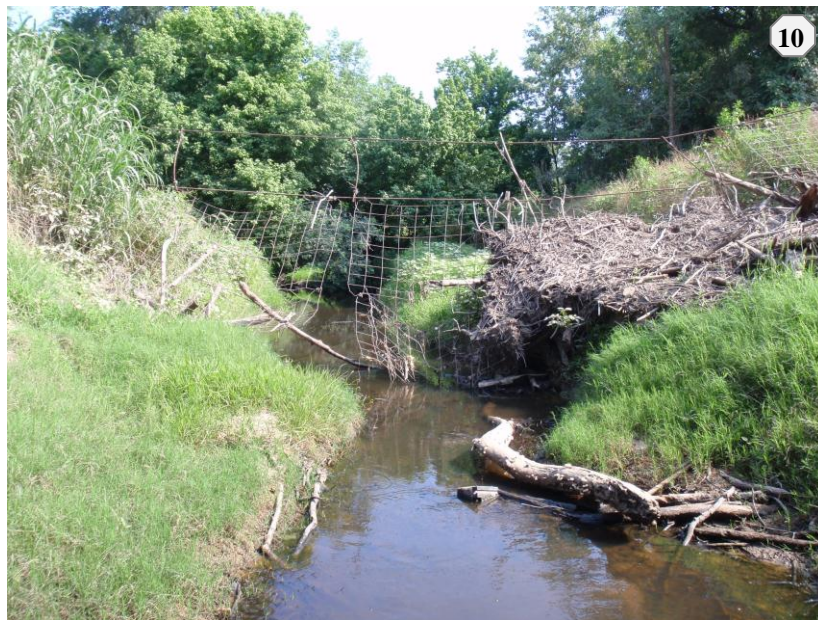
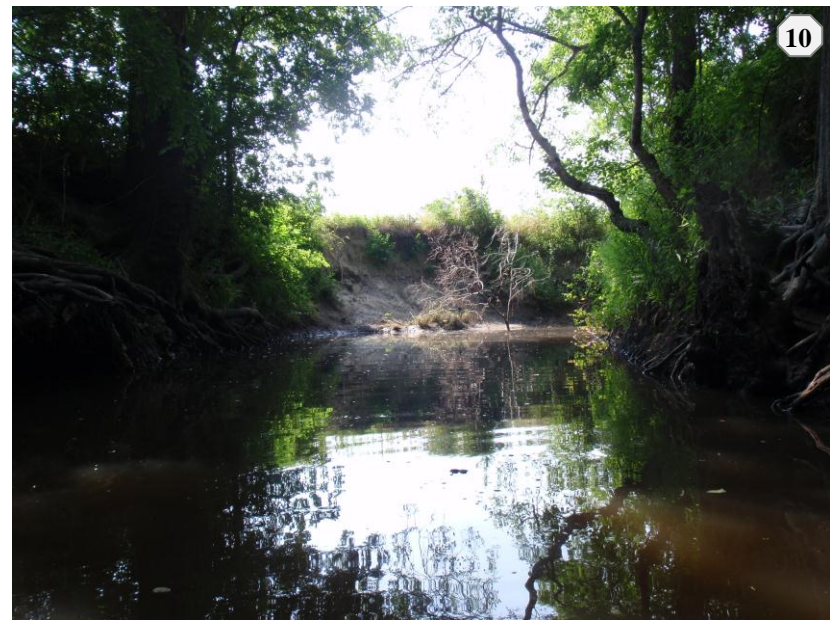
Every effort was made to obtain supplementary recreational use information about the entire length of the segment, including areas other than the selected sites in this Basic RUAA. Topographic maps and aerial imagery were used to provide the needed geographic information about potential recreational opportunities, potential access points, and potential access obstacles along the Wickson Creek. Review of these resources resulted in reconnaissance site selection. The subsequent reconnaissance site visits confirmed the limited public access along the Wickson Creek. Fences, gates, and no trespassing signage are common public access limitations on the segment and resulted in less than three (3) sites for every five (5) miles of stream. Figure 3 depicts the range of variability of physical attributes found along Wickson Creek.

Figure 3. Pictures from field survey sites 2, 5, and 10 depicting the various physical attributes observed along Wickson Creek, Segment 1209E.
