Armand Bayou Water Quality Improvement Grant: UHCL Created Stormwater Treatment Wetland

Prepared in cooperation with the Galveston Bay Estuary Program
Contract #: 582-9-84949

Environmental Institute of Houston (EIH) Report #13-003
5/27/2014
University of Houston Clear Lake
Environmental Institute of Houston

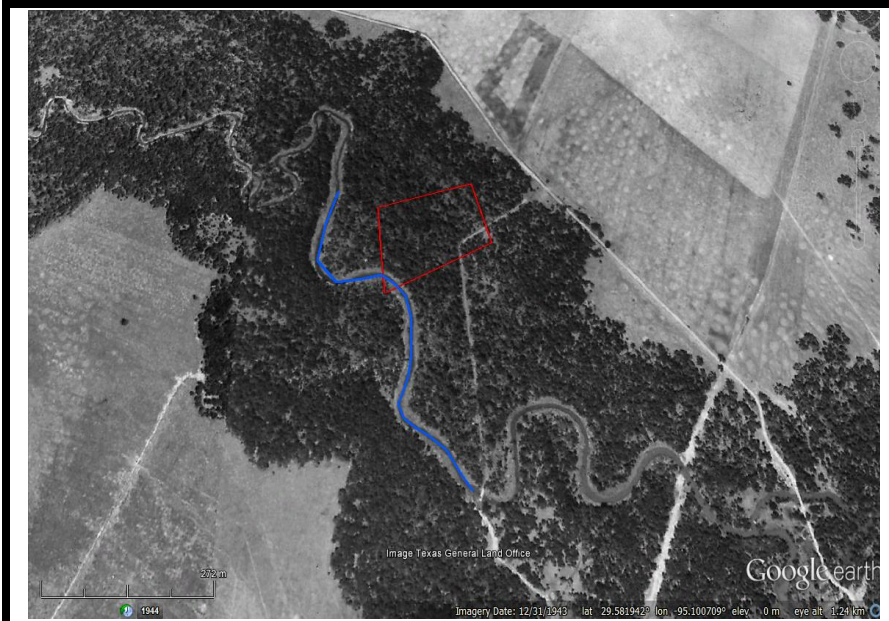
Figure 2. Historical Horsepen Bayou watershed 12/31/1943. Source: Google Earth and Texas General Land Office. Red square shows project area and blue line highlights Horsepen Bayou. Note the extensive riparian forested area and meandering geomorphology.

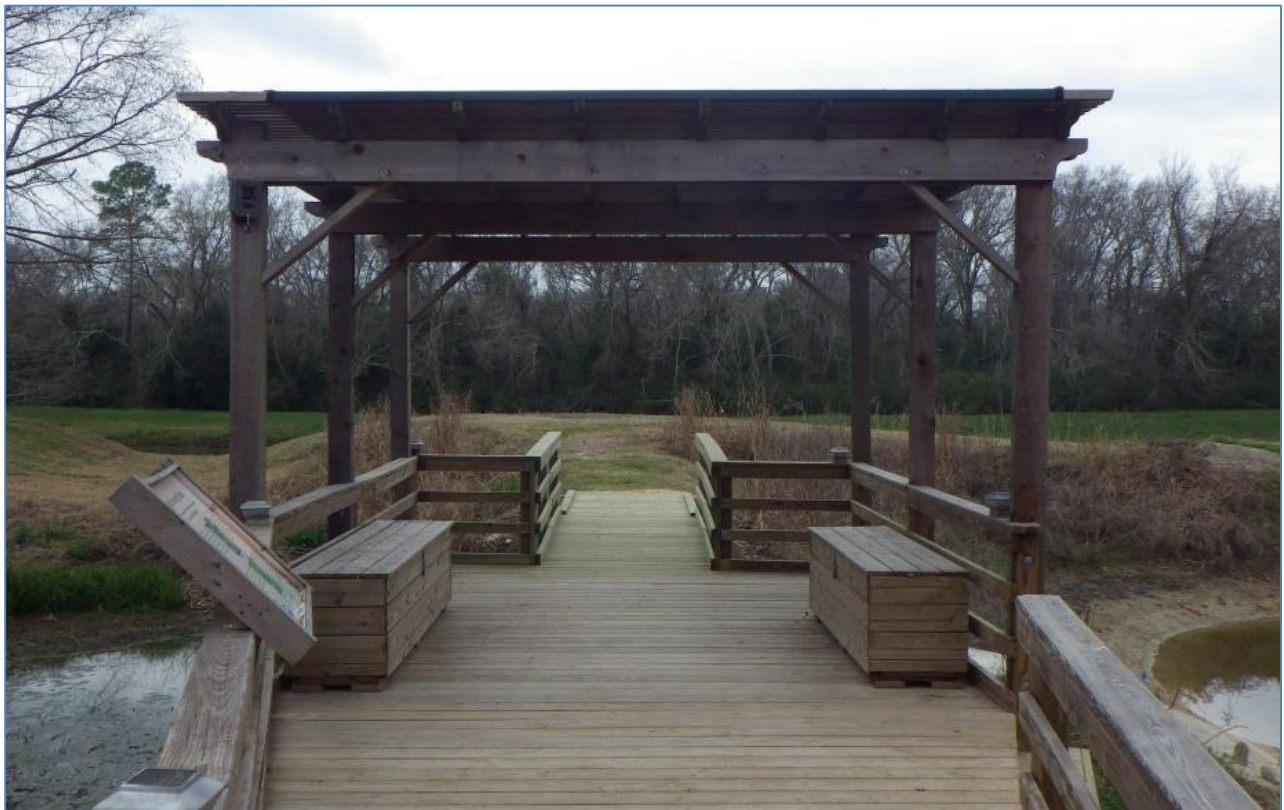
Figure 6. The Arbor at the end of the boardwalk at the secondary wetland on the UHCL campus. Note the benches with storage for dip nets, boots, and sorting trays for class visits to the site. Alligator Pond is located to the right.

The final engineered created wetland involved excavating a pool-run complex out of the previously grass-lined ditch, and the upland area located to the east of the pre-existing Alligator Pond (Figure 5). The excavated dirt was used to fill the deepest parts of Alligator Pond, creating lesser sloped banks and reducing the overall depth of the pond. This increased the potential for vegetative growth (which now serves as new habitat) whereas, before construction, it could not grow due to the deep, steep banks. In addition, during construction, three large cypress trees were removed, and their trunks were used to build the three check dams that were installed in the primary wetland. These check dams function to slow water and allow for sedimentation of suspended solids into the wetland. Finally, a boardwalk, complete with a covered arbor and informational placards, was installed at the secondary wetland leading visitors through the pool-run complex ending at the weir over-fall into Alligator Pond (Figure 6). The design specification for the system is provided in Figure 7.

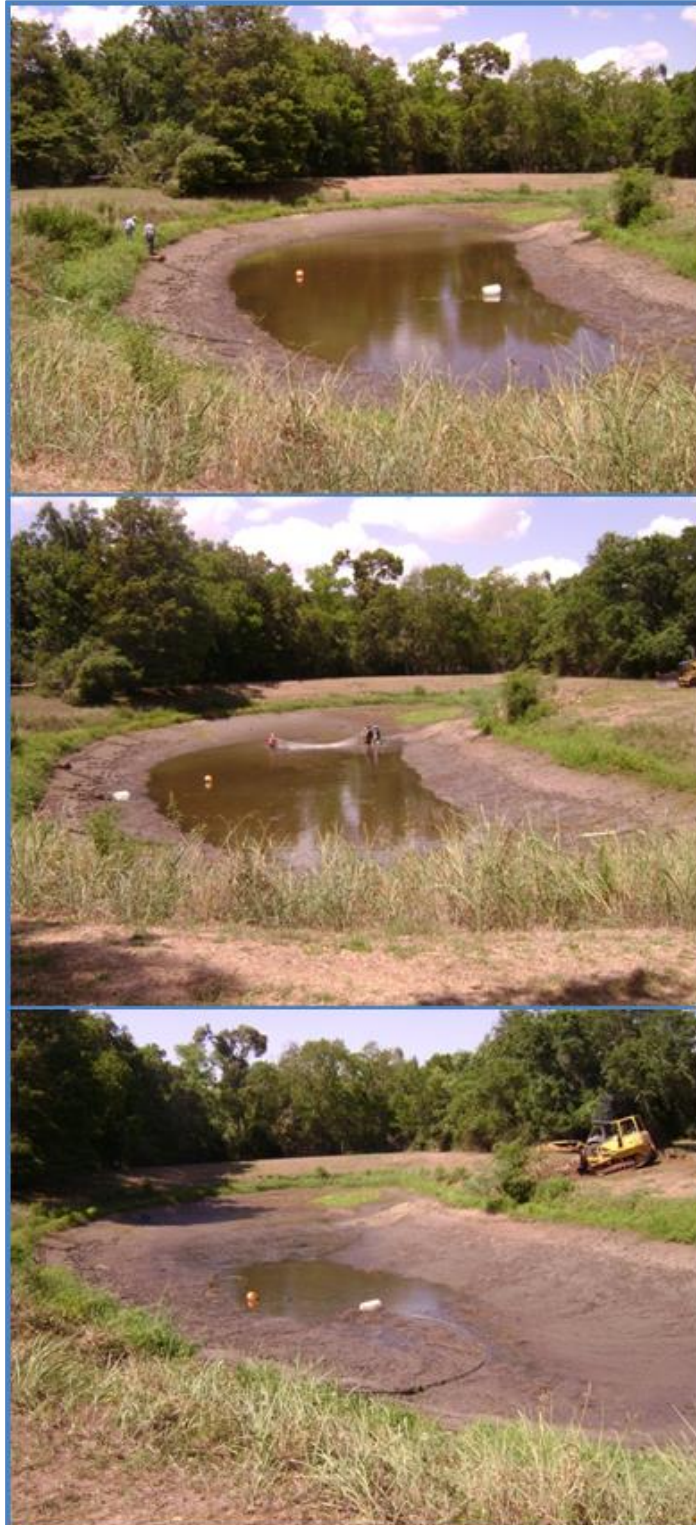
Figure 8. Time-lapse of the pond draining pre-construction at the UHCL created wetland site (Alligator Pond). Draining occurred over a 2 day period during July 2011.

Prior to any construction numerous permits were obtained including 1) a nationwide permit 27 through the section 404 program from the Army Corps of Engineers, 2) a TCEQ temporary water rights permit for the solar pump, 3) and notification of net gain in flood storage to the City of Pasadena and the HCFCD. The construction schedule was less than two months and this process began with draining the existing Alligator Pond (Figure 8). This pond draining event allowed EIH to quantify the existing nekton community of the pond and compare its contents to previous sampling techniques used to measure fish populations prior to the draining.

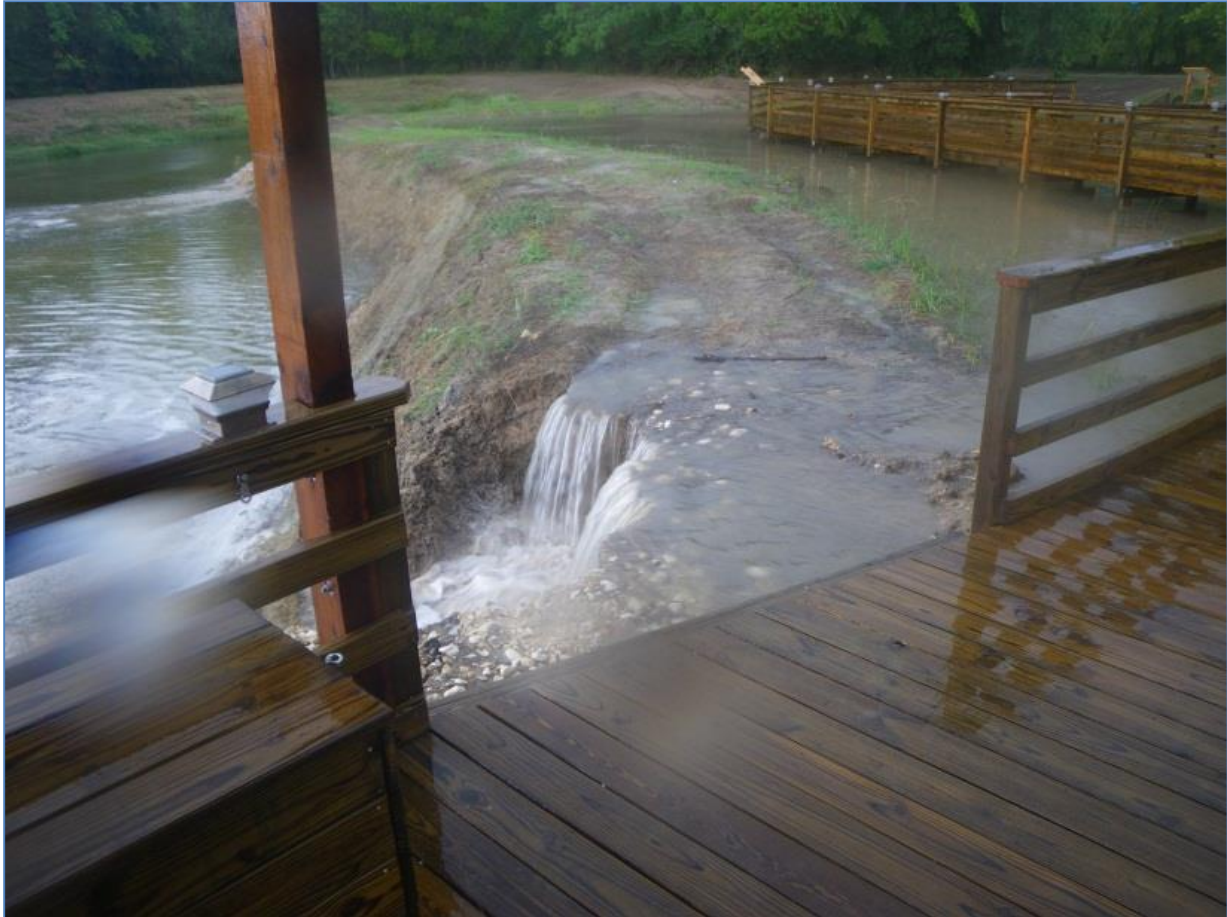
Figure 10. Photo of the Levee breach and erosion experienced by an extreme rain event post-construction at the UHCL wetland into Alligator Pond

Post construction the area experienced an extreme rainfall event, and the newly constructed levee at the secondary wetland was breached (Figure 10). Part of the levee near the arbor at the end of the walkway and the weir from the secondary wetland into Alligator Pond had eroded, and required repair and slight modification to the construction design. The levee was reinforced, and an overflow low point was constructed allowing for a 100 year flood to overflow directly into Horsepen Bayou to alleviate the pressure on the constructed levee.

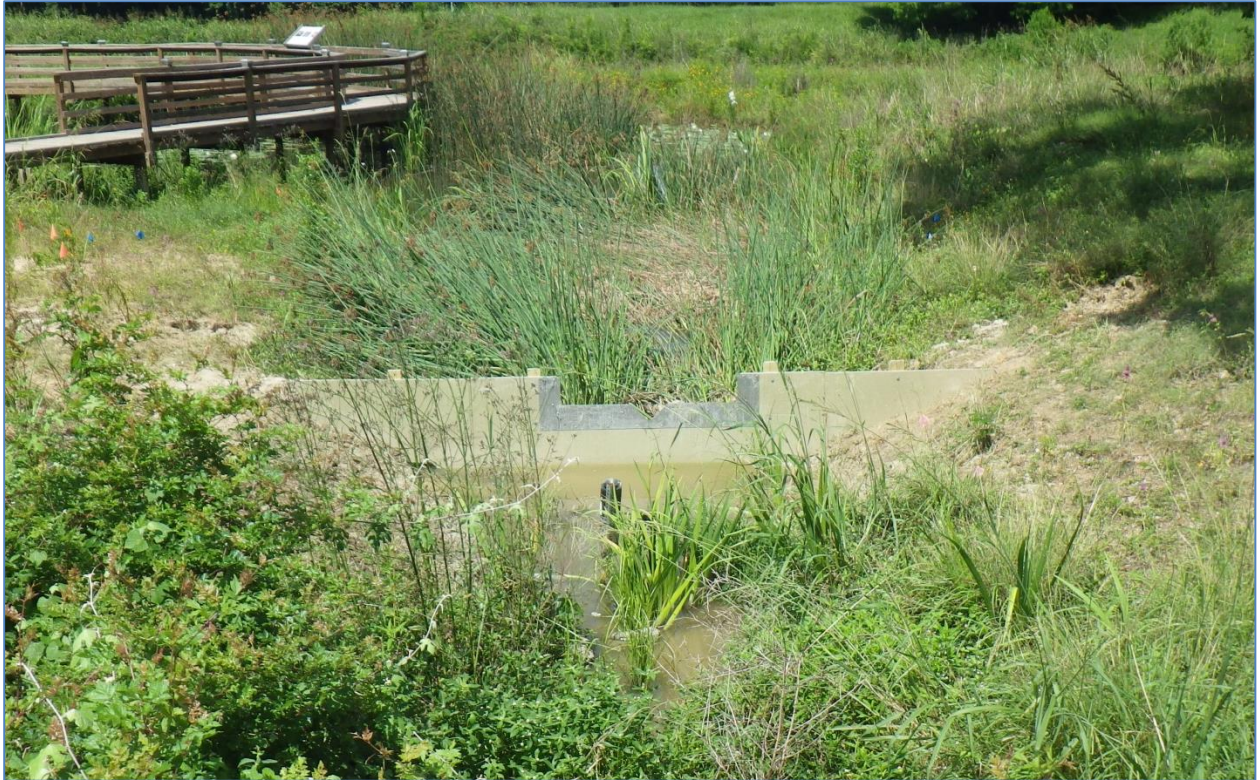
Figure 11. V-notched weir installed at the most upstream point of the secondary wetland, UHCL created wetland site. The weir is used to monitor water flow.

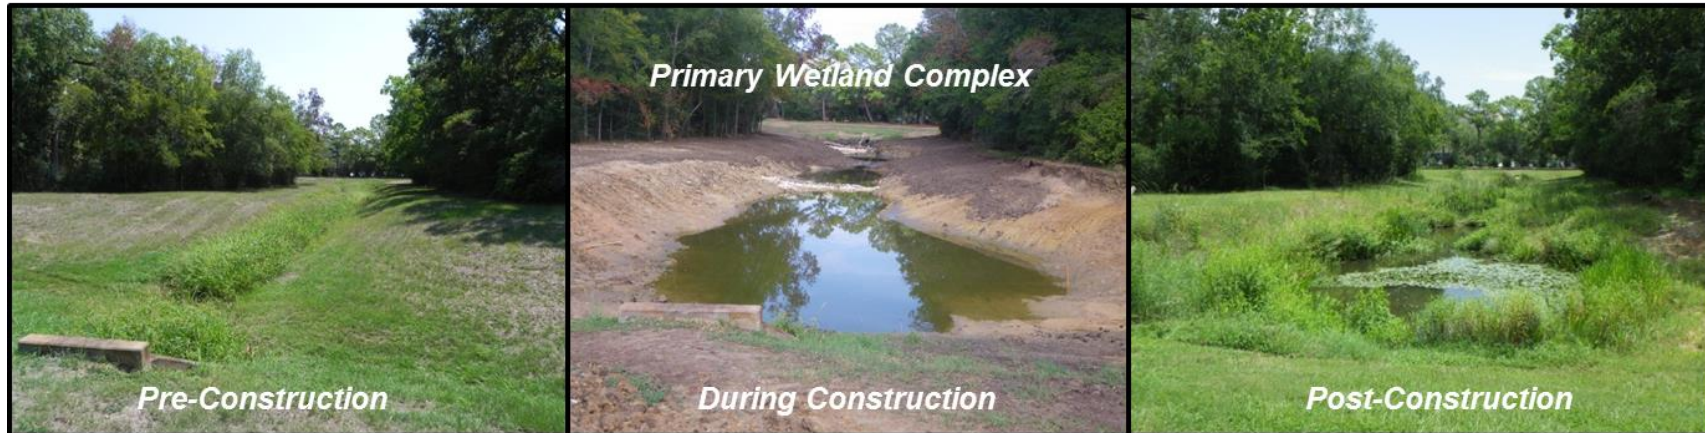
Figure 12. Time series photographs of the primary wetland complex showing pre-construction, during construction, and post-construction conditions.

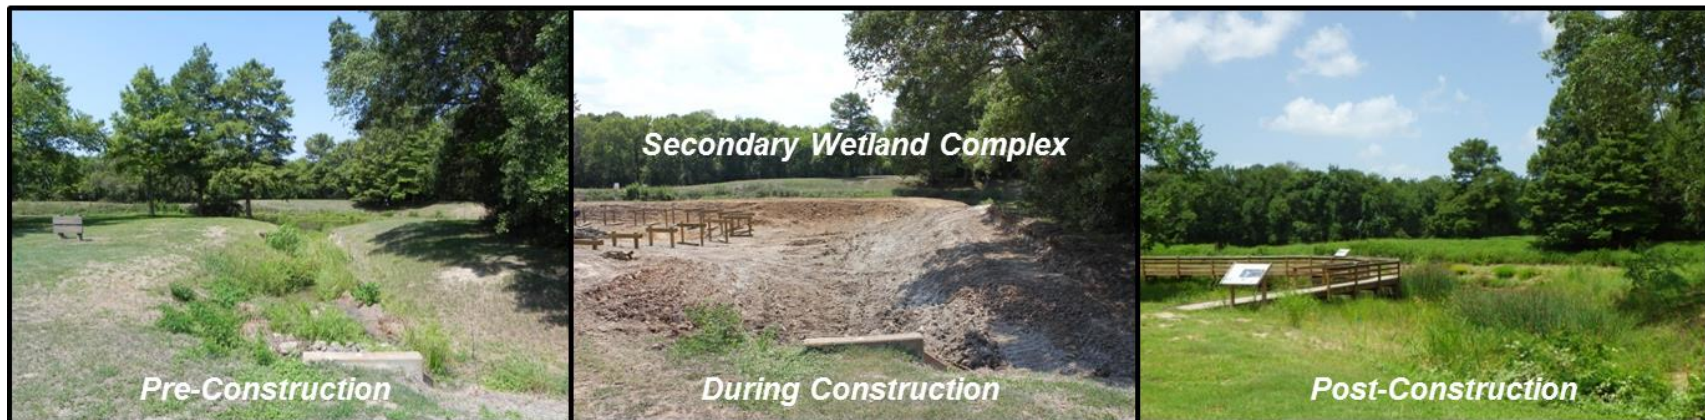
Figure 13. Time-series photographs of the secondary wetland complex showing pre-construction, during construction, and post-construction conditions.

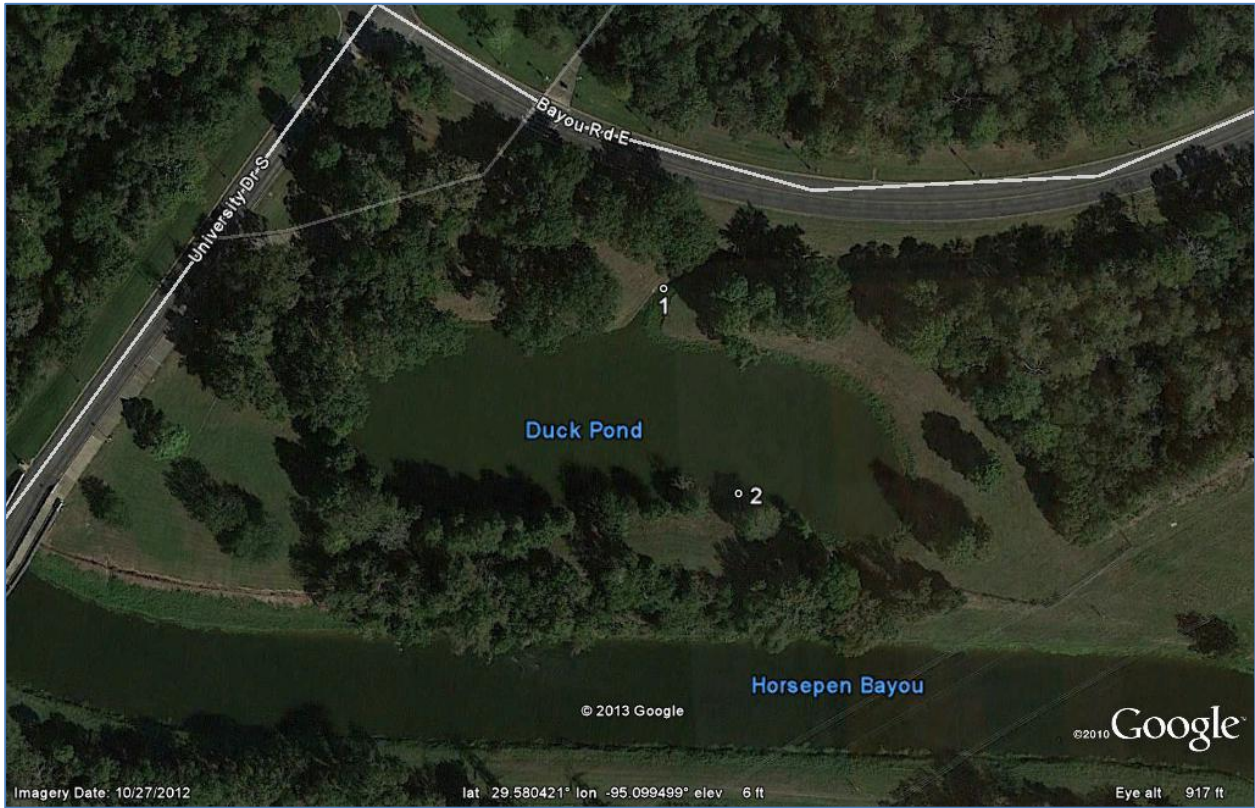
Figure 15. Control sample sites one and two located at Duck Pond on the UHCL campus. Sites Correspond to Figure 14.

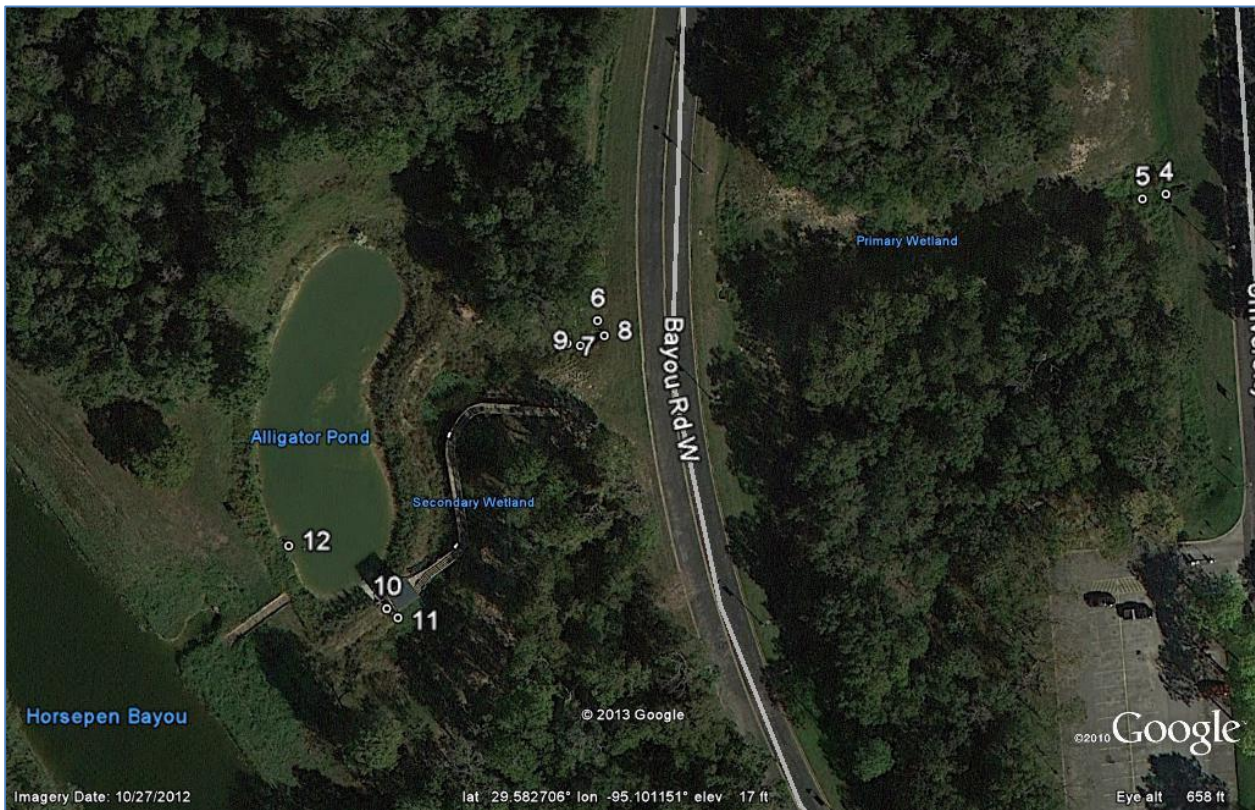
Figure 16. Created treatment wetland sample sites. Sites correspond to Figure 14.

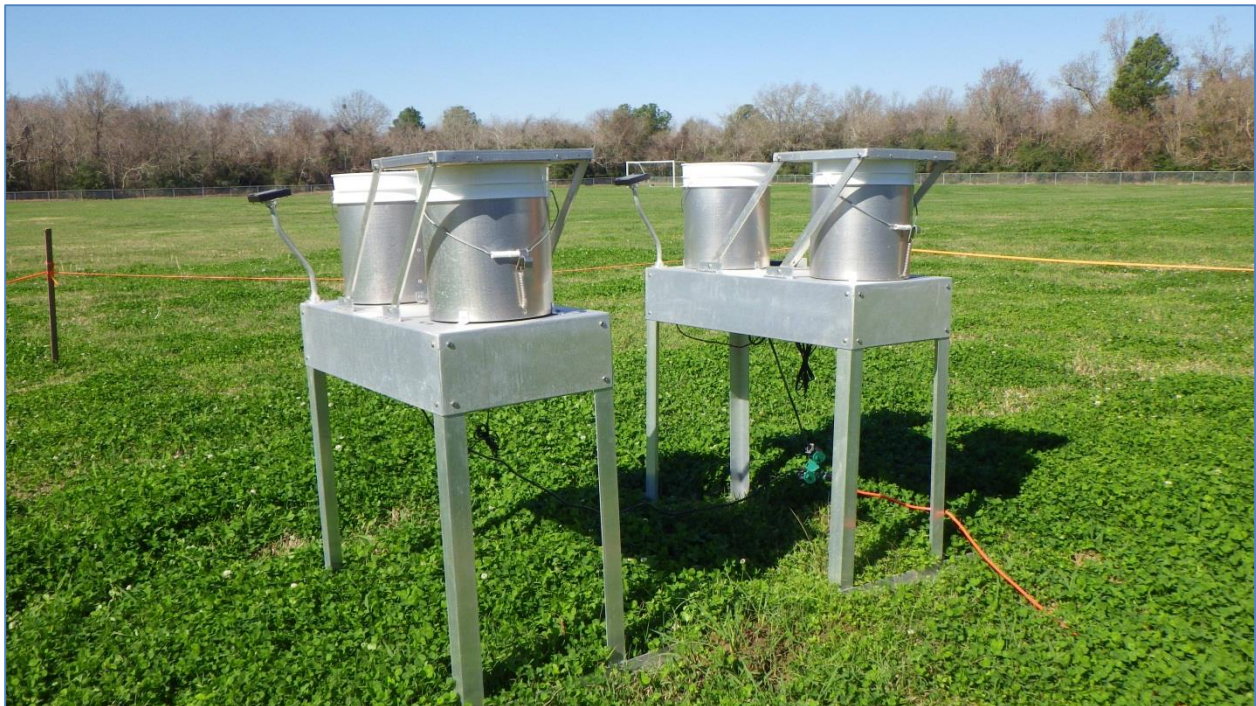
Figure 17. Dry deposition and precipitation samplers deployed in the field near the N.O.A. building on the UHCL campus.

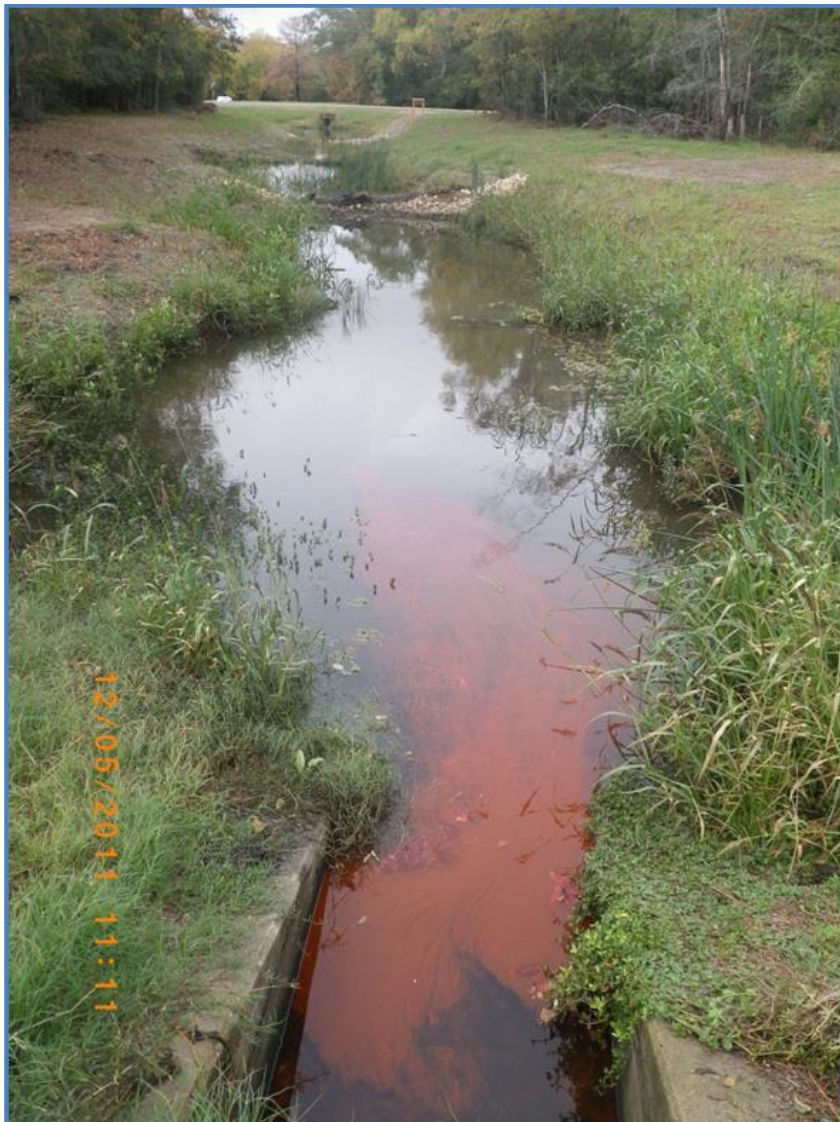
Figure 18. Rhodamine Dye release at the top of the primary wetland complex (Site 4).

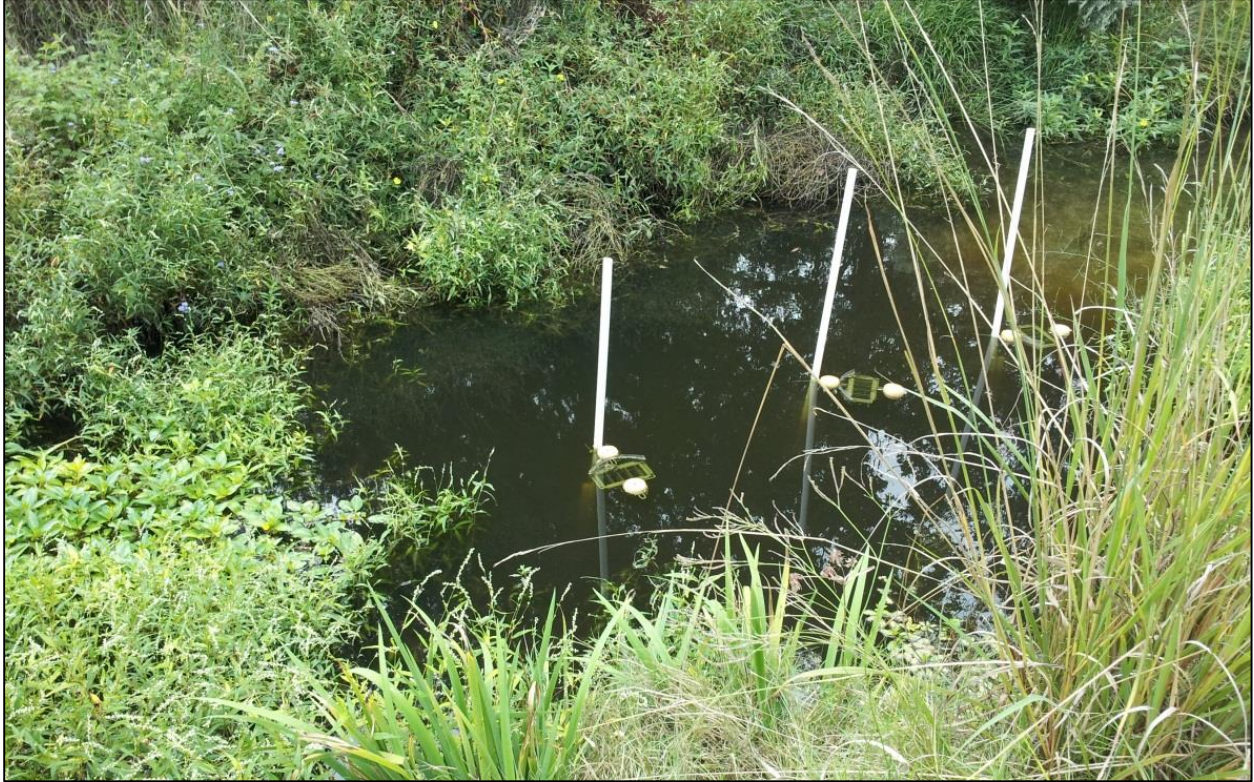
Figure 20. Periphyton samplers deployed at site 4, primary wetland complex at the UHCL created wetland.

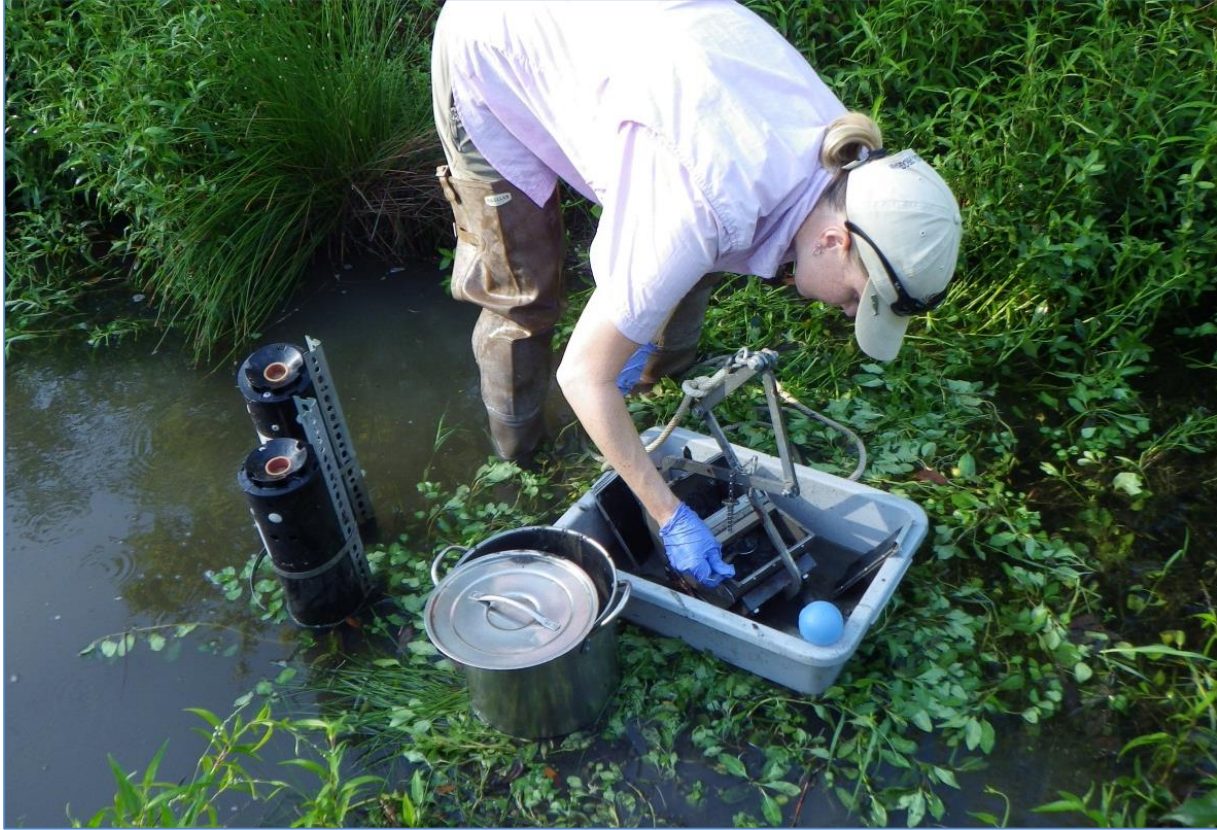
Figure 21. EIH staff sampling sediment using a petite ponar at the primary wetland site 4.

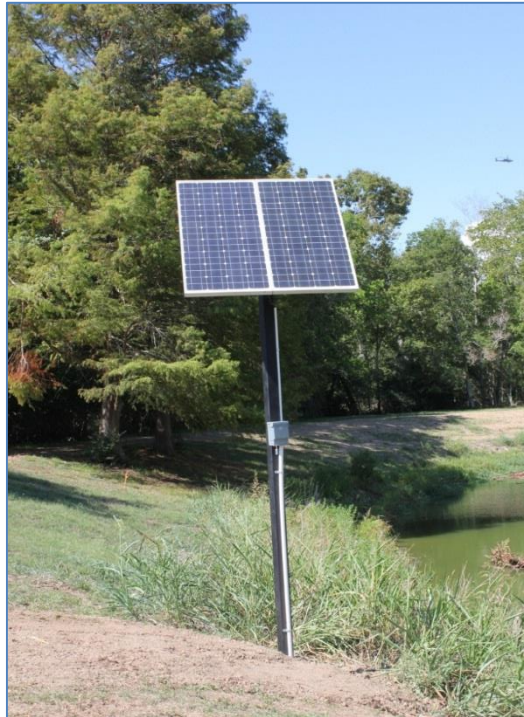
Figure 22. Solar panel that powers a pump which conveys water from Horsepen Bayou uphill to the top of the secondary wetland complex for additional water quality treatment through the created wetland.

A solar pump was installed to pump water from Horsepen Bayou up to the top of the secondary wetland complex in order to provide additional water quality treatment of Horsepen Bayou water through the created wetland complex. The pump intake is located near the outfall pipe from Alligator pond, in order to protect it from high flow events in the bayou. The solar panel that

powers the pump is located on the berm between Alligator Pond and Horsepen Bayou (Figure 22). A feasibility study was completed to evaluate the use of a solar pump to treat water from Horsepen Bayou. Flow discharge from the pump outfall pipe was compared to solar radiation readings from a LI-COR photosynthetically active radiation (PAR) meter to study the effectiveness of this design. Due to the tidal nature of Horsepen Bayou, an Onset HOBO conductivity data logger was installed at the pump inlet to measure salinity. Water was only pumped into the wetland system when conductivity levels were below 1000 $\mu\text{S}/\text{cm}$ specific conductivity to reduce the likelihood of damage/stress to the freshwater wetland plant community.

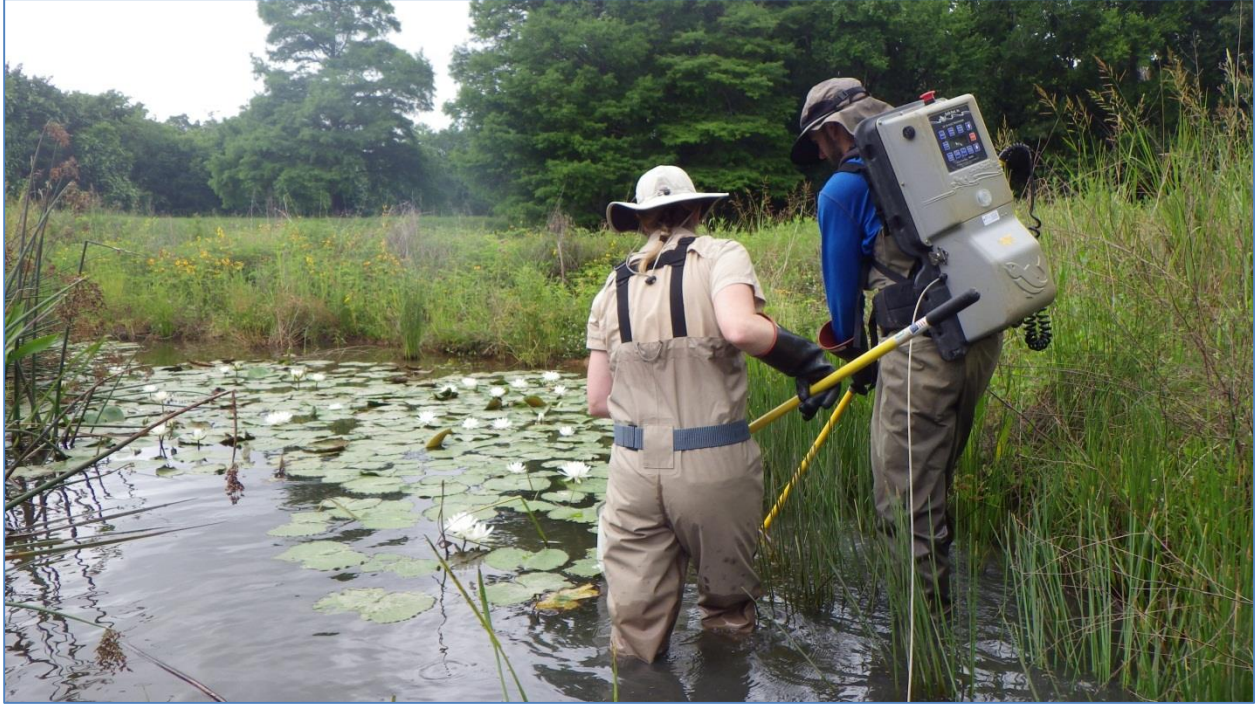
Figure 24. EIH staff sampling for nekton using a backpack electroshocker in the Secondary Wetland complex at the UHCL created wetlands.

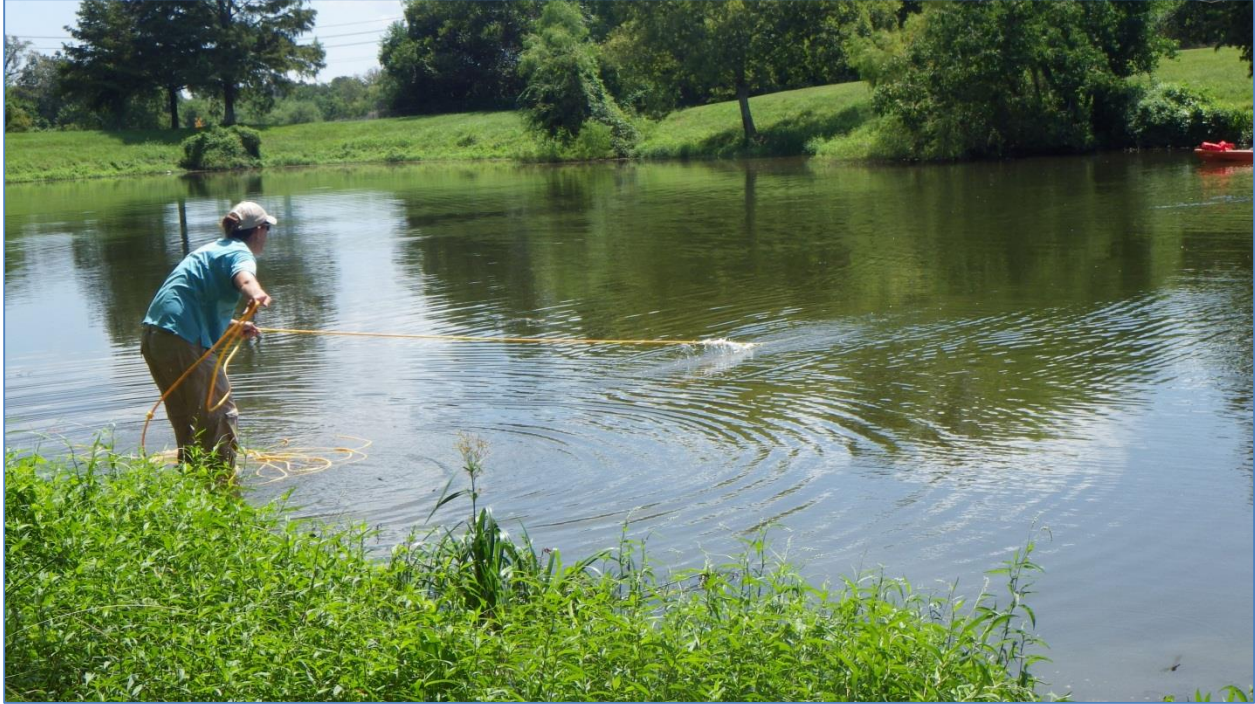
Figure 25. EIH staff pulling a zooplankton tow at Duck Pond (Site 2), UHCL campus.

Zooplankton tows were completed at sites 2 and 12 in post-construction years 2 and 3. All zooplankton were identified and enumerated following procedures outlined in the TCEQ *Surface Water Quality Monitoring Procedures, Volume 2* (TCEQ 2007). The zooplankton net used was a Wisconsin sampler (approx. 23" in length, 363 μ m nitex mesh with 5" diameter mouth and 7" diameter ring). This net was towed across the pond using kayaks, and then released and pulled across the pond at a steady rate to the shore, keeping the net just below the surface of the water (Figure 25). The distance and time pulled was recorded.

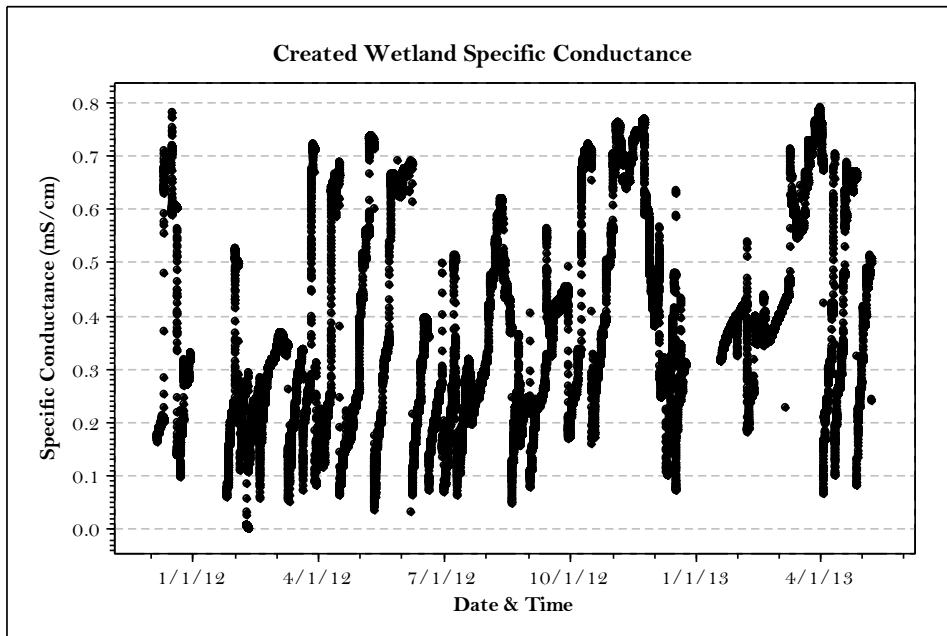
Figure 43. Results of automated continuous monitoring of specific conductance at the constructed wetland upstream of Alligator Pond.

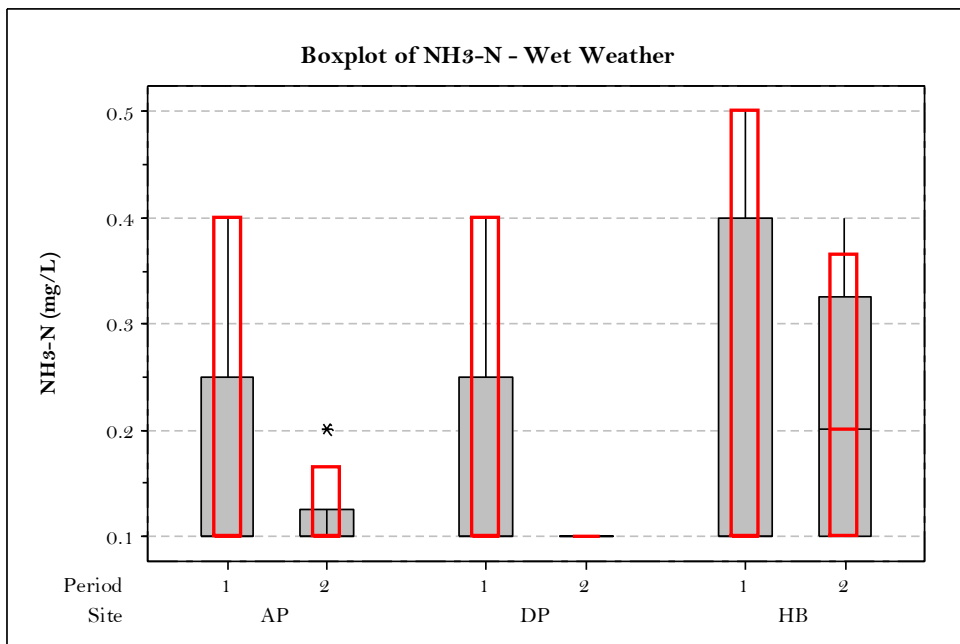
Figure 83. Boxplot of ammonia nitrogen measured during wet weather conditions at outfall from each pond system (AP – alligator pond downstream from wetland; DP – Duck Pond; HB – Horsepen Bayou at Bay Area Blvd; 1 = pre-construction and 2 = post construction wetland). Red bar denotes 95% confidence interval of median.

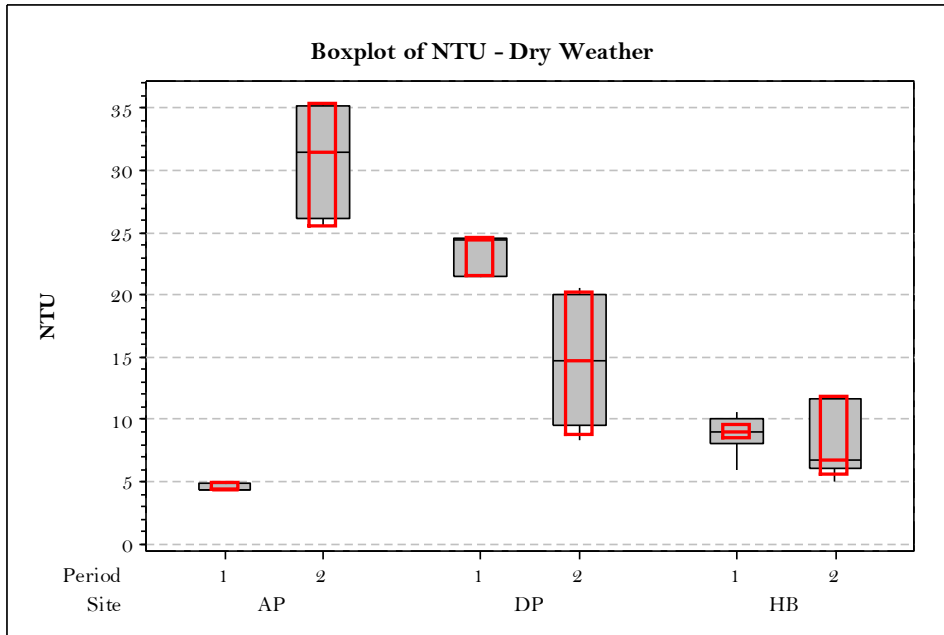
Figure 94. Boxplot of nephelometric turbidity units measured during dry weather conditions at outfall from each pond system (AP – alligator pond downstream from wetland; DP – Duck Pond; HB – Horsepen Bayou at Bay Area Blvd; 1 = pre-construction and 2 = post construction wetland). Red bar denotes 95% confidence interval of median.

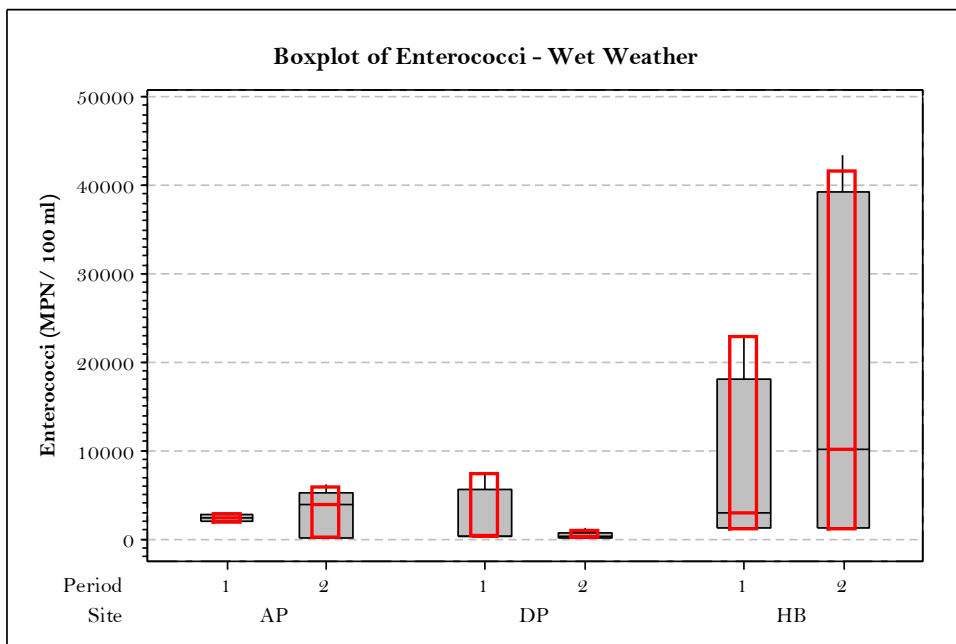
Figure 97. Boxplot of most probable number of Enterococci bacteria measured during wet weather conditions at outfall from each pond system (AP – alligator pond downstream from wetland; DP – Duck Pond; HB – Horsepen Bayou at Bay Area Blvd; 1 = pre-construction and 2 = post construction wetland). Red bar denotes 95% confidence interval of median.

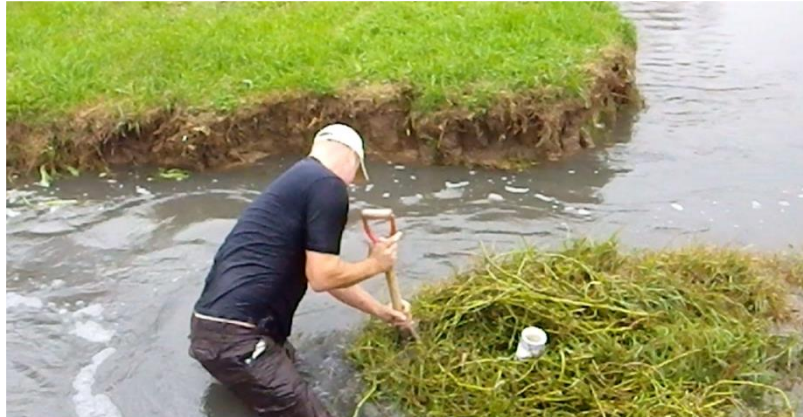
Figure 117. EIH Staff removing debris from around the solar pump intake in order to turn on the pump.

In addition to the necessary conductivity monitoring, maintenance on the pump intake was a constant issue. The pump was installed in a small indentation of the bank immediately below the outfall from the pond in order to protect it from high flow events, but this indentation also collector of small debris. The debris (aquatic vegetation, trash, etc) would clog the pump intake and would have to be manually cleared before each time the pump was started (Figure 117).
