Targeted Bacteria Monitoring Project Field Investigation Final Report Assessment Unit 1007T _01 Bintliff Ditch

May 8, 2023

Environmental Institute of Houston, University of Houston-Clear Lake

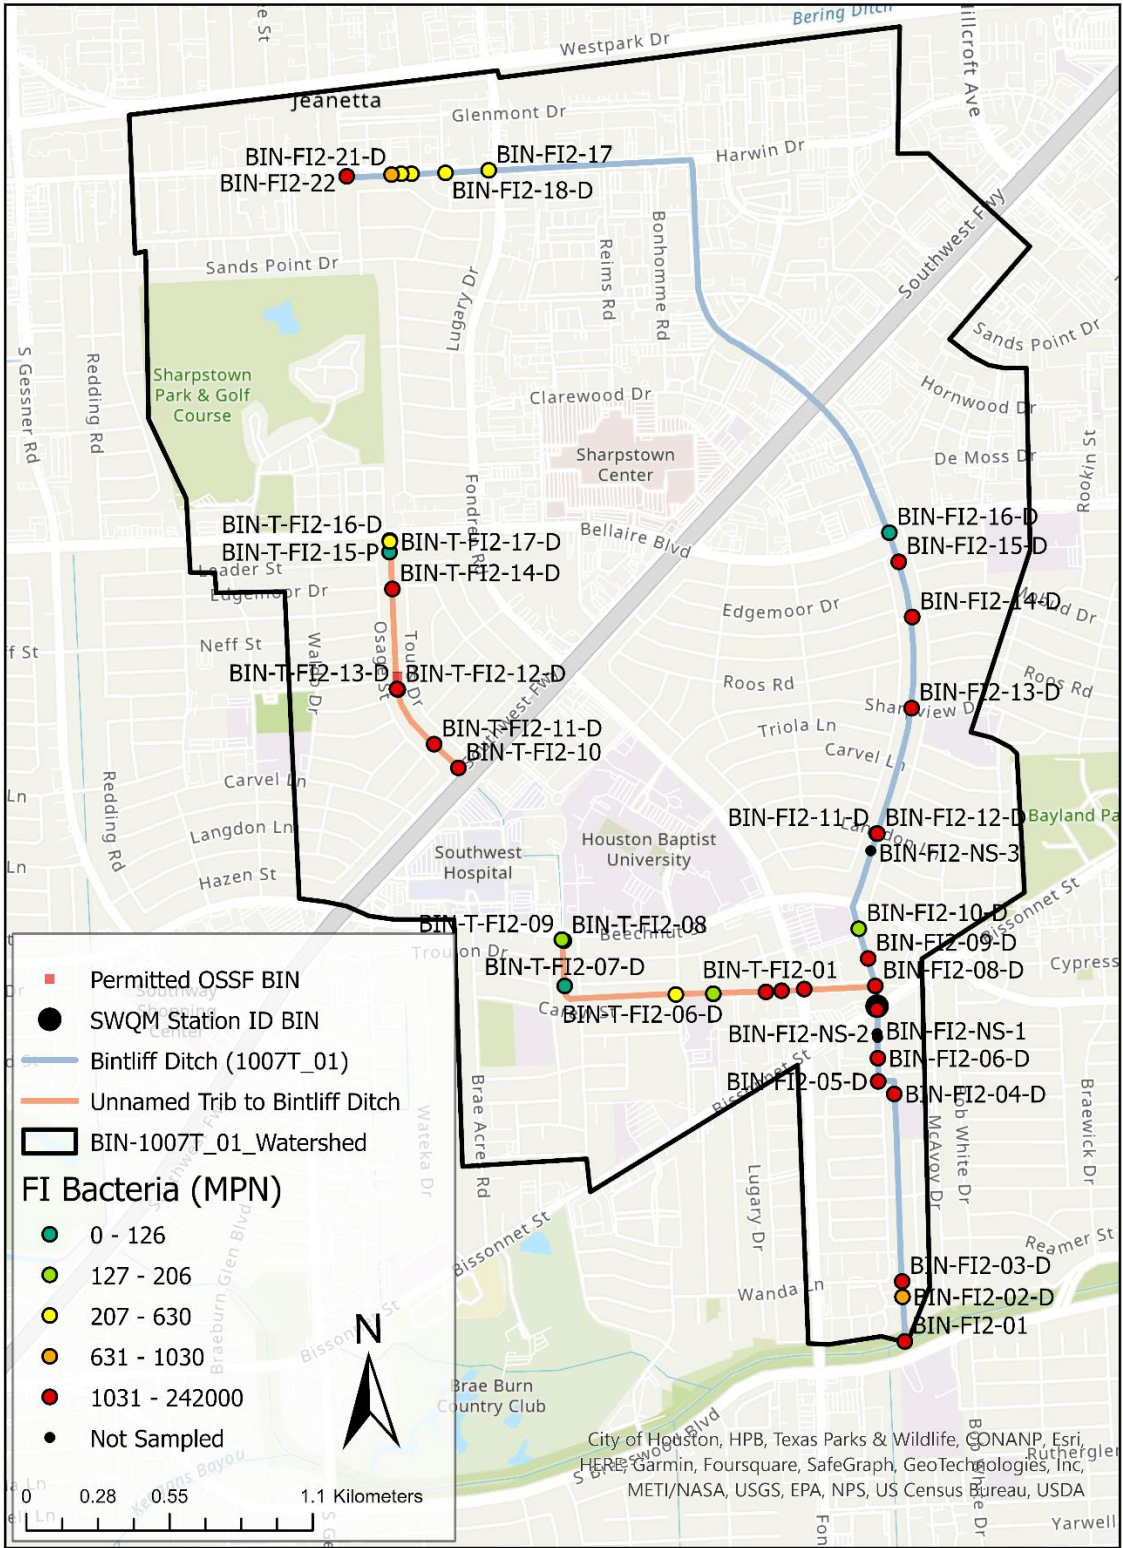
Figure 3: Field investigation bacteria sampling results from 4/11/2023 on Bintliff Ditch (Assessment Unit 1007T_01).

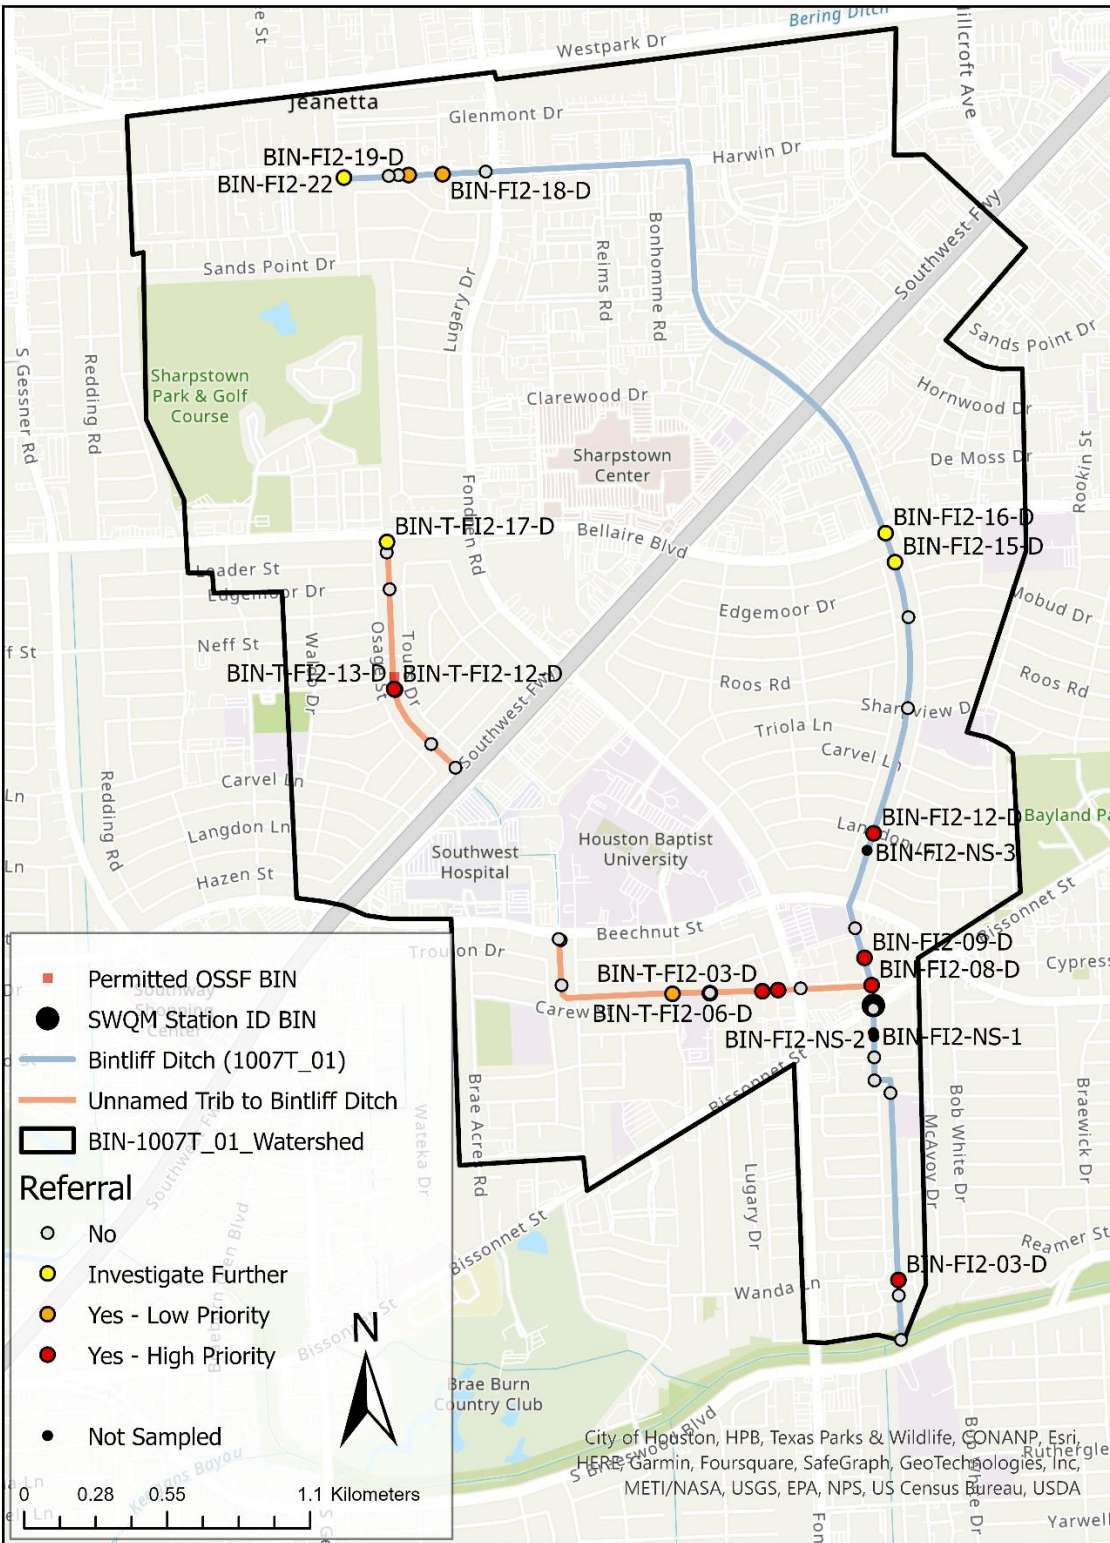
Figure 4: Field investigation sites identified for referral from 4/11/2023 to the proper authorities on Bintliff Ditch (Assessment Unit 1007T_01).
