# Targeted Bacteria Monitoring Project Field Investigation Final Report Assessment Unit 1017A\_01 Brickhouse Gully

May 16, 2023

Environmental Institute of Houston, University of Houston-Clear Lake

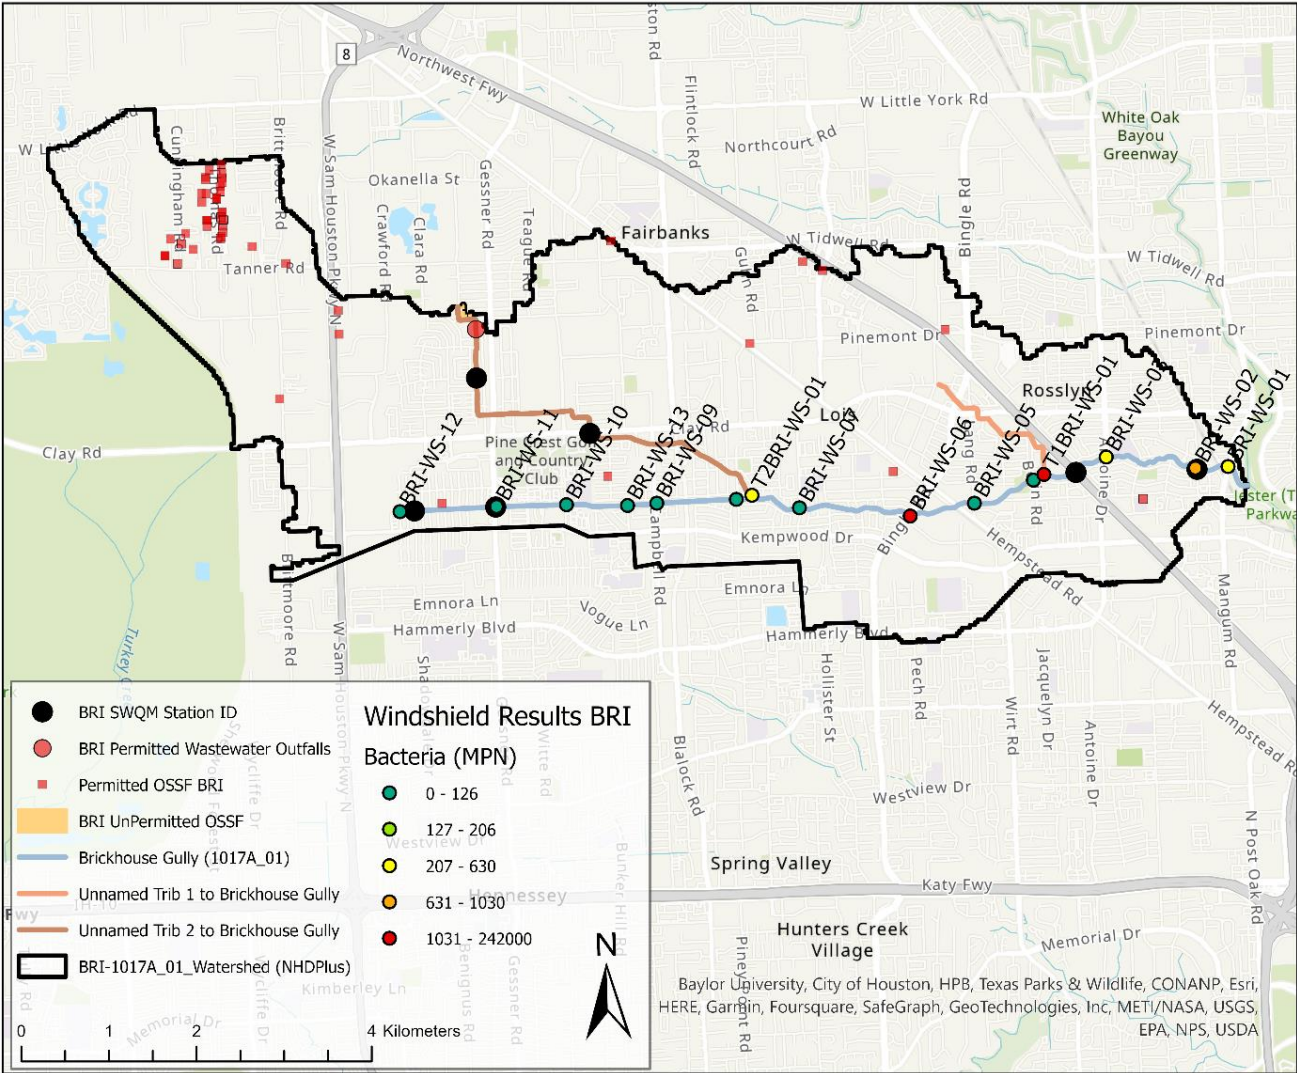
Figure 4: Windshield survey/ground truthing bacteria results from sampling on 03/09/2023 on Brickhouse Gully (AU 1017A\_01). Samples were taken at bridge crossings and other easily accessible points.

The WS was conducted on March 09, 2023. At that time, it had been 6 days since the last significant rainfall in the watershed. A total of 13 samples were collected on AU 1017A\_01 and 2 on contributing tributaries during the WS (Table 1 and Figure 4).

Based upon the results of the WS, FIs covering the length of the AU from its confluence with White Oak Above Tidal to Peppermill Rd. and of the entire unnamed tributary 1 (confluence with Brickhouse Gully lies between Bolin Rd. and US 290) was recommended. If time and supplies permit, a FI of the entire length of the AU was recommended, but the WS results show the portion upstream of Peppermill Rd. to be of least concern. Based on the results of the WS, we expected to identify potential non-point or point sources of elevated bacteria near the following portions of the AU:

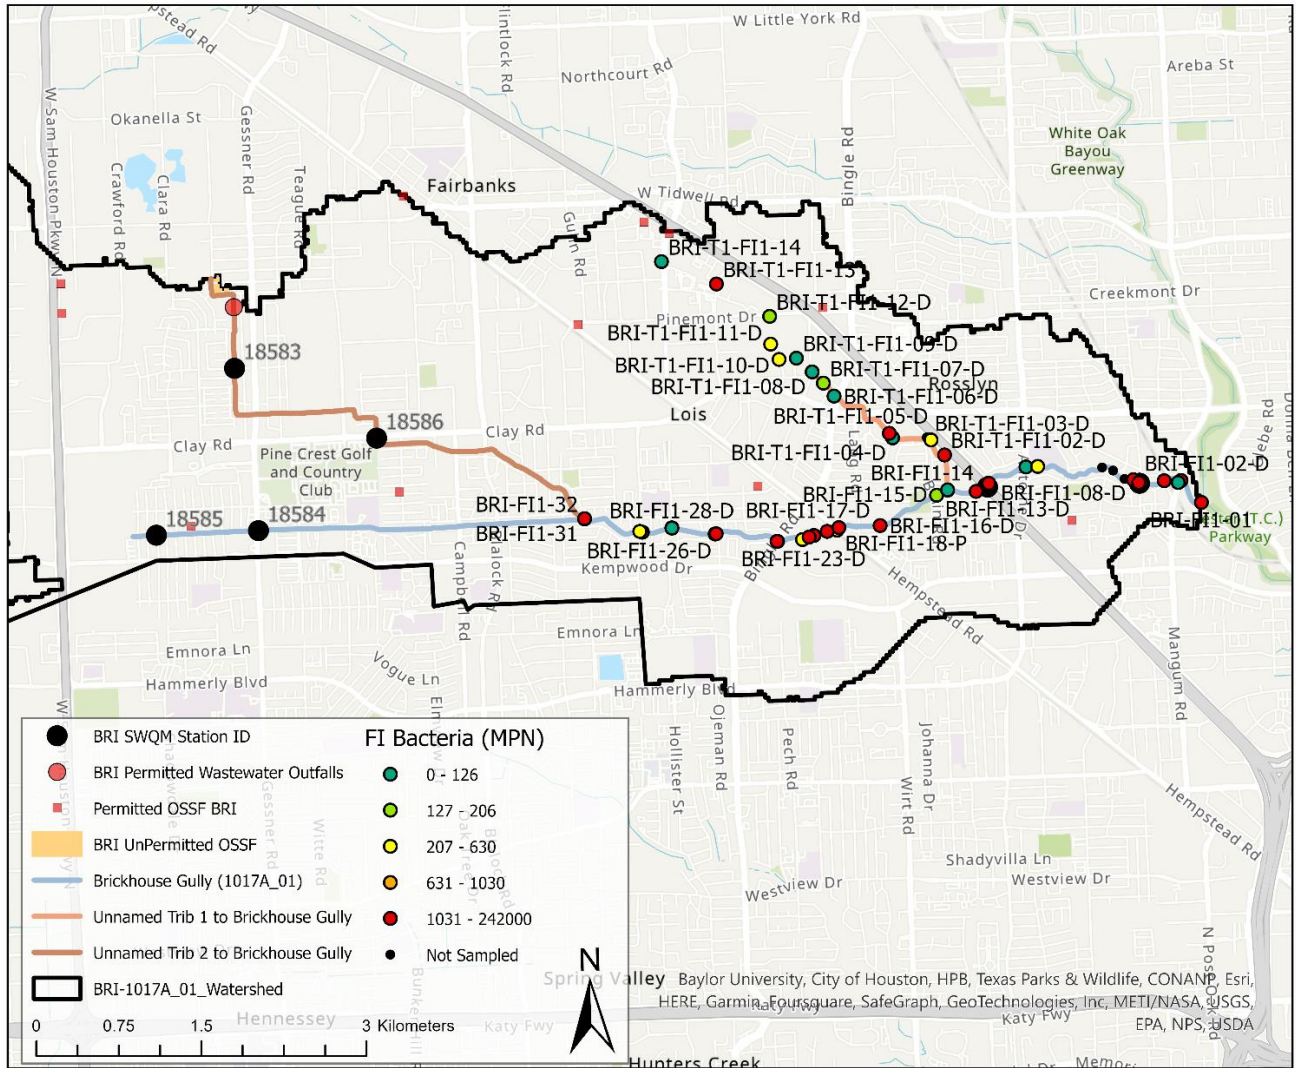
Figure 5: Field investigation bacteria sampling results from 04/12/2023 on unnamed tributary 1 of Brickhouse Gully and from 4/13/2023 on Brickhouse Gully (Assessment Unit 1017A\_01).

permitted outfalls, directly from unpermitted outfalls, or as ambient samples are summarized in Table 2 and Figure 5. Based on the data collected, eight locations with elevated *E. coli* bacteria levels measured during the field investigation are recommended for high priority, and four locations for low priority investigation by the proper authorities. High priority sites had the highest potential bacteria loading observed and are recommended to be the areas for local authorities to focus efforts on should there be insufficient resources to address all referral sites. As time and resources allow the low priority and “investigate further” referrals also are recommended for further investigation. These locations are summarized in Table 2 and Figure 6. Four locations were flagged where ambient or upstream samples had elevated bacteria levels with no obvious explanations. Further investigation of these areas by the proper authorities are recommended. Each of these referrals are summarized by site, herein. The referral summaries are listed in order of priority (High, Low, then Investigate Further). Within each priority group, sites are listed from downstream to upstream.
