Targeted Bacteria Monitoring Project Field Investigation Final Report Assessment Unit 1017B_02, Cole Creek

June 2, 2023

Environmental Institute of Houston, University of Houston-Clear Lake

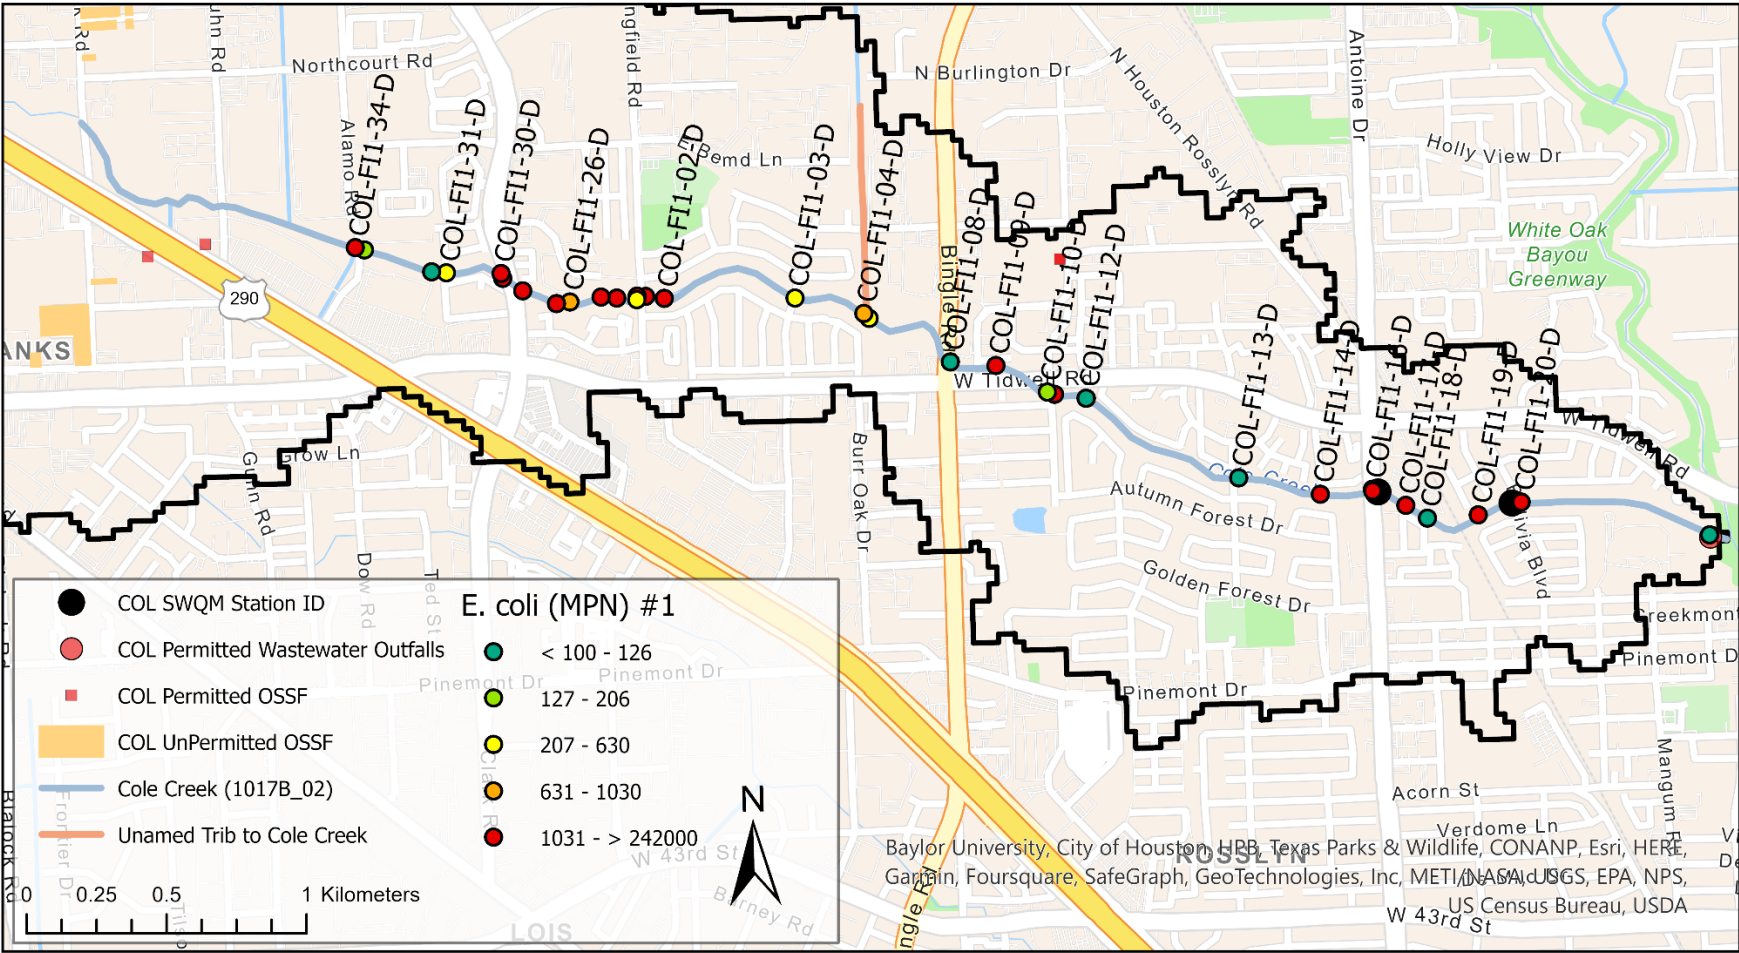
The FI was conducted on May 24, 2023 (eight days since last significant rainfall) and a total of 61 bacteria samples were collected. The values of the bacteria samples collected from downstream of permitted outfalls, directly from unpermitted outfalls, or as ambient samples are summarized in Table 2 and Figure 3. Based on the data collected, four locations with elevated *E. coli* bacteria levels measured during the FI are recommended for high priority and five locations for low priority investigation by the proper authorities. High priority sites had the highest potential bacteria loading observed and are recommended to be the areas for local authorities to focus efforts on should there be insufficient resources to address all referral sites. As time and resources allow the low priority and investigate further referrals also are recommended for further investigation. These locations are summarized in Table 2 and Figure 4. Four locations were flagged where ambient or upstream samples had elevated bacteria levels with no obvious explanations. Further investigation of these areas by the proper authorities is recommended. Each of these referrals are summarized by site, herein. The referral summaries are listed in order of priority (High, Low, then Investigate Further). Within each priority group, sites are listed from downstream to upstream.

Figure 3: Field investigation bacteria sampling Results from on 5/24/2023 on Cole Creek (Assessment Unit 1017B_02).

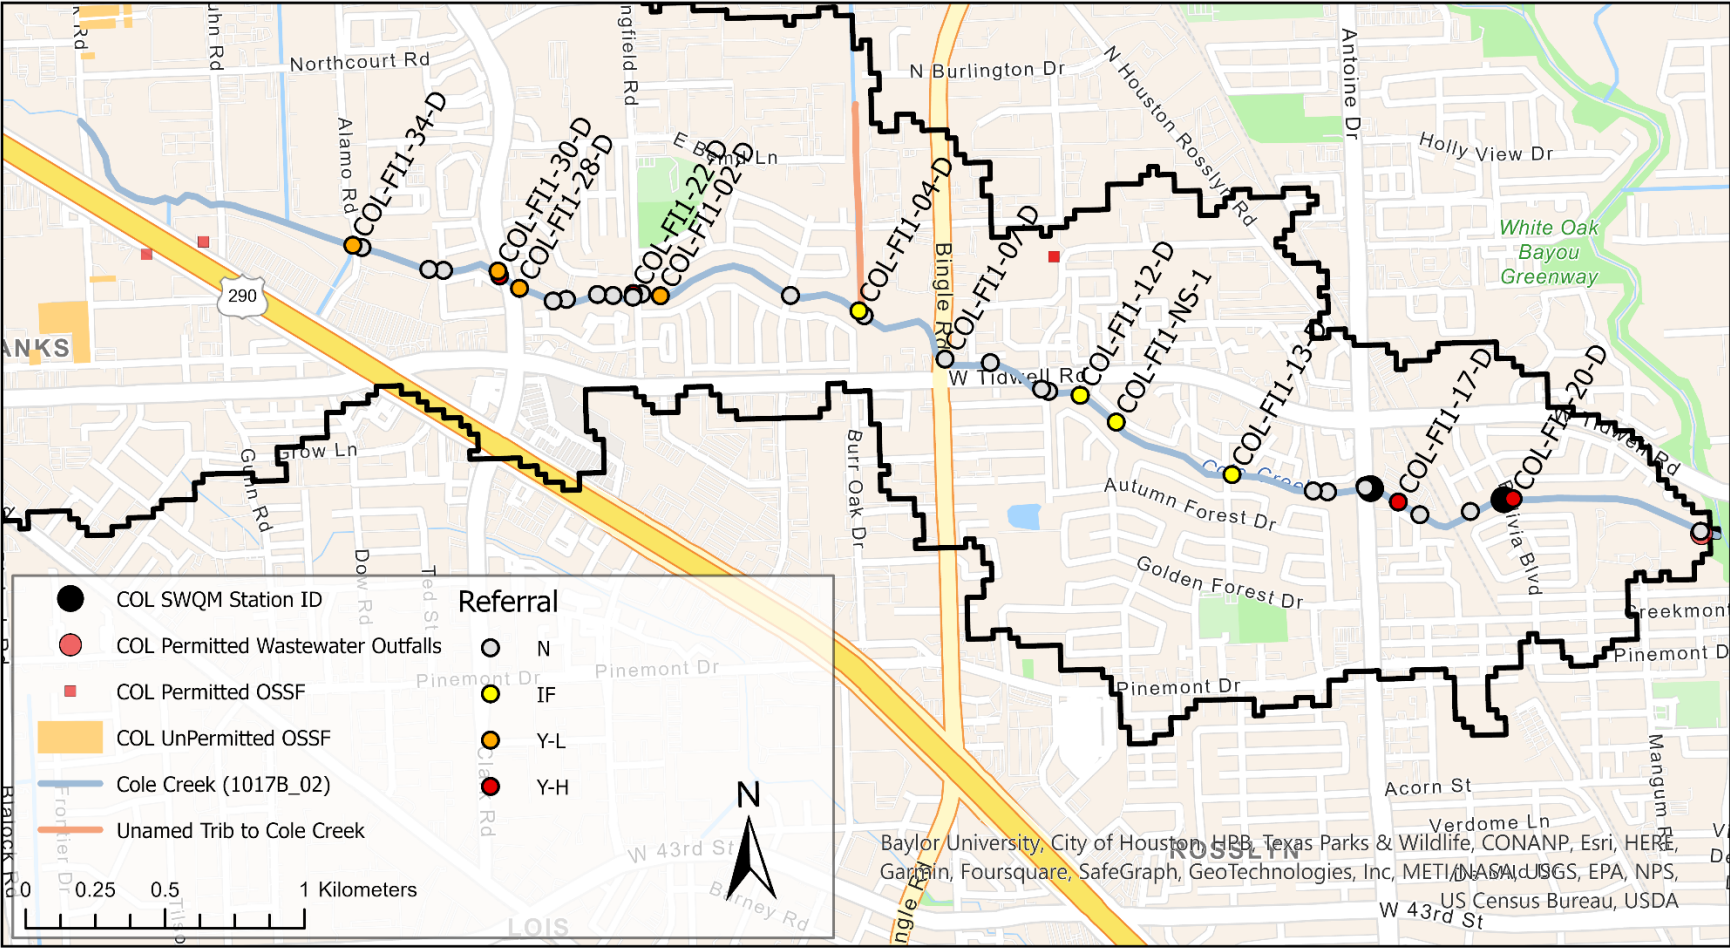
Figure 4: Field investigation sites identified for referral to the proper authorities on Cole Creek (Assessment Unit 1017B_02).
