Targeted Bacteria Monitoring Project

Field Investigation Draft Report

Assessment Unit 1101D_01, Unnamed Tributary of Robinson

May 9, 2023

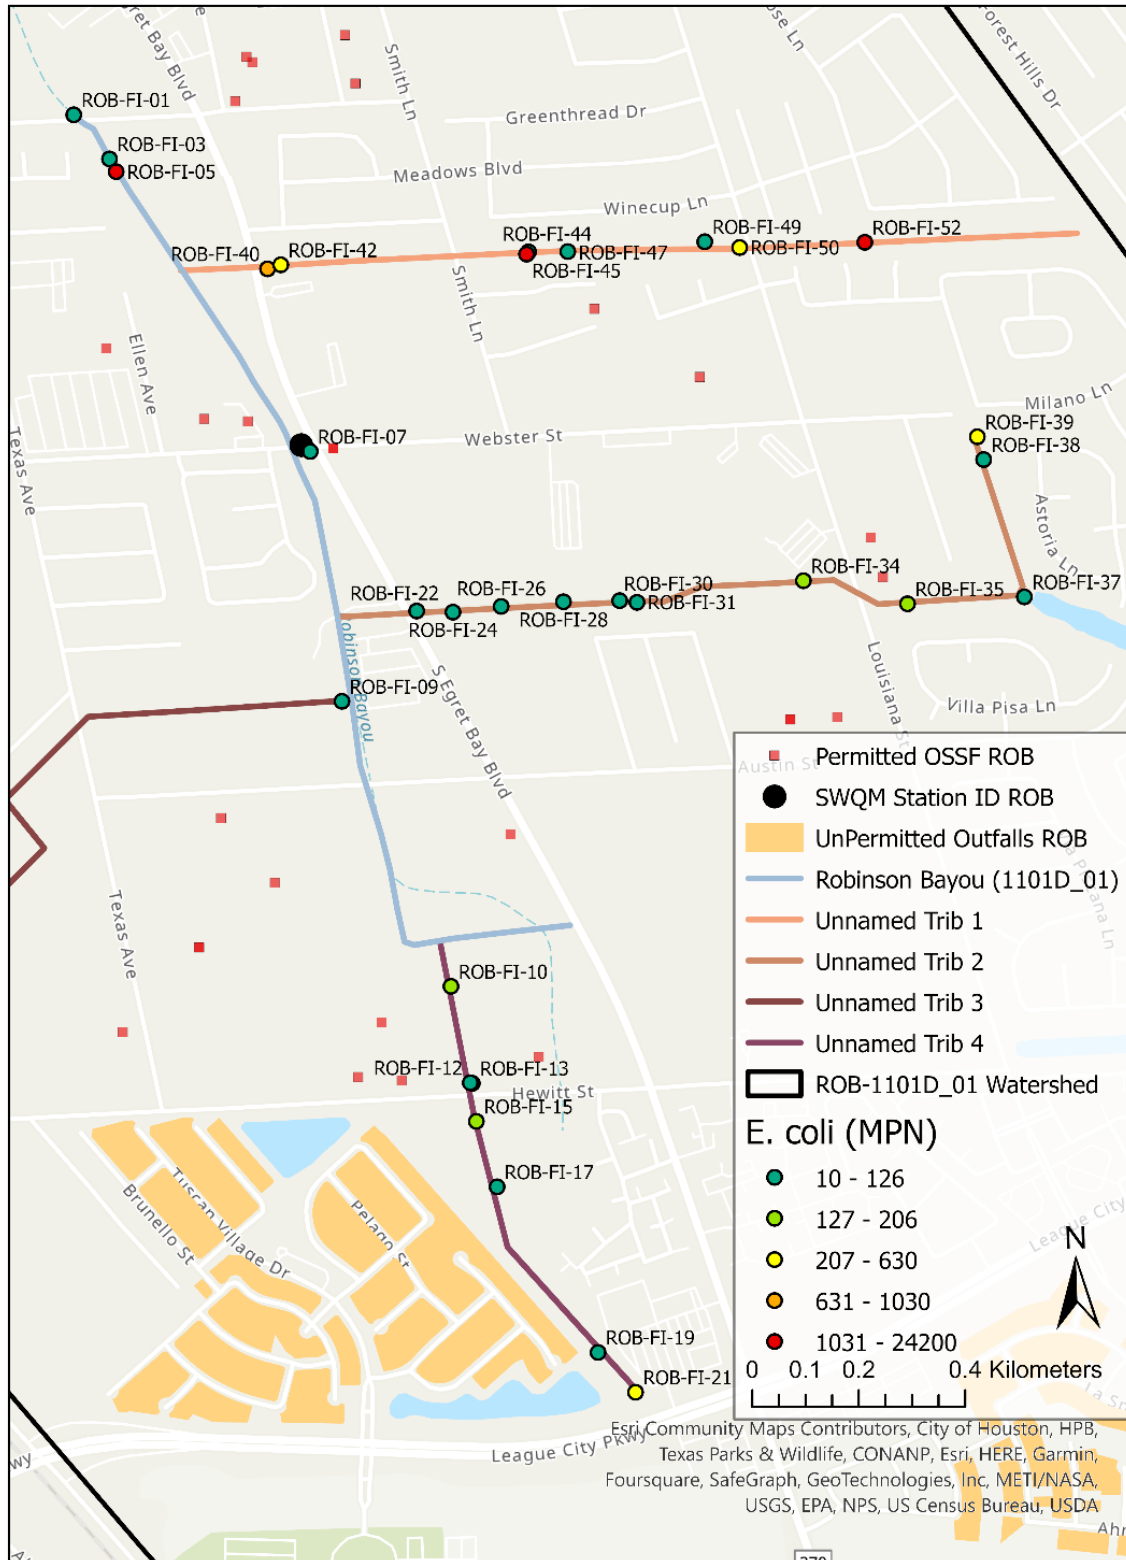
Figure 2: Field investigation bacteria sampling results from 03/11/2021 on Robinson Bayou (AU 1101D_01).

The results from the WS were used to prioritize the FI in 2021 to focus on the main Robinson Bayou assessment unit and the two tributaries on the eastern side of the Bayou which had the highest ambient bacteria results from the WS (Unnamed Trib 1: 355 MPN/100 mL and Unnamed Trib 2: 794 MPN/10 mL). The FI was conducted on March 11, 2021 (6 days since last significant rainfall) and a total of 53 bacteria samples were collected. During the 2021 FI, Robinson Bayou and three unnamed tributaries resulted in multiple culverts and pipes contributing to elevated bacteria levels. The values of the bacteria samples collected from downstream of permitted outfalls, or directly from unpermitted outfalls are illustrated in Figure 2. A total of nine referral locations with elevated *E. coli* bacteria levels measured during the FI in 2021 were recommended for further investigation by the proper authorities (Oakley, 2021). Based on these results, a second FI on this segment was recommended to be sampled in 2023.

Because no elevated bacteria levels were observed downstream of this AU during the 2021 FI, only the above-tidal portion of this segment was sampled in 2023 (AU 1101D_01). Based upon the results of the 2021 FI, a FI covering the entire length of the AU was recommended. The first unnamed tributary at the northern portion of Robinson Bayou exhibited the highest bacteria levels of all of the unnamed tributaries during the 2021 FI and as time allowed, was sampled again in 2023. A sample was taken at the confluence of the western most unnamed tributary to Robinson Bayou during the 2021 WS and FI and the bacteria levels were < 126 therefore it was not recommended to be sampled in 2023.

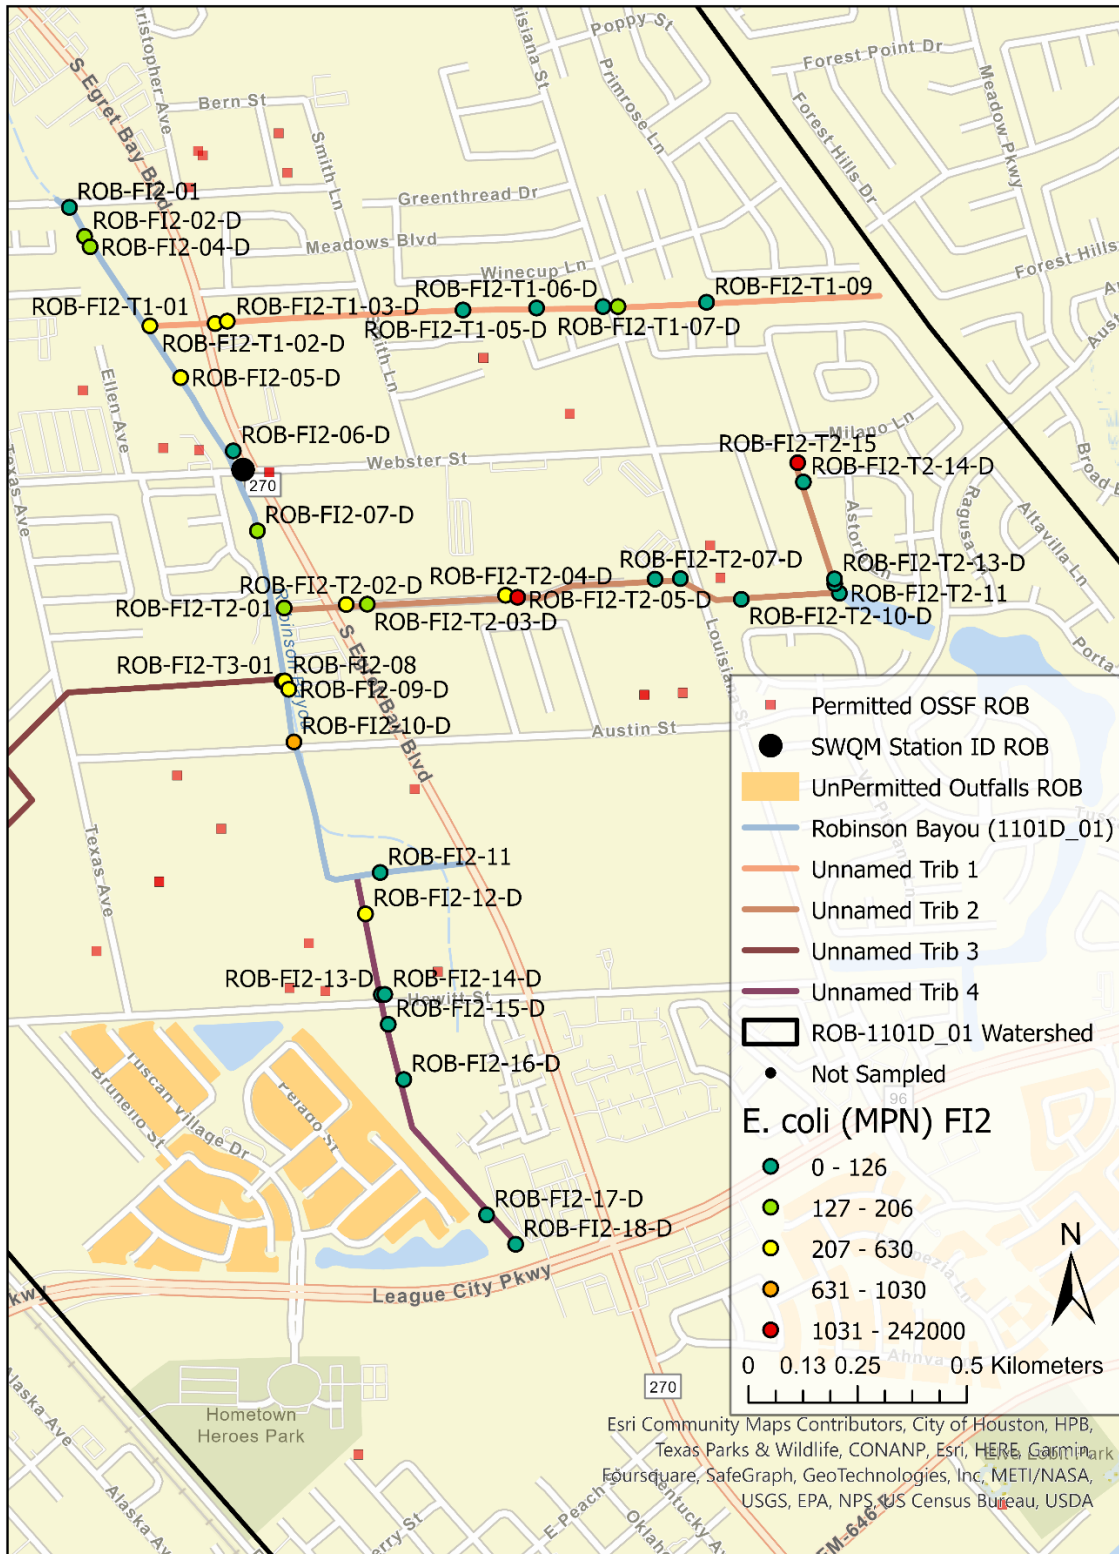
Figure 3: Field investigation bacteria sampling results from 5/2/2023 on Robinson Bayou (Assessment Unit 1101D_01).

The FI was conducted on May 2, 2023 (three days since last significant rainfall) and a total of 70 bacteria samples were collected. The values of the bacteria samples collected from downstream of permitted outfalls, directly from unpermitted outfalls, or as ambient samples are summarized in Table 1 and Figure 3. Based on the data collected, four locations with elevated *E. coli* bacteria levels measured during the field investigation are recommended for high priority, and three locations for low priority investigation by the proper authorities. These locations are summarized in Table 1 (highlighted in grey) and Figure 4. In addition, one location was flagged where the ambient sample had elevated bacteria levels with no obvious explanations. High priority sites had the highest potential bacteria loading observed and are recommended to be the areas for local authorities to focus efforts on should there be insufficient resources to address all referral sites. As time and resources allow the low priority and investigate further referrals also are recommended for further investigation. Further investigation of these areas by the proper authorities is recommended. Each of these referrals are summarized by site, herein. The referral summaries are listed in order of priority (High, Low, then Investigate Further). Within each priority group, sites are listed from downstream to upstream.
