Targeted Bacteria Monitoring Project

Field Investigation Final Report

Assessment Unit 10140_01

Spring Branch (Tributary of Buffalo Bayou)

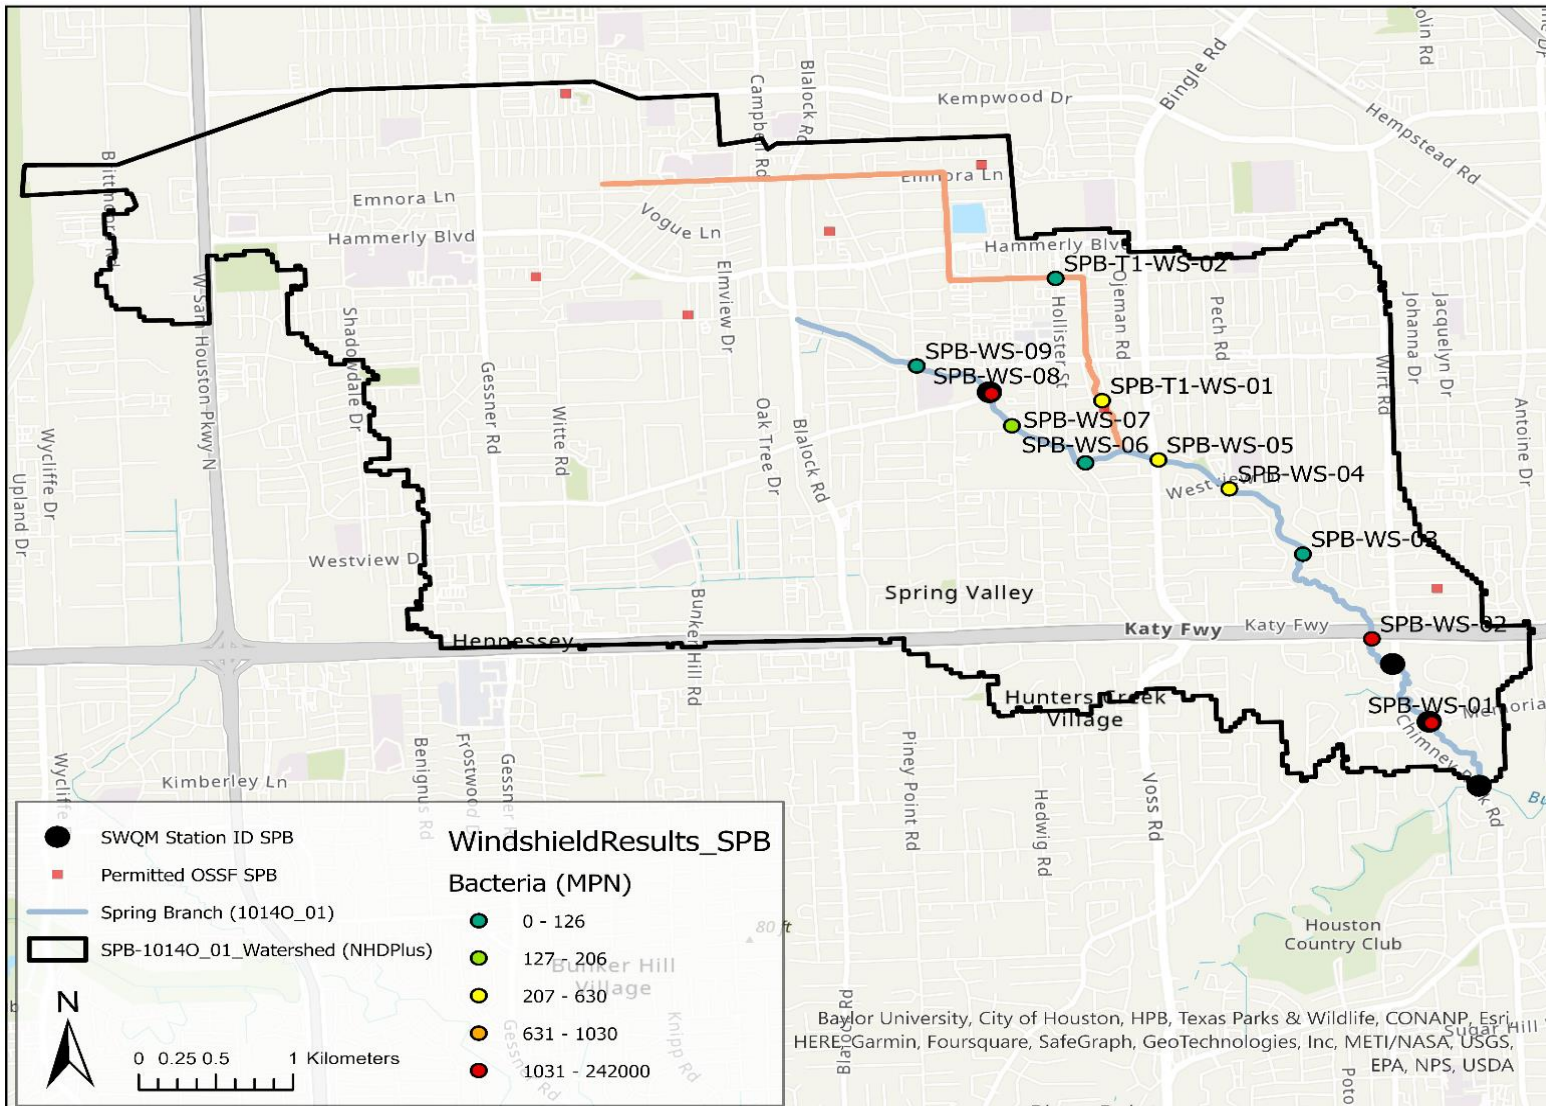
Figure 2 Windshield survey/ground truthing bacteria results from sampling on 03/14/2023 on Spring Branch (Tributary of Buffalo Bayou) (AU 10140_01). Samples were taken at bridge crossings and other easily accessible points.

- 1) SPB-WS-02 was collected on the downstream side of the Interstate 10 Frontage Road and had a bacteria level of > 242,000 MPN/100 mL. The notes indicate that there was an encampment under the bridge upstream of where the sample was collected. This could be a potential source, as the sample collected ~0.6 miles upstream had a result of < 100 MPN/100

mL and that stretch of the stream is surrounded by single-home residences and a large church compound. The one sample collected downstream of this site also had a high level of bacteria (3,180 MPN/100 mL).

Based upon the results of the WS and ground-truthing, a FI covering the entire length of the AU and the unnamed tributary was recommended. Based on the results of the WS, we expected to identify potential point or non-point sources of elevated bacteria near the following portions of the AU:

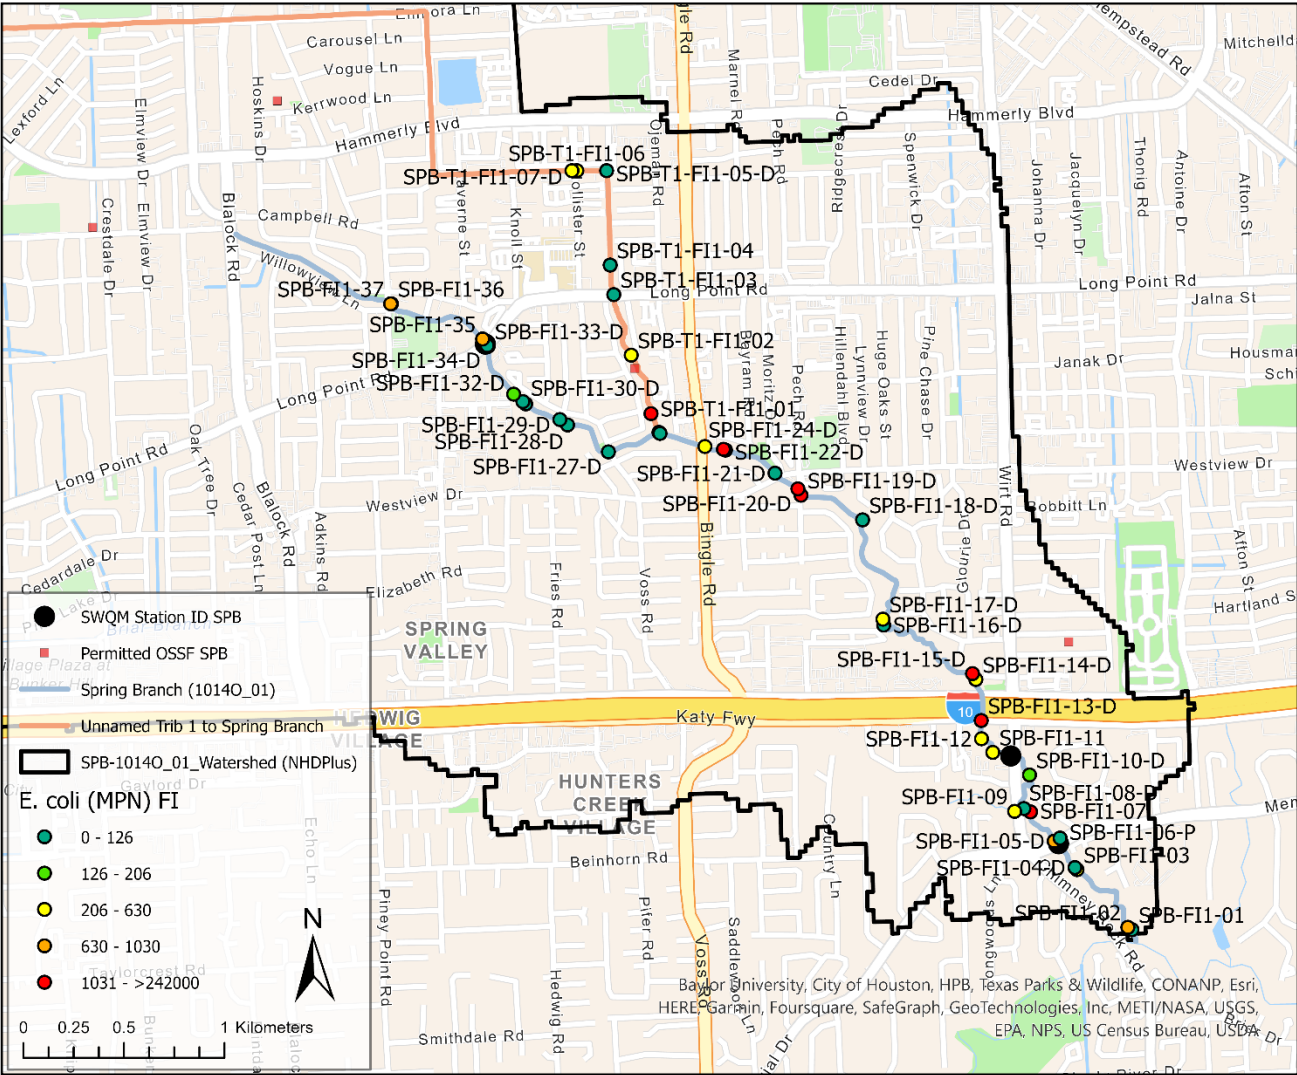
Figure 3: Field investigation bacteria sampling Results from 5/03/2023 on Spring Branch (Assessment Unit 10140_01).

The FI was conducted on May 3rd, 2023 (five days since last significant rainfall) and a total of 70 bacteria samples were collected. The values of the bacteria samples collected from downstream of permitted outfalls, directly from unpermitted outfalls, or as ambient samples are summarized in Table 2 and Figure 3. Based on the data collected, three locations with elevated *E. coli* bacteria levels measured during the FI are recommended for high priority and two locations for low priority investigation by the proper authorities. High priority sites had the highest potential bacteria loading observed and are recommended to be the areas for local authorities to focus efforts on should there be insufficient resources to address all referral sites. As time and resources allow the low priority and investigate further referrals also are recommended for further investigation. These locations are summarized in Table 2 (highlighted in grey) and Figure 4. In addition, nine locations were flagged where ambient or upstream samples had elevated bacteria levels with no obvious explanations. Further investigation of these areas by the proper authorities are recommended. Each of these referrals are summarized by site, herein. The referral summaries are listed in order of priority (High, Low, then Investigate Further). Within each priority group, sites are listed from downstream to upstream.

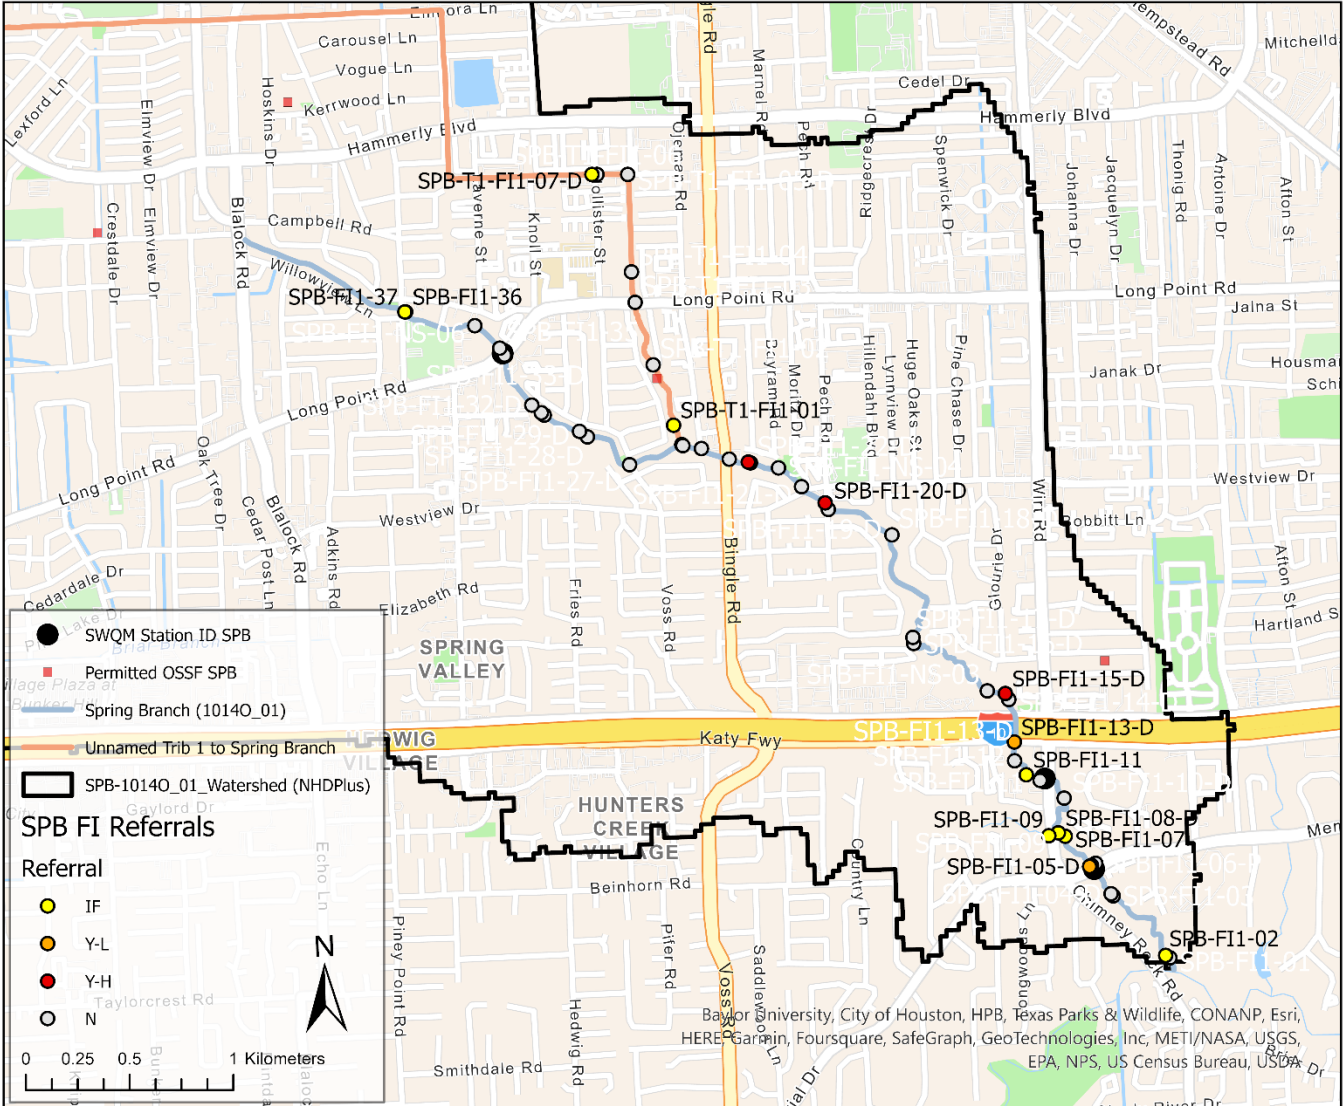
Figure 4: Field investigation sites identified for referral to the proper authorities on Spring Branch (Assessment Unit 10140_01).

Referral site: SPB-FI1-15-D- High Priority
