Targeted Bacteria Monitoring Project

Field Investigation Final Report

Assessment Unit 1017D_01,
Unnamed Tributary of White Oak Bayou

May 10, 2023

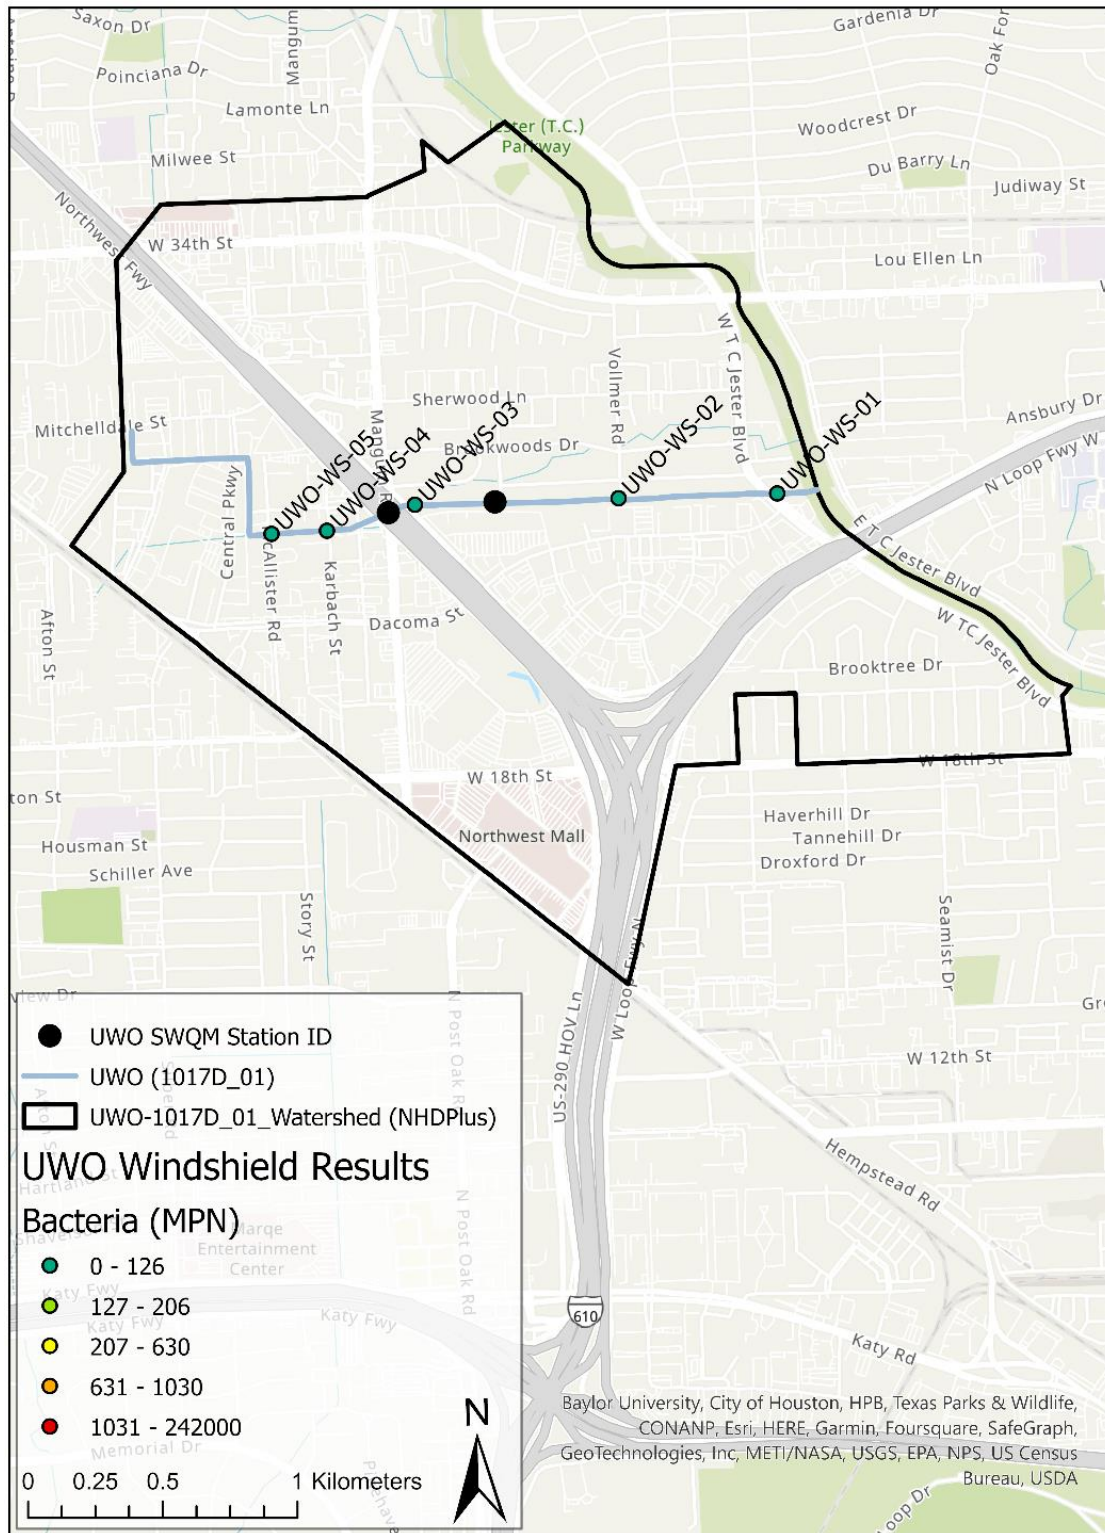
Figure 4 Windshield survey/ground truthing bacteria results from sampling on 03/14/2023 on Unnamed Tributary of White Oak Bayou (AU 1017D_01). Samples were taken at bridge crossings and other easily accessible points.

The WS was conducted on March 14, 2023. At that time, it had been 12 days since the last significant rainfall in the watershed. A total of five samples were collected on AU 1017D_01 during the WS (Table 1 and Figure 4). While the AU continues past UWO-WS-05 at McAllister Rd., there was no surface water observed upstream of this point. While AU 1017D_01 is 2.96 km long, the distance of the wetted stream for the WS was 2.1 km. Based upon the results of the WS, no sections of the AU were identified for focus during future FIs. A detailed FI throughout the entire assessment unit was still conducted.

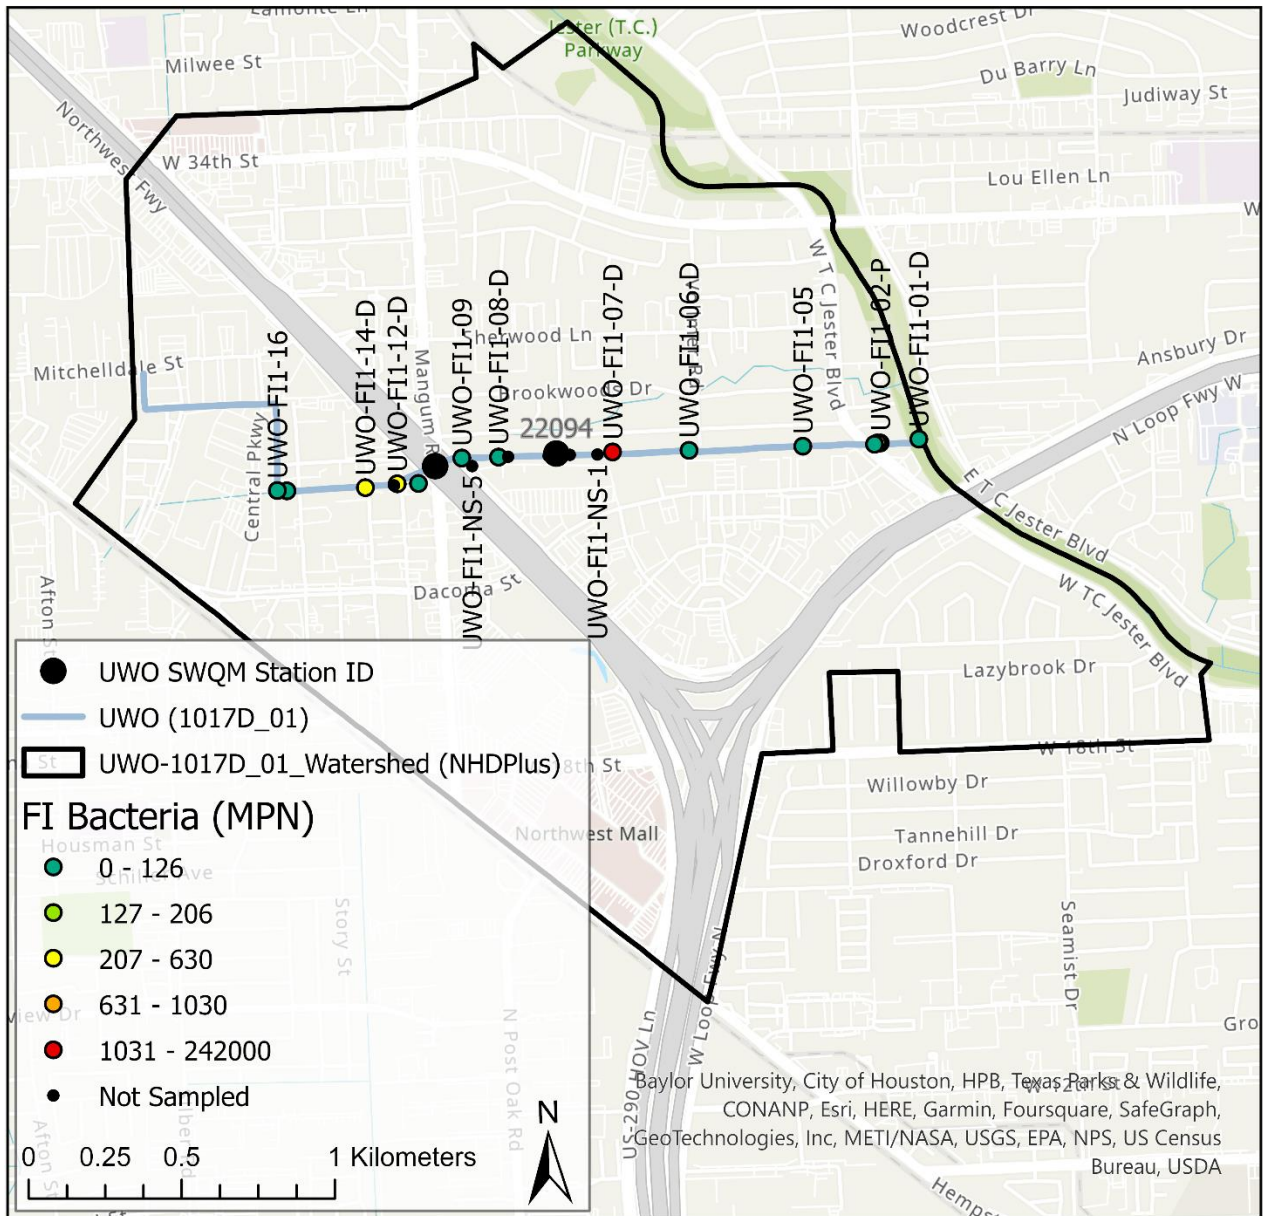
Figure 3: Field investigation bacteria sampling Results from 3/31/2023 on Unnamed Tributary of White Oak Bayou (Assessment Unit 1017D_01).

are summarized in Table 2 and Figure 3. Based on the data collected, two locations with elevated *E. coli* bacteria levels measured during the field investigation are recommended for high priority, and one location for low priority investigation by the proper authorities. These locations are summarized in Table 2 (highlighted in grey) and Figure 4. In addition, one location was flagged for investigate further where the upstream sample had elevated bacteria levels with no obvious explanations. High priority sites had the highest potential bacteria loading observed and are recommended to be the areas for local authorities to focus efforts on should there be insufficient resources to address all referral sites. As time and resources allow the low priority and investigate further referrals also are recommended for further investigation. Each of these referral summaries are listed in order of priority (High, Low, then Investigate Further). Within each priority group, sites are listed from downstream to upstream.

UWO-FI1-14-D	29.80980	-95.46139	410	100	310	Y-L	Pipe is submerged and we are unable to tell if it is leaking but the concrete bank around it is collapsed and there is a deep pool under it.
UWO-FI1-15	29.80977	-95.46404	< 100	NA	NA	N	Ambient sample. White film on substrate. Small pool amidst very narrow and shallow section of tributary. Possible chemical (grease?) smell to sample. Flow is just a trickle.
UWO-FI1-16	29.80979	-95.46436	< 100	NA	NA	N	Top of wetted segment. Pipe seems to be main source of flow as it is completely dry upstream of here (after it turns 90 degrees to north) pipe comes from underground to west.
