Targeted Bacteria Monitoring Project

Field Investigation Final Report

Assessment Unit 1017_03, White Oak Bayou Above Tidal

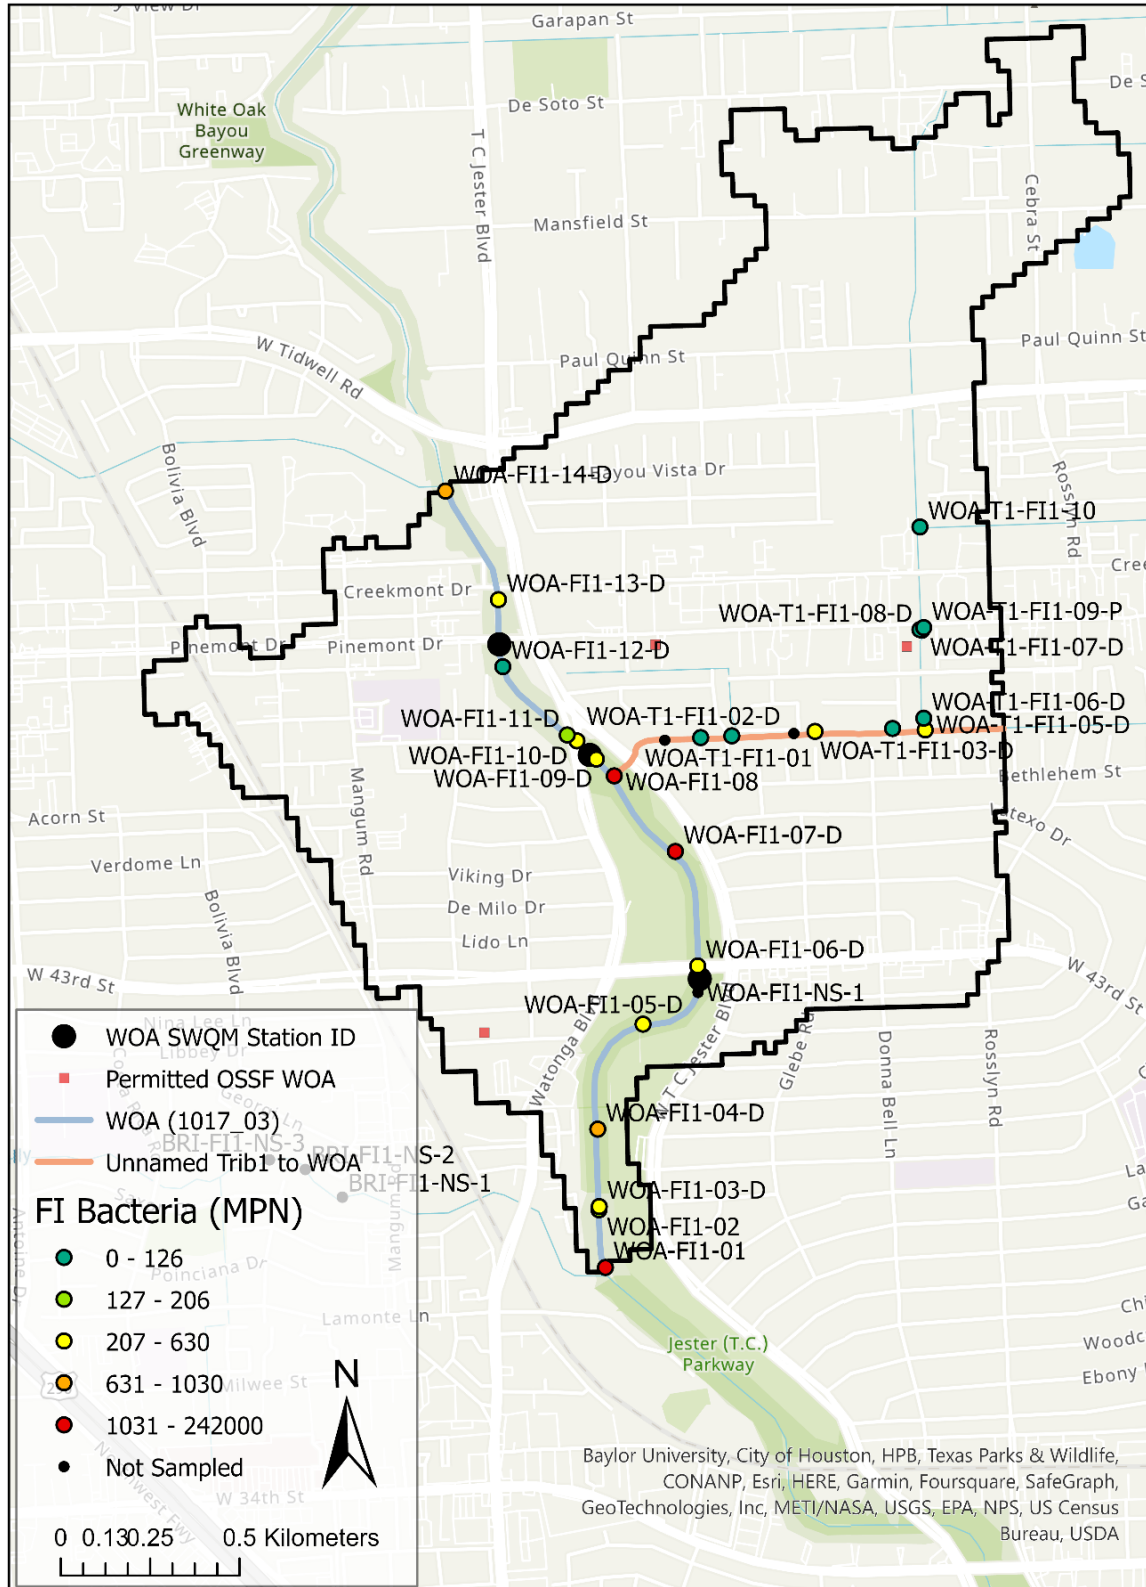
Figure 3: Field investigation bacteria sampling results from 4/3/2023 on White Oak Bayou Above Tidal (Assessment Unit 1017_03).

The FI was conducted on April 3, 2023 (seventeen days since last significant rainfall) and a total of 41 bacteria samples were collected on the main AU and a contributing tributary. The values of the bacteria samples collected from downstream of permitted outfalls, directly from unpermitted outfalls, or as ambient samples are summarized in Table 2 and Figure 3. Based on the data collected, three locations with elevated *E. coli* bacteria levels measured during the FI are recommended for high priority, and three locations for low priority investigation by the proper authorities. High priority sites had the highest potential bacteria loading observed and are recommended to be the areas for local authorities to focus efforts on should there be insufficient resources to address all referral sites. As time and resources allow the low priority and investigate further referrals also are recommended for further investigation. These locations are summarized in Table 2 and Figure 4. In addition, three locations were flagged where ambient or upstream samples had elevated bacteria levels with no obvious explanations. Further investigation of these areas by the proper authorities are recommended. Each of these referrals are summarized by site, herein. The referral summaries are listed in order of priority (High, Low, then Investigate Further). Within each priority group, sites are listed from downstream to upstream.

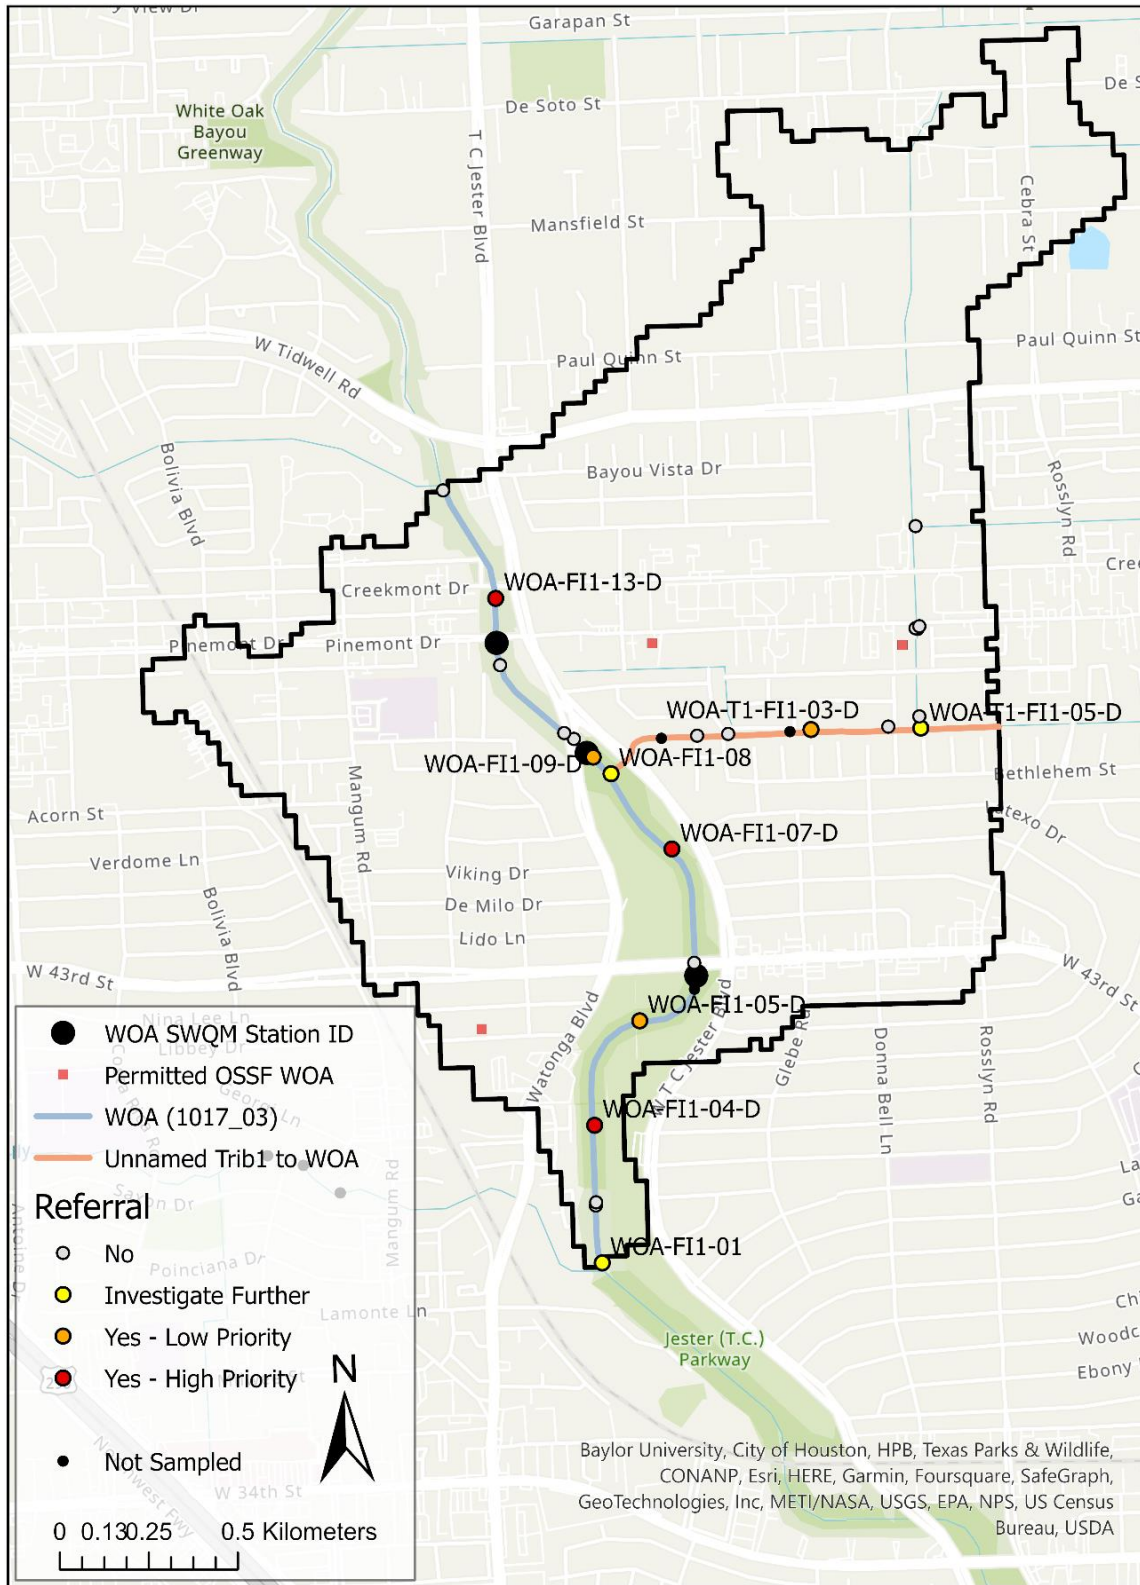
Figure 4: Field investigation sites sampled on 4/3/23 and identified for referral to the proper authorities on White Oak Bayou Above Tidal (Assessment Unit 1017_03).

Referral site: WOA-FI1-04-D - High Priority

This is a 52 in. diameter metal pipe located on the left bank of White Oak Bayou Above Tidal. Water within the pipe was 0.25 in. deep and discharged onto a concrete lining before entering the AU. There is a walking trail that runs parallel with the bayou located on the left bank of this sampling location. Many joggers with dogs were observed utilizing this trail as the field crew was sampling. There is also a park with a public pool located on the left bank of this site, as well as many residential homes located in the adjacent area on the left bank. The area on the right bank is predominantly residential, with many apartment complexes and several schools. A sample taken 5.0 m downstream of the pipe had a bacteria value of 750 MPN/100 mL. The ambient sample collected upstream of the pipe had a bacteria value of 100 MPN/100 mL. This pipe is a high priority referral site for the proper local authority.
