Targeted Bacteria Monitoring Report

Field Investigation Final Report

Assessment Unit 1017E_01, Unnamed Tributary of White Oak Bayou

May 15, 2023

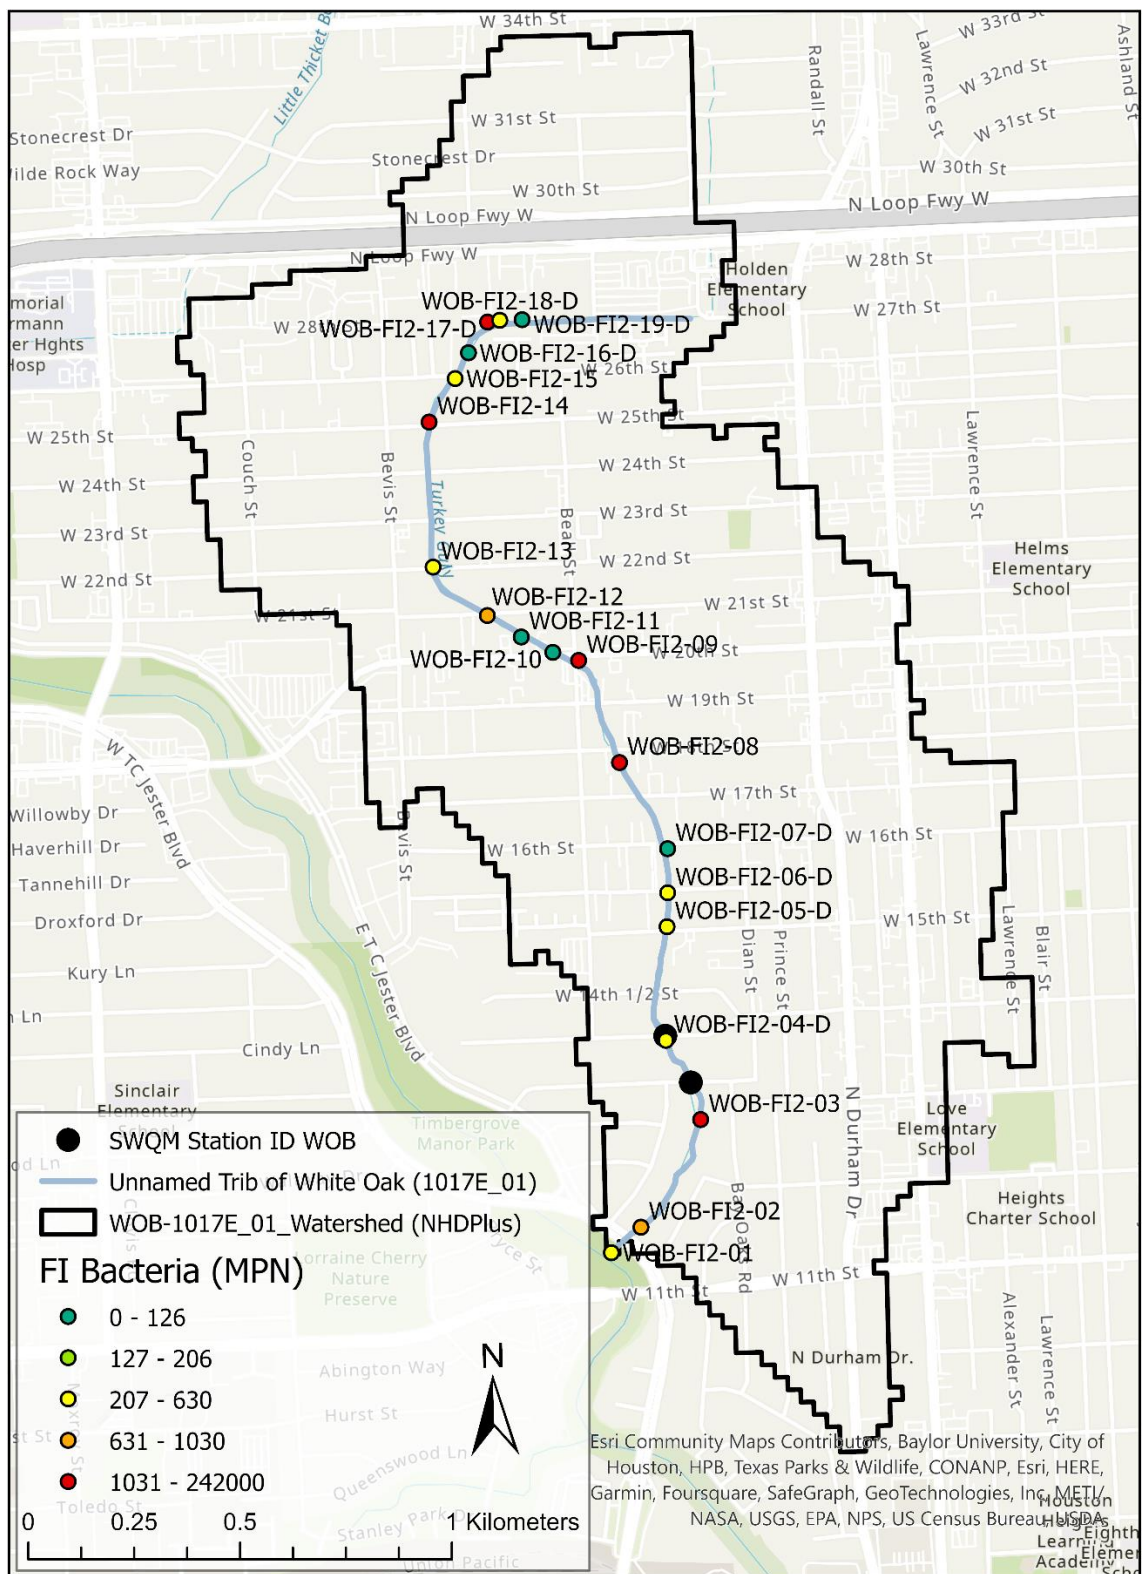
Figure 3: Field investigation bacteria sampling Results from 03/30/2023 on the Unnamed Tributary of White Oak Bayou (Assessment Unit 1017E_01).

The FI was conducted on March 30, 2023 (13 days since last significant rainfall) and a total of 27 bacteria samples were collected. The values of the bacteria samples collected from downstream of permitted outfalls, directly from unpermitted outfalls, or as ambient samples are summarized in Table 1 and Figure 3. Based on the data collected, two locations with elevated *E. coli* bacteria levels measured during the FI are recommended for high priority investigation by the proper authorities. High priority sites had the highest potential bacteria loading observed and are recommended to be the areas for local authorities to focus efforts on should there be insufficient resources to address all referral sites. As time and resources allow the low priority and investigate further referrals also are recommended for further investigation. These locations are summarized in Table 1 and Figure 4. In addition, two locations were flagged where ambient or upstream samples had elevated bacteria levels with no obvious explanations. Further investigation of these areas by the proper authorities are recommended. Each of these referrals are summarized by site, herein. The referral summaries are listed in order of priority (High, Low, then Investigate Further). Within each priority group, sites are listed from downstream to upstream.

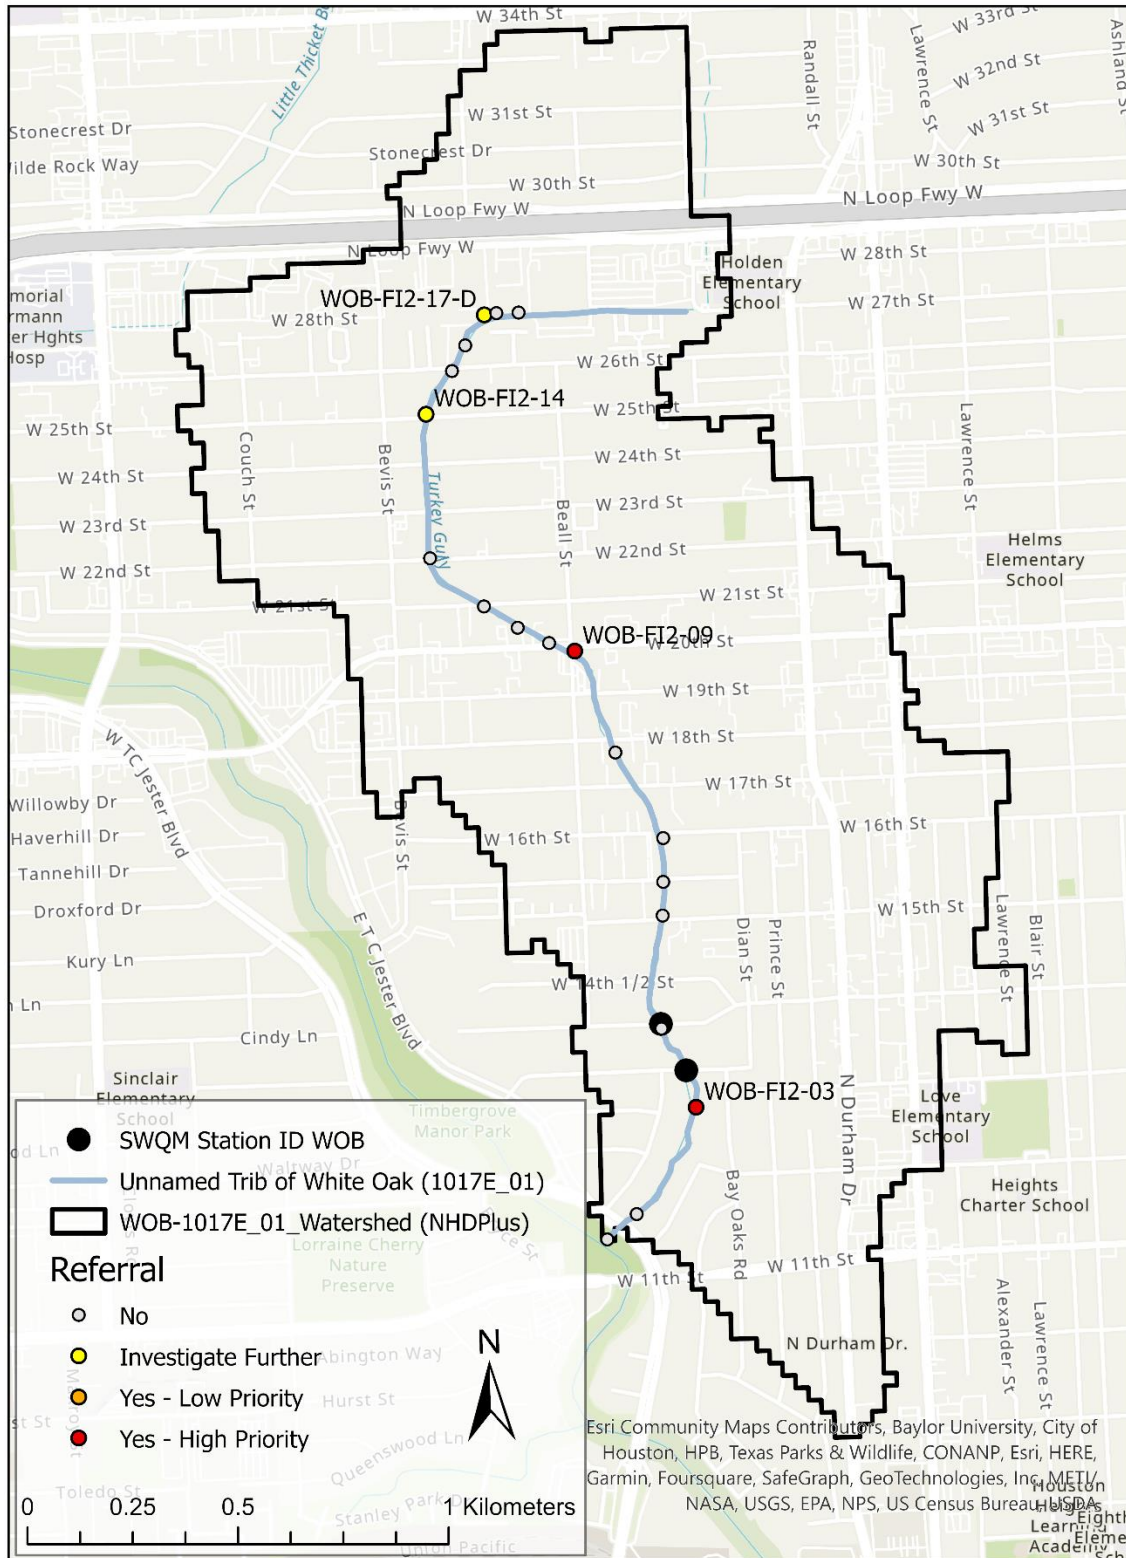
Figure 4: Field investigation sites sampled on 03/30/2023 and identified for referral to the proper authorities on the Unnamed Tributary of White Oak Bayou (Assessment Unit 1017E_01).

Referral site: WOB-FI2-03 – High Priority
