**Central and Southeast Texas Recreational Use-Attainability Analyses Project
Country Club Branch (Segment 1209D) Basic RUA**

Results Report

Contract No. 582-9-90440
EIH Technical Report # 10-008

Prepared by:
George Guillen & Jenny Wrast
University of Houston-Clear Lake

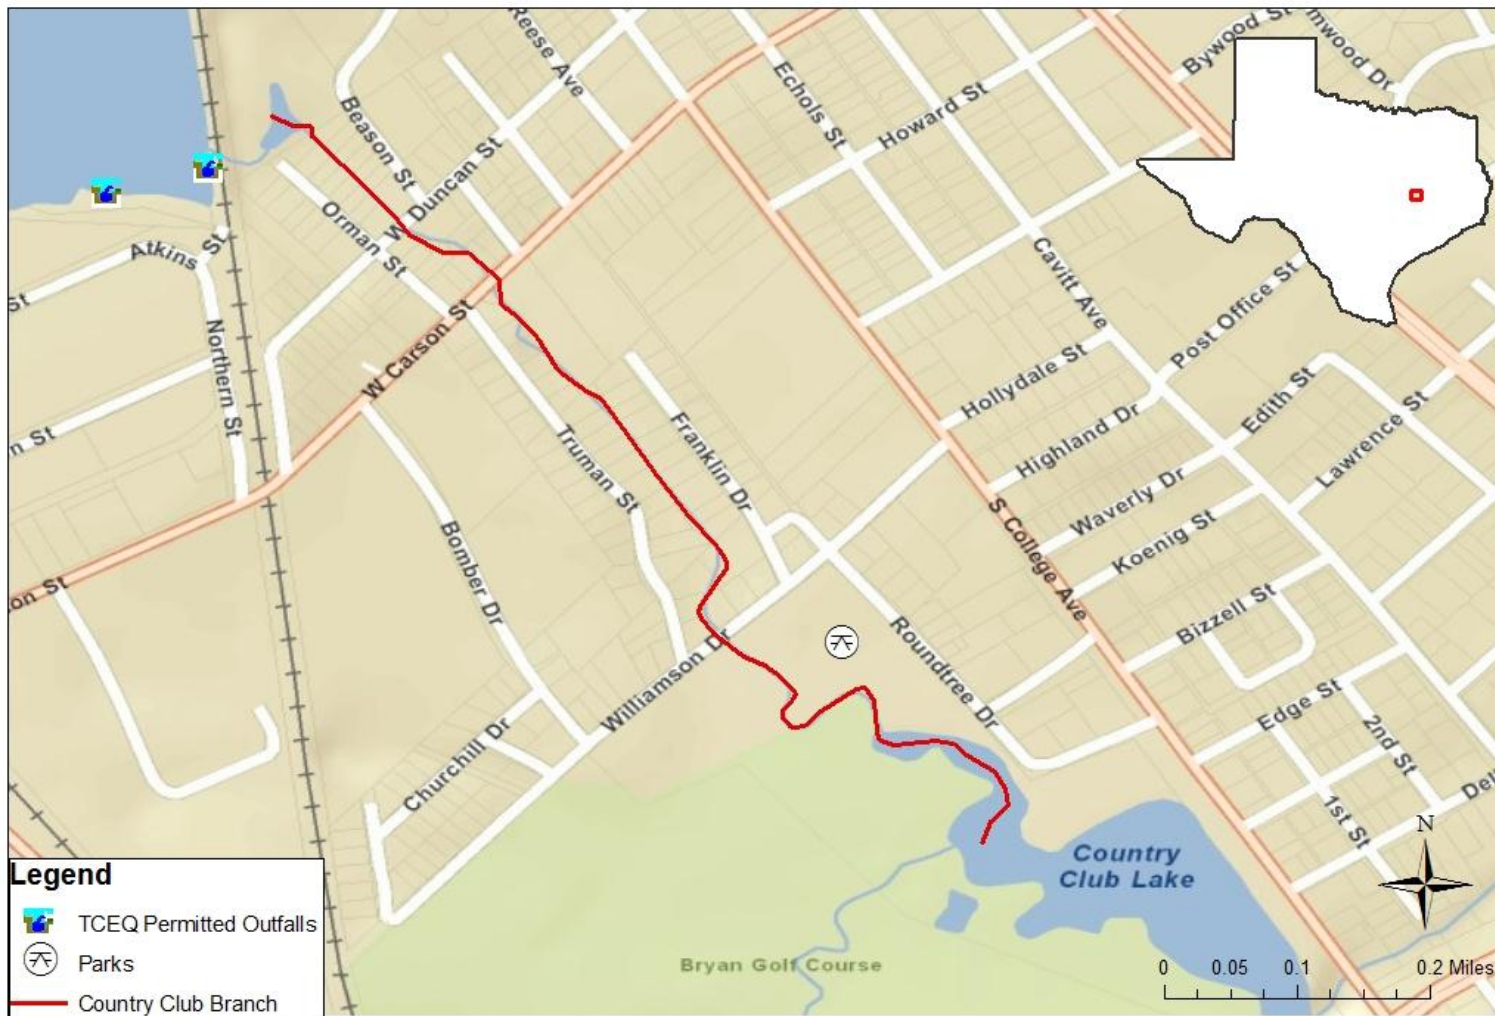
Figure 1. TCEQ permitted outfalls, and public parks adjacent to Country Club Branch, Segment 1209D

Country Club Branch is affected by permitted outfalls as well as storm water runoff from agricultural, industrial, and urban areas. Under TPDES, the TCEQ has two issued permits to the City of Bryan (1) and Atofina Chemical Inc (1) to discharge treated wastewater to the Segment 1209D watershed (Figure 1).

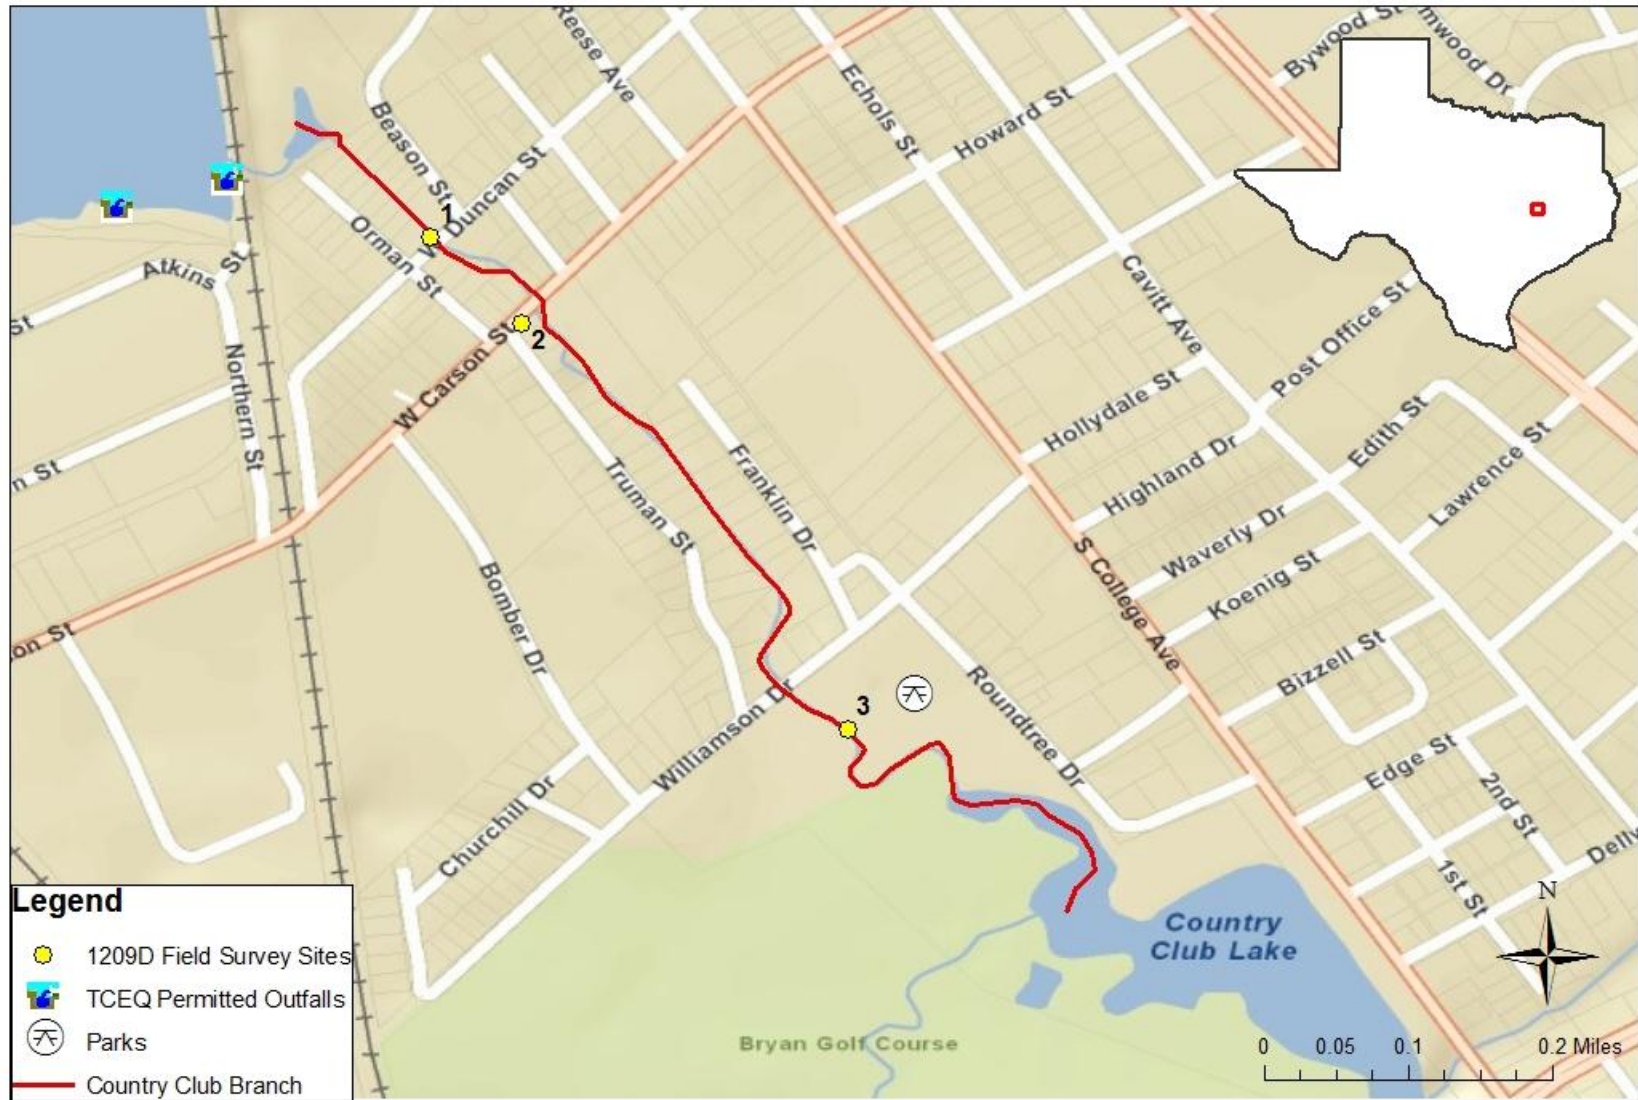
Figure 2. Basic RUAA survey sites on Country Club Branch, Segment 1209D, selections based on river mile/assessment units, accessibility and recreational features.

Table 2. Survey sites for the Basic RUAA Survey on Country Club Branch, Segment 1209D (corresponding to Figure 2 and Table 1)

Recon Site	Field Survey Site	Description	Latitude	Longitude	Approx. River Mile
2	1	W Duncan @ Country Club Branch (TCEQ Site: 11795)	30.64850	-96.36903	0.75
3	2	Carson St @ Country Club Branch	30.64764	-96.36812	0.65
4	3	Williamson Park @ Country Club Branch	30.64354	-96.36484	0.29

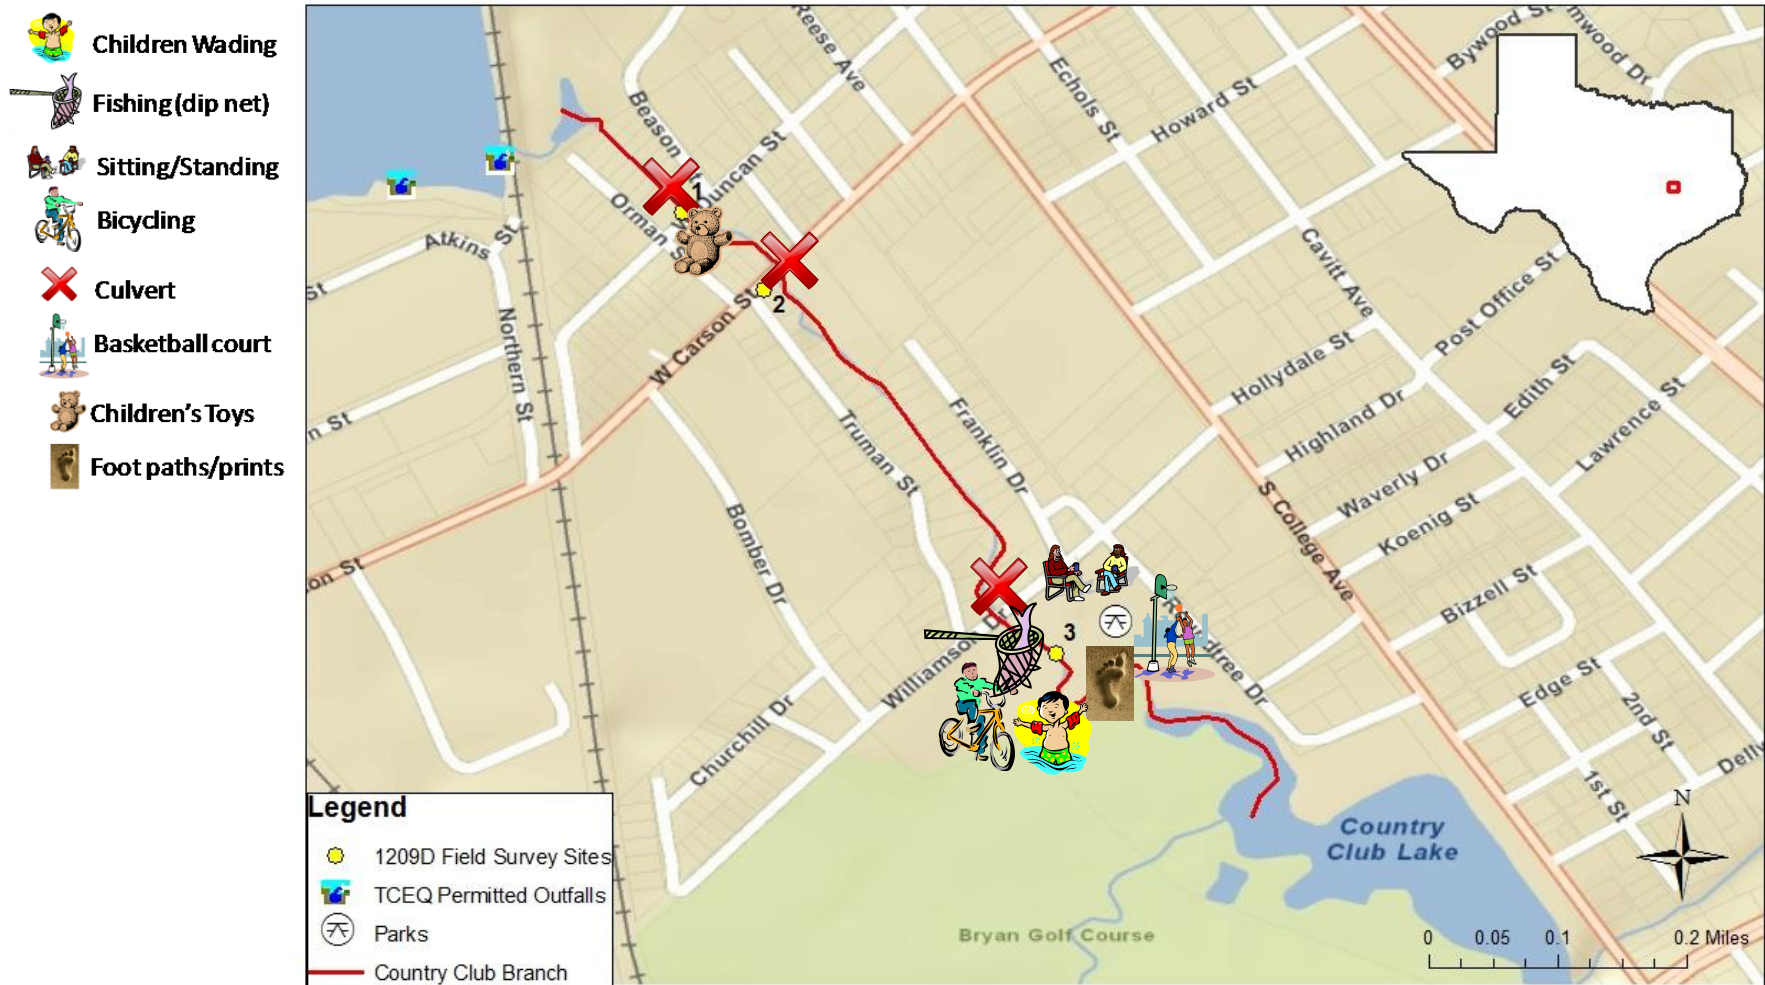
Figure 4. Basic RUAA survey sites on Country Club Branch, Segment 1209D, with depictions of observed recreational uses, evidence of recreational uses, and impediments. Locations are approximate. See Appendix 5: Google Earth Interactive Map for exact locations of uses, evidence, and impediments.

Uses observed from all combined site visits include: Children wading, fishing (dip net), standing, sitting, and bicycling (Table 5, Figure 4, & Appendix 5). The instance of children wading and fishing (using dip nets) occurs frequently (the children mentioned that they go to the creek to catch fish almost every day). The wading children were using small dip nets to capture fish in Country Club Branch, and placing them into Tupperware containers. They continued to play with them and handle the water and fish on the bank. These observed uses occurred at field survey site 3. Other non-contact recreational uses were documented at field survey site 3 and included bicycling, sitting/standing, and playing basketball. Evidence of recreational use in the form of children's toys was documented at field survey site 1. Evidence of foot paths/prints that lead into and out of the water were documented at field survey site 3. Impediments (culverts) to recreational uses were also noted during the field surveys at all three of the field survey sites (Table 5, Figure 4, & Appendix 5).
